**FIELD STUDY OF THERMALLY-INDUCED SOIL-STRUCTURE
INTERACTIONS IN SEMI-INTEGRAL BRIDGE STRUCTURES**

Dissertation

The University of Texas at Austin

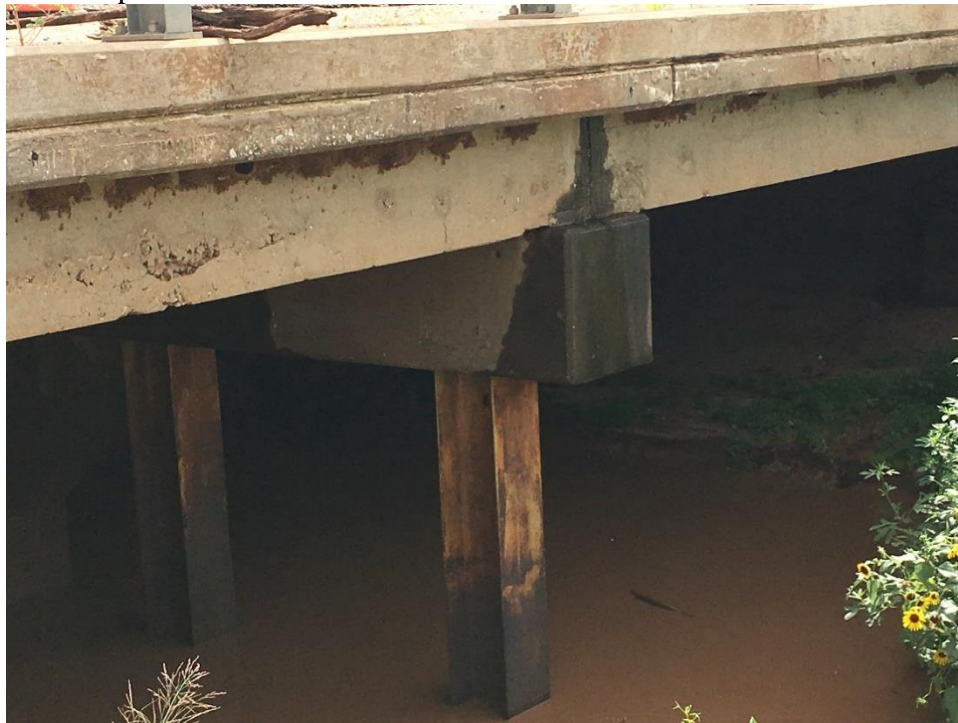
Figure 1. 2: Seepage of surface runoff through the bridge expansion joint between two adjacent spans in China Creek Bridge, Wichita County, TX

It is worth noting that deicing chemicals are commonly used in many areas across the US, as well as in other countries, that experience snow and frost in the wintertime. Such is the case for the bridge shown in Figure 1.2 which is located in the North Texas region. The usage of deicing chemicals increases the corrosivity of the surface runoff and accelerates the rate of deterioration of various bridge components that come in contact with the surface runoff.

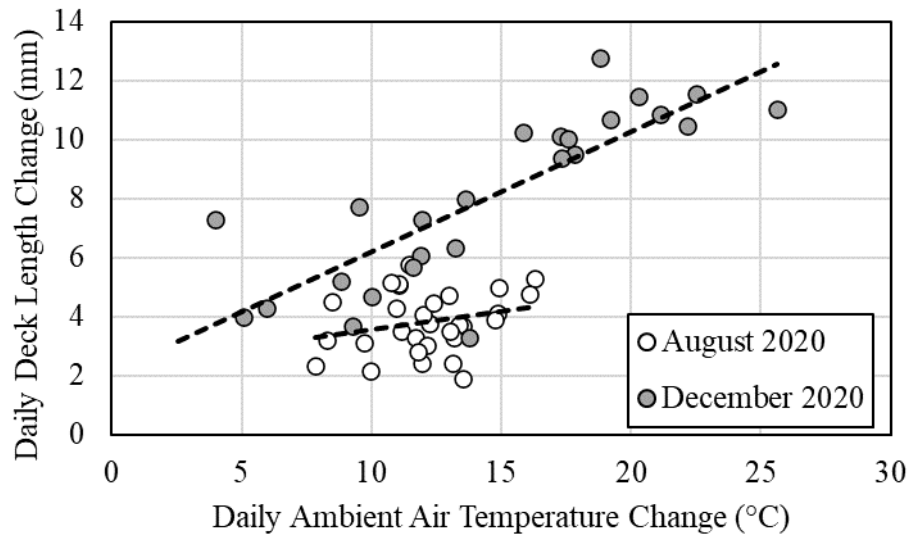
Figure 2.9: Daily changes in deck length as a function of daily ambient air temperature changes (for August and December 2020)

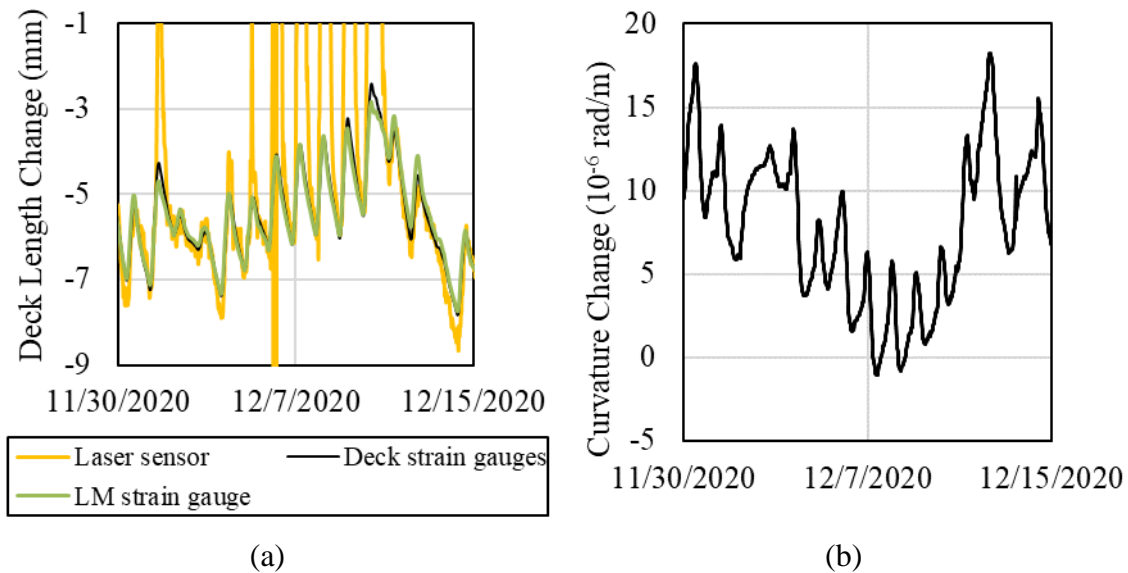
Figure 3.3: Typical time history of data collected in the bridge deck: (a) Deck length changes measured by laser distance sensor, longitudinal deck-embedded strain gauges and perpendicular low modulus (LM) strain gauge (Note: Vertical axis range is truncated and does not display full range of laser sensor measurements); and (b) Changes in deck curvature near the location of the laser distance sensor.

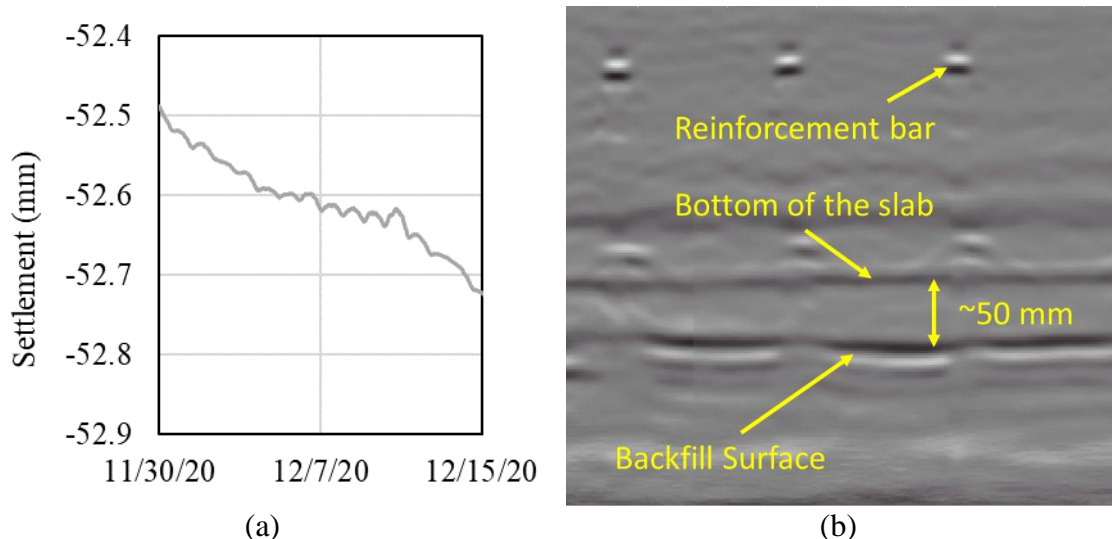
Figure 3.4: Field monitoring results of backfill settlements: (a) West abutment settlements as recorded by the settlement sensor; and (b) west abutment GPR survey profile showing a 50 mm gap between backfill and approach slab at location of settlement sensor.

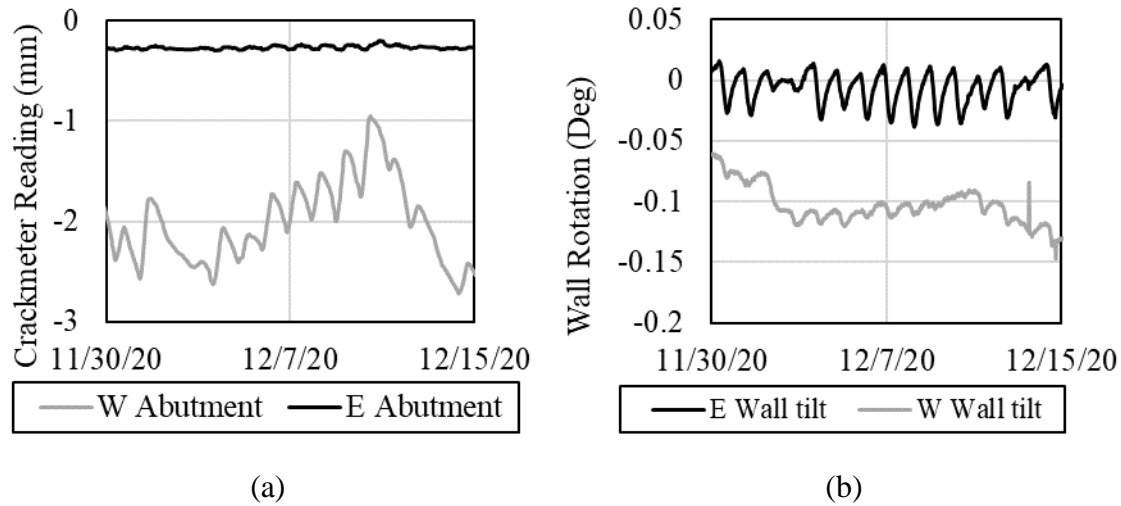
Figure 3.5: Typical time history of movements in the abutment walls: (a) Changes in width of the abutment cap joint as measured by a crackmeter; and (b) abutment wall rotation as measured by a tiltmeter (Note: Positive values indicate tilting towards the backfill)

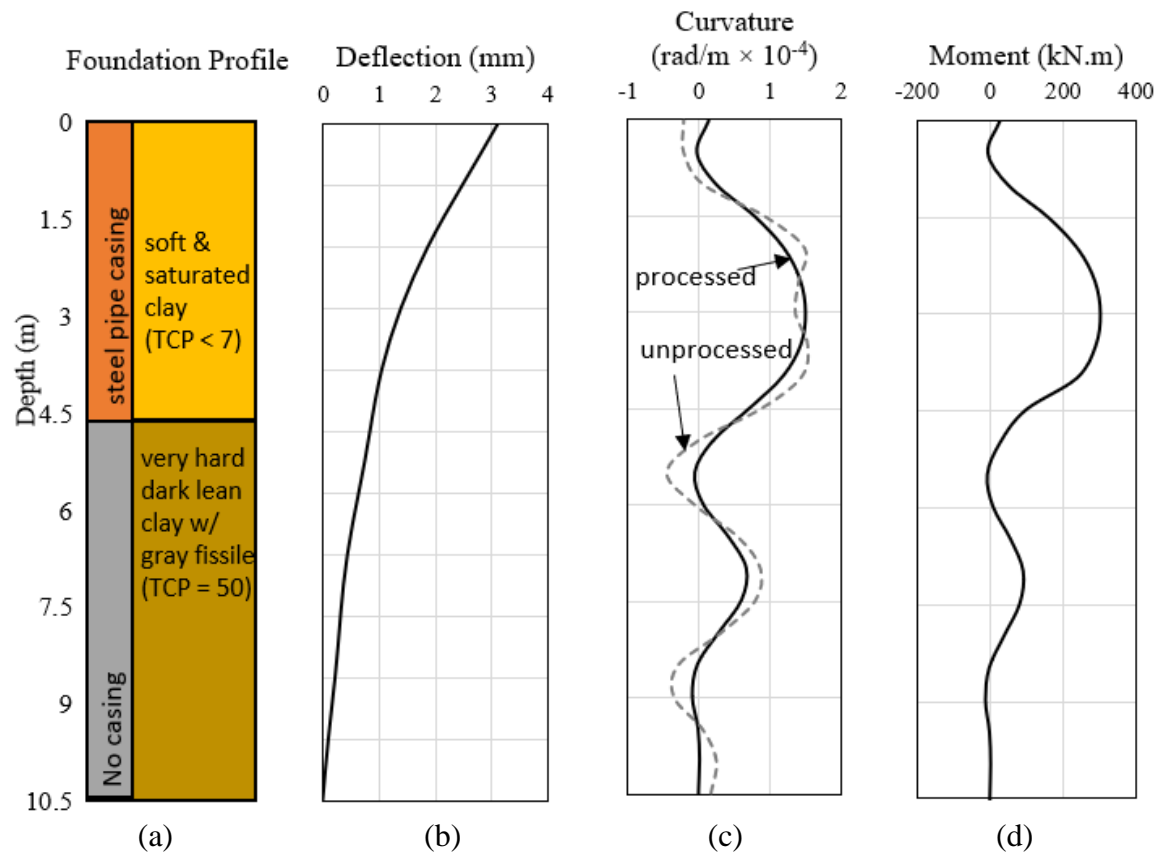
Figure 3.6: West abutment drilled shaft profiles: (a) foundation profile; (b) deflection profile; (c) curvature profile; and (d) moment profile (shape array data captured at 7:30 pm on December 5, 2020).

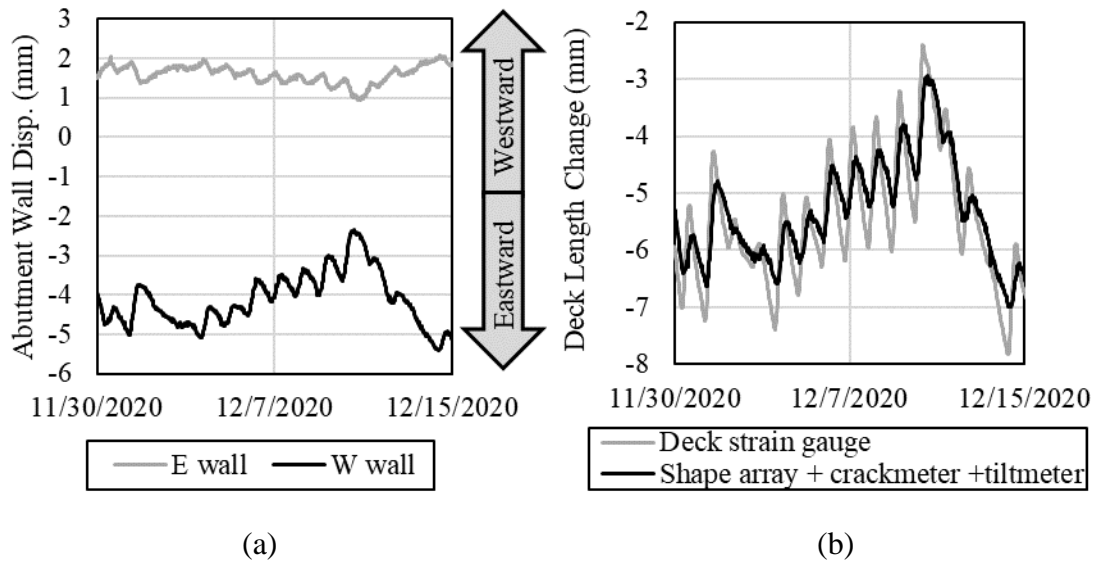
Figure 3.9: Effect of daily temperature variation on expansion/contraction of the bridge: (a) Abutment wall displacement calculated by adding results from the drilled shaft shape arrays to those obtained from the abutment cap crackmeters; and (b) Comparison between the changes in deck length calculated using data from shape arrays, abutment cap crackmeters, and abutment wall tiltmeters versus the data from the deck strain gauges.

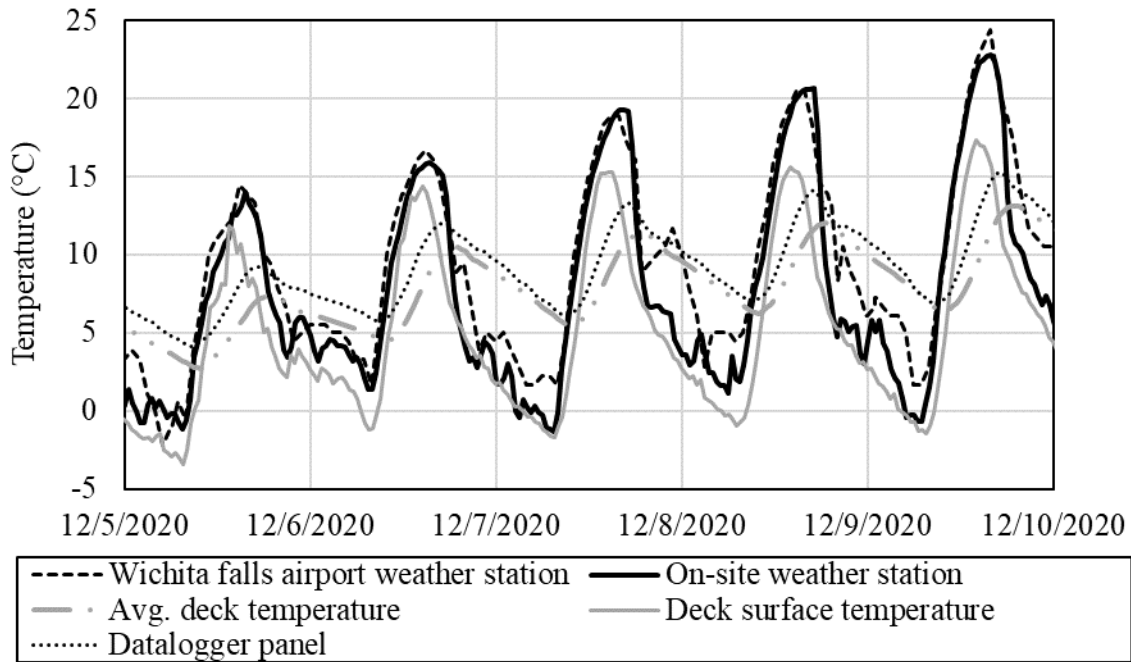
Figure 3.10: Comparison of different temperature records collected at the China Creek Bridge site.

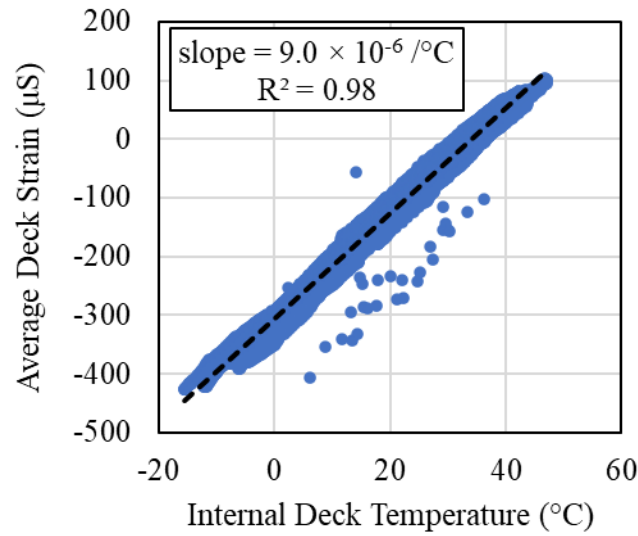
Figure 4.5: Coefficient of Thermal Expansion (CTE) calculation based on deck strain gauges.

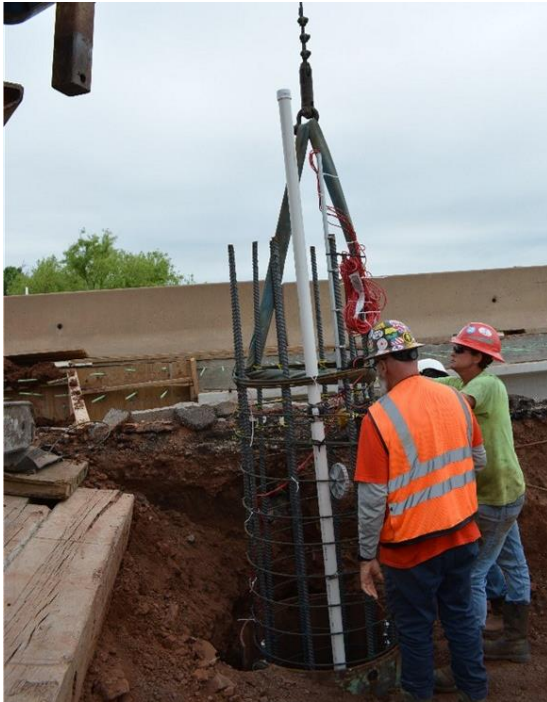
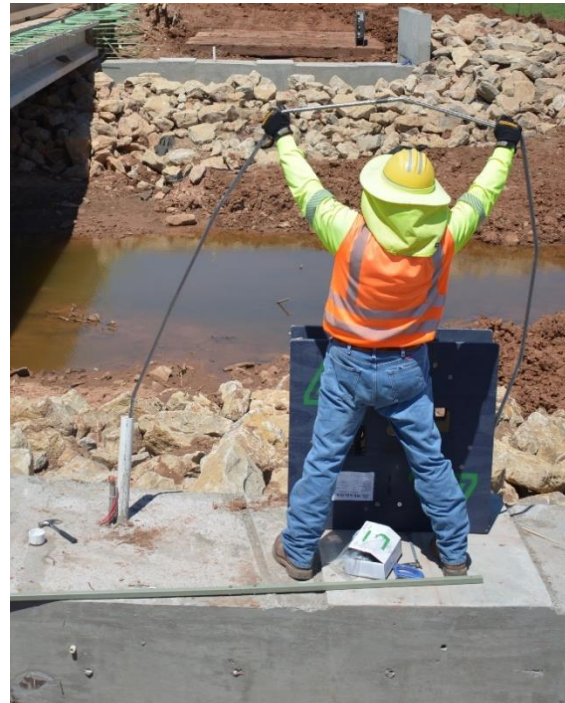
Figure 5.2: Installation of shape arrays in the drilled shaft foundations: (a) Installation of drilled shaft rebar cage fitted with shape array casing; and (b) installation of shape array inside casing after abutment caps were formed.

Figure 5.2 shows instances of the installation of the drilled shaft rebar cage (fitted with a 70-mm PVC conduit) as well as the placement of the shape arrays in one of the drilled shafts. The shape arrays used in this study consist of 22 segments, each of which measuring 0.5 m in length and providing a 3D deformation profile of the drilled shafts.

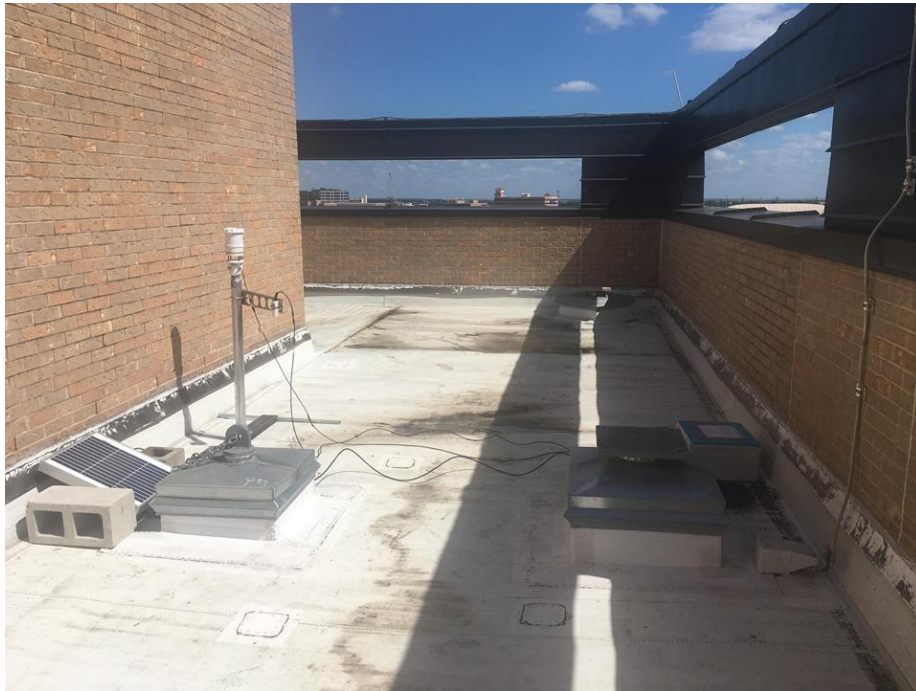
Figure A. 3: Testing of the equipment on the rooftop of Civil Engineering department at UT Austin

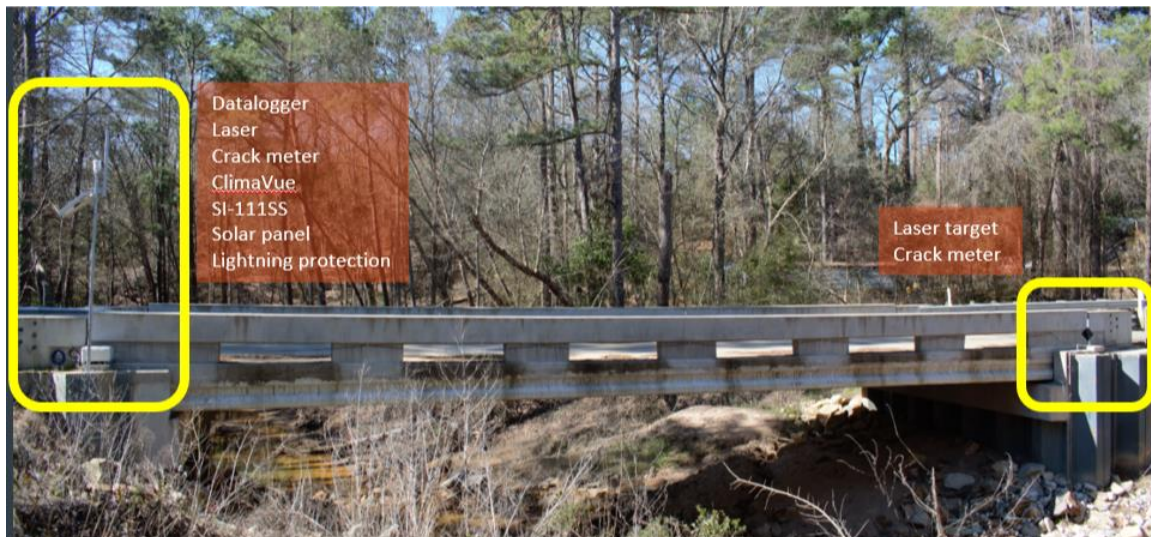
Figure A. 9: Equipment installed on Mack Creek in January 2020

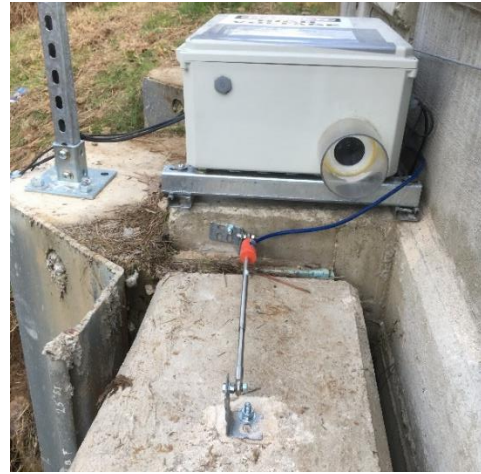
Figure A. 10: Closeup of equipment installed on the south abutment: (a) Logger equipment and laser distance meter (b) crackmeter installed between backwall and pile cap + loggerbox

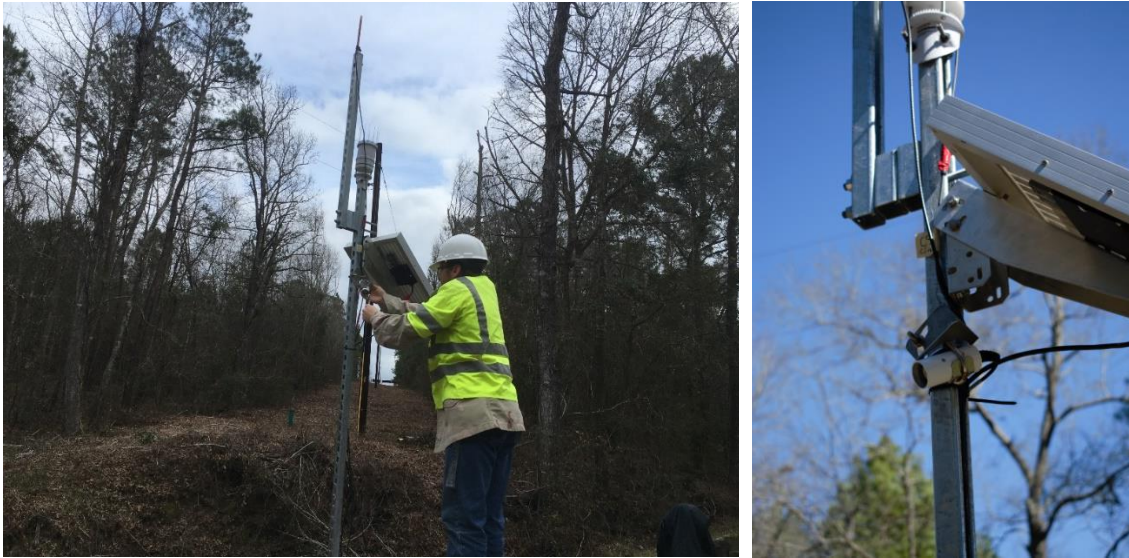
Finally, a 3.3 m unistrut section was used as a pole to install solar panel, ClimaVue50, SI-111SS and lightning protection equipment (Figure A. 12). This pole was placed as far from the road as possible on the edge of the wingwall. The solar panel faces south to catch the most sun and ClimaVue50 was equipped with a bird spike kit to prevent issues arising from birds sitting on top of the device. Moreover, SI-111SS which has a 22° half angle field of view was mounted near the top and pointed at the deck in such way that full field of view of the device, covers the deck and not the surroundings. This device is designed to measure the average temperature of the surface it is pointed at, based on the infrared radiations coming from the target surface.

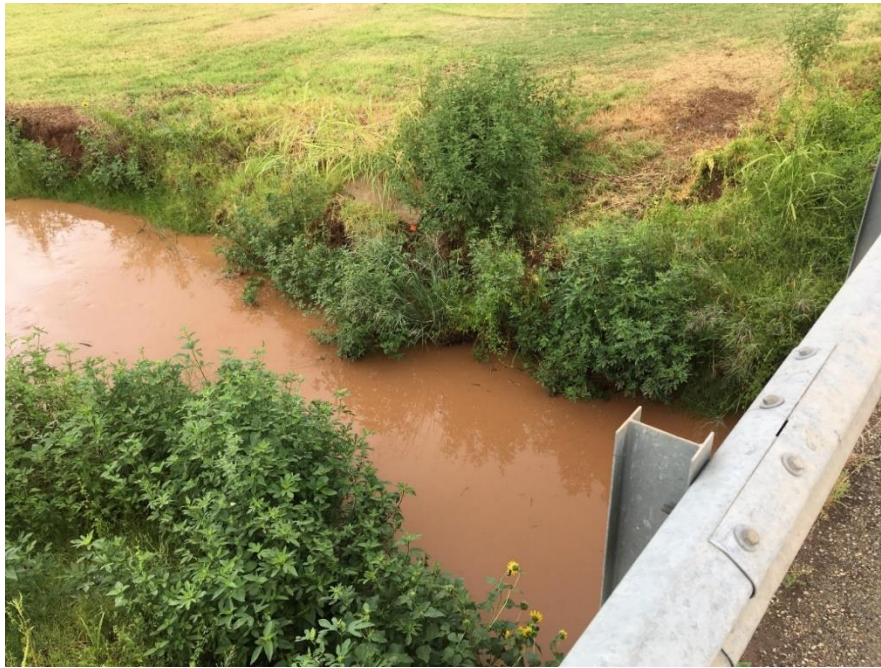
Figure B. 1: High water level in China Creek after a precipitation event in August 2018

During this visit, the high water levels in the creek (Figure B. 1) made it impossible to inspect the bridge from underneath and look for signs of deterioration. Despite the limitations caused by high water level, the bridge was examined from the distance. It was observed that the existing bents underneath the bridge had experienced corrosion damage (Figure B. 2). Moreover, it was observed that during precipitation events, water would easily find its way through the joints of the bridge which would cause damage to the concrete, as was evident by the looks of the concrete surface close to the joints (Figure B. 3).

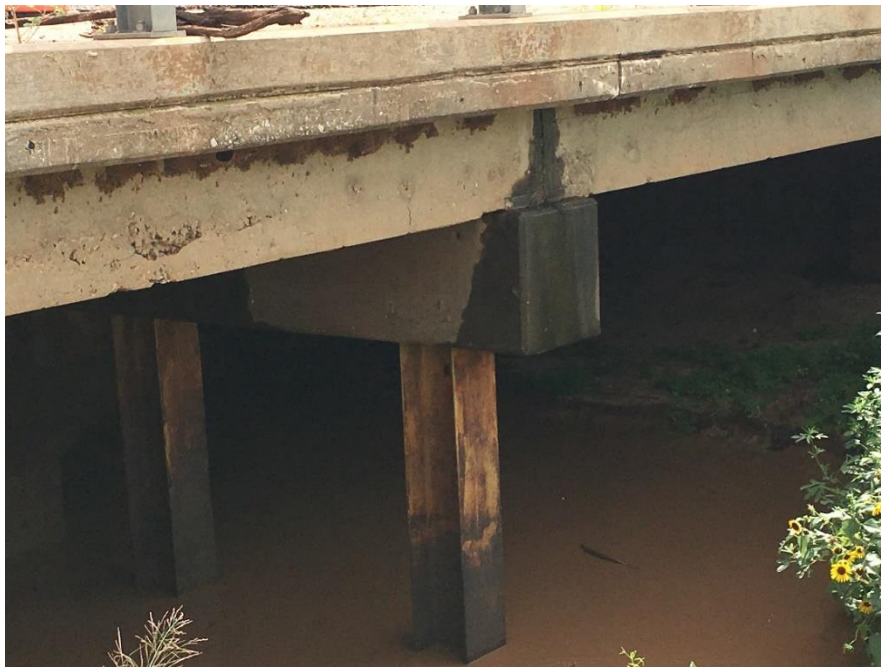
Figure B. 2: Corroded bents under China Creek bridge to be replaced

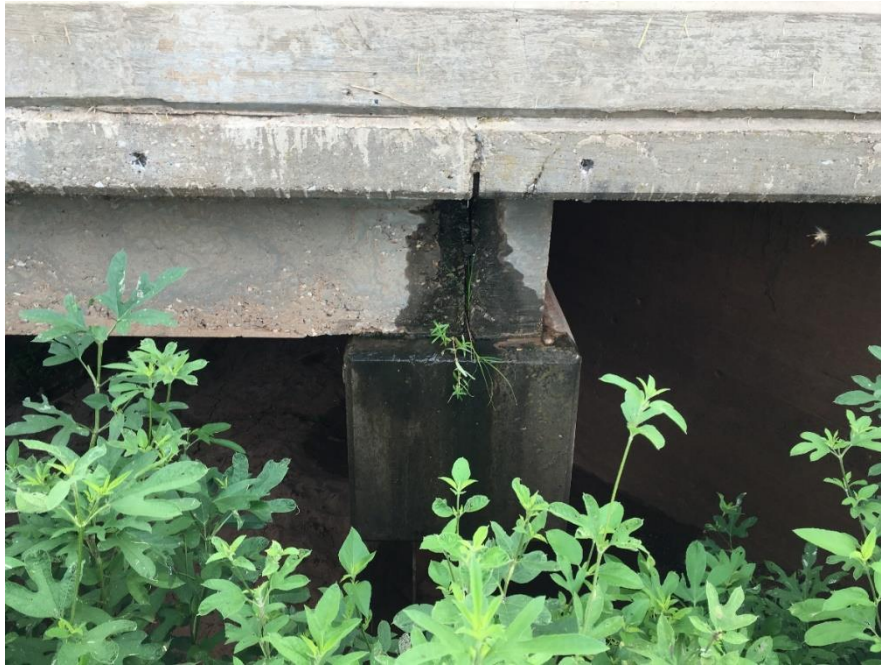
Figure B. 3: Seepage of water through the deck joints

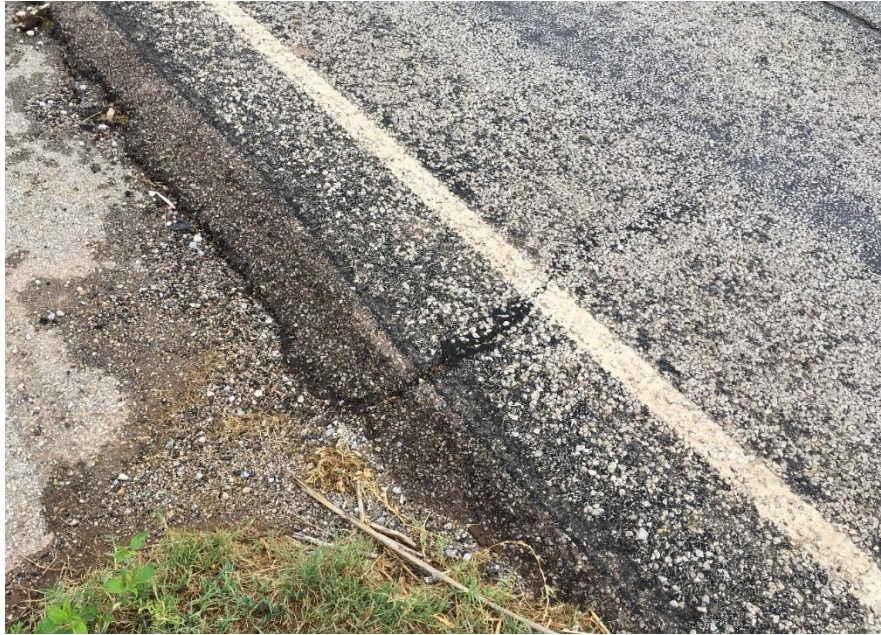
Figure B. 4: Cracked edge of pavement at the end of the approach slab due to backfill settlement

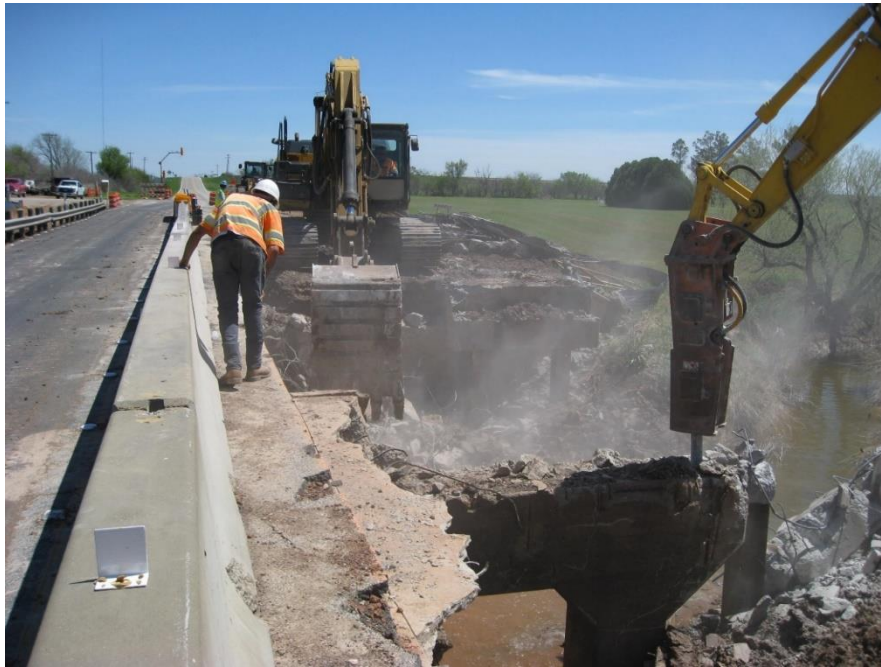
Figure B. 5: Demolition of the first half of the old China Creek Bridge

The construction of the China Creek Bridge was planned to be done in 2 phases in order to maintain traffic flow while the construction activities were ongoing. The demolition of the first half of the bridge using heavy machinery is shown in in Figure B. 5. Also, in order to protect the active roadway on the other half of the bridge, a temporary

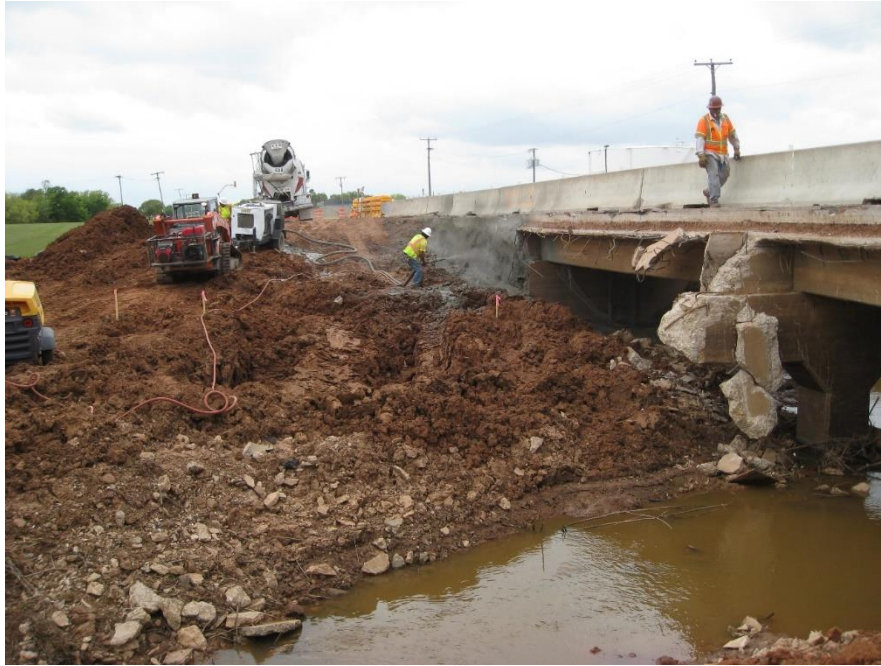
Figure B. 6: Installation of soil nail wall as temporary support for the active roadway crossing the undemolished half of the bridge (Picture provided by Samuel Groves)

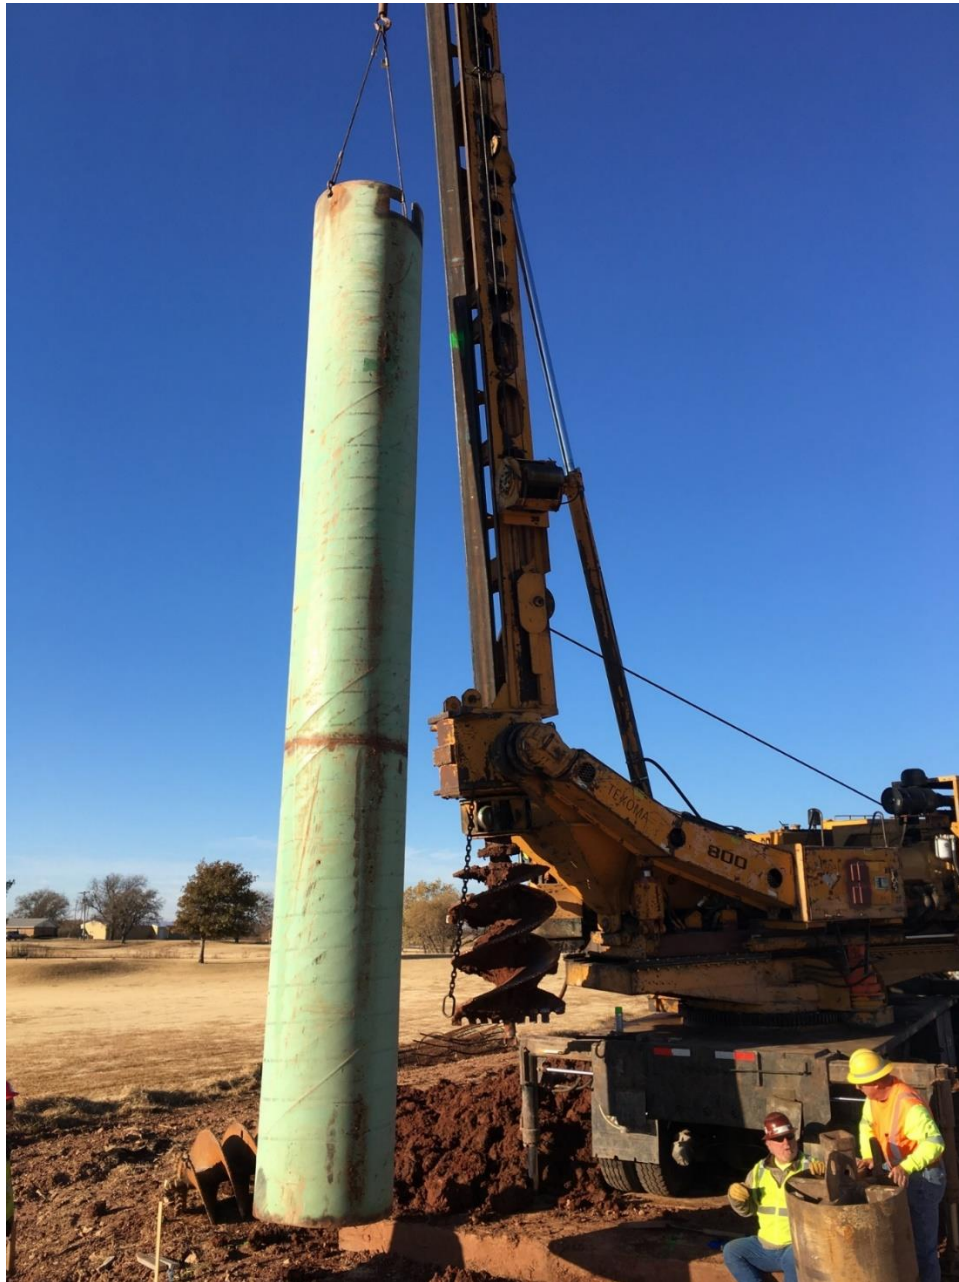
Figure B. 7: Casing used for the top portion of the drilled shafts

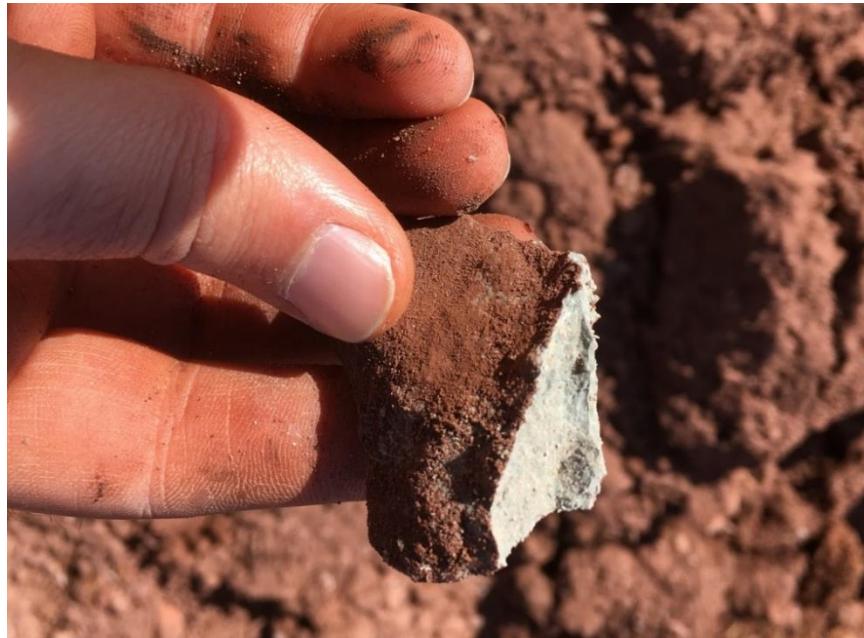
Figure B. 8: Gray shale covered with powdery red dirt recovered from 8 m depth

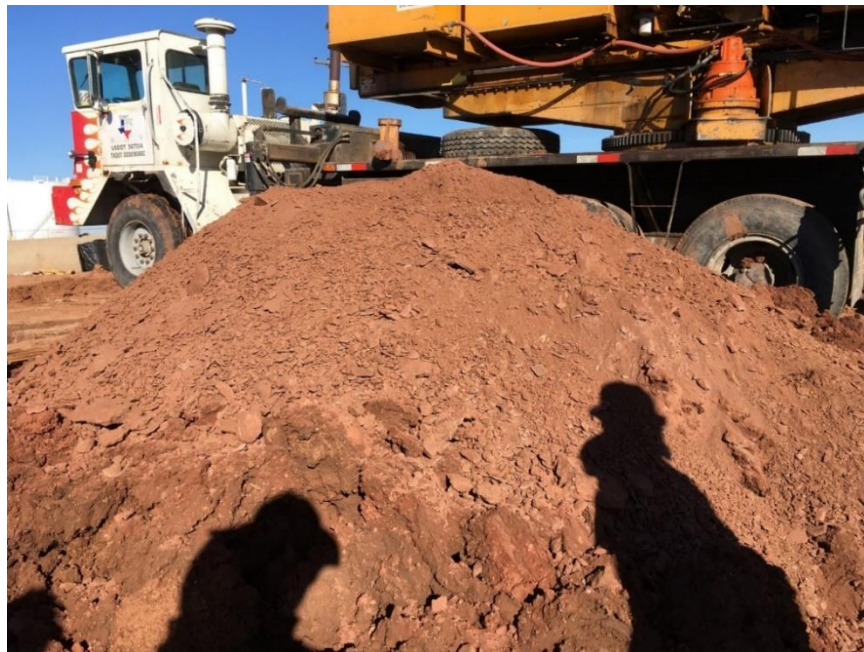
Figure B. 9: Heap of soil excavated from the drilled shaft. Note the broken pieces of shale on top (depths of 7.5 m and lower) and wetter/plastic material removed beforehand

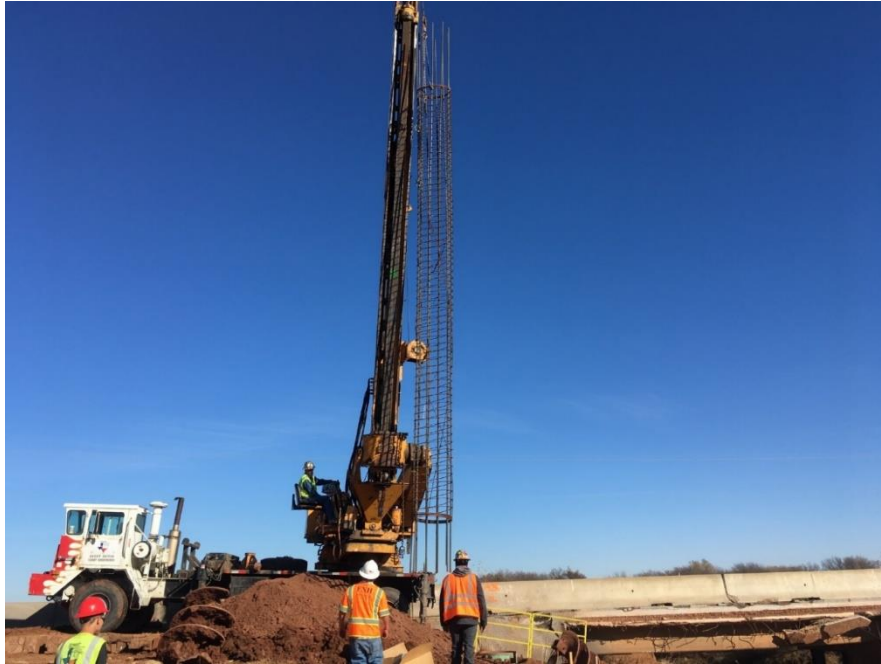
Figure B. 10: Placement of one of the west abutment drilled shafts' rebar cage

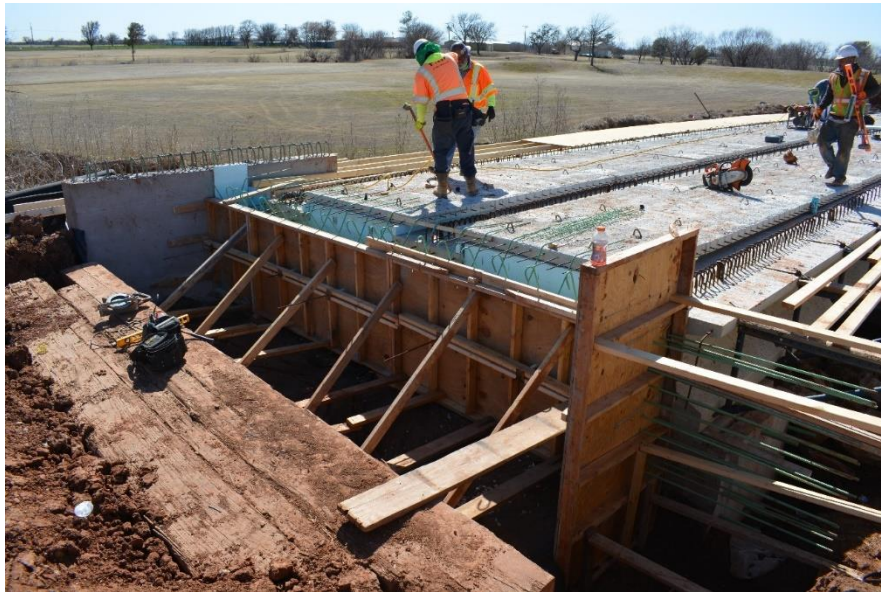
Figure B. 11: Forming of abutment walls after placement of girders and precast panels, March 2020 (East abutment)

As work on forming the abutment walls began (Figure B. 11), the research team visited the site during the first week of March 2020, in order to place the first set of

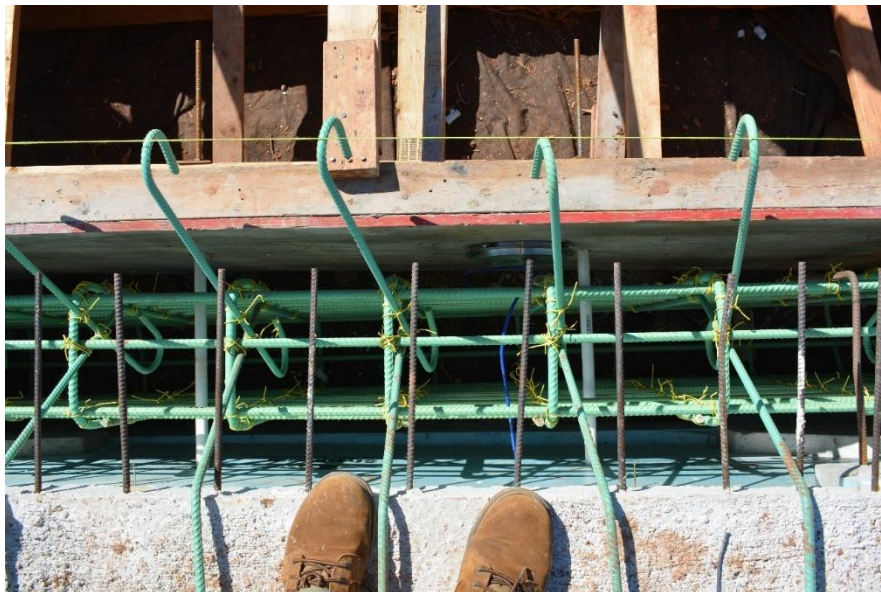
Figure B. 12: Top view of the earth pressure cell (GK-4810) installed on the inside of the form on the west abutment wall, photographer standing on one of the precast panels placed on the deck, March 2020

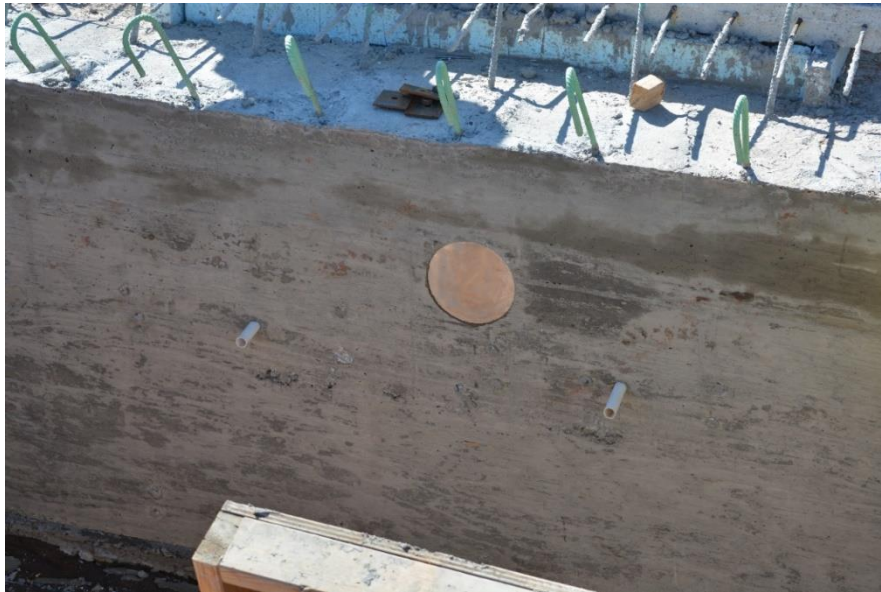
Figure B. 13: Finished surface of the east abutment wall with the pressure cell (GK-4810) installed between the two girders on the left, March 2020

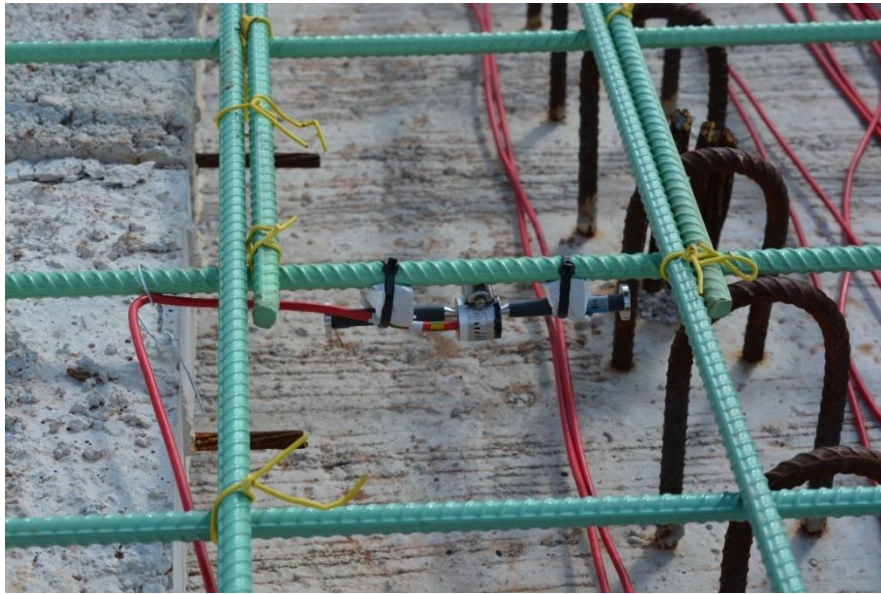
Figure B. 14: GK-4200L as installed on the deck, perpendicular to the direction of the bridge, March 2020

For instrumentation of the deck, a total of 11 concrete strain gauges were brought to the site. 10 of these strain gauges were model GK-4200 which were placed in evenly spaced pairs (top and bottom of the deck profile) along the longitudinal axis of the deck. The other one was a GK-4200L which was placed perpendicular to the longitudinal axis of the bridge (Figure B. 14) close to first pair of GK-4200s near the west abutment. The difference between the two types is that GK-4200L has lower stiffness and to capture early shrinkage deformations of the concrete as well, while the other ones do not deform until the concrete sets and reaches higher stiffness.

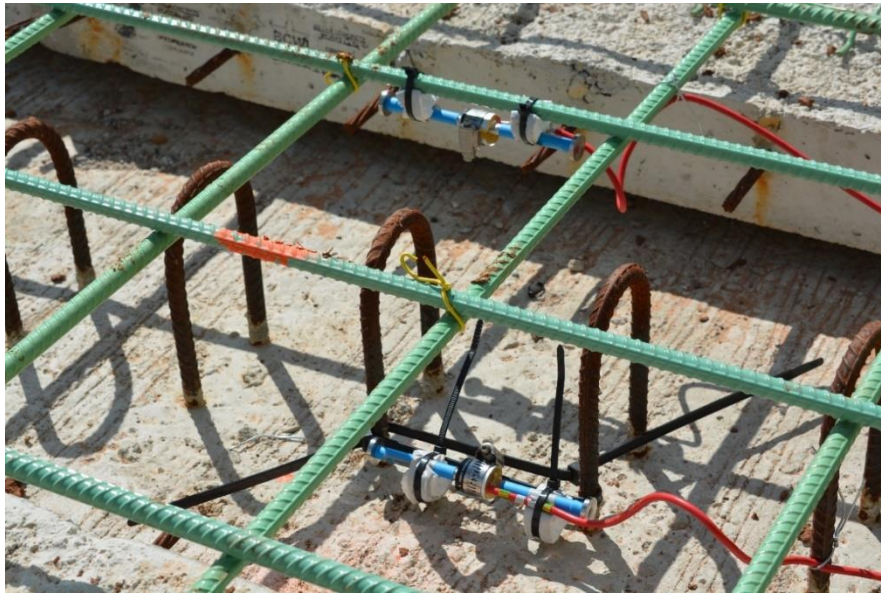
Figure B. 15: A pair of GK-4200 strain gauges installed on the deck during phase 1 of the construction

A pair of GK-4200 installed on the deck are shown in Figure B. 15. As can be seen, one is attached to the bottom of the top rebar using zipties and blocks of Styrofoam as a spacer and the other is installed near the bottom (top of the girder). As there are no rebars at the bottom, a set of zipties were wrapped between two “U” shaped hooks of the girder and the strain gauges were tied to those as shown in Figure B. 16.

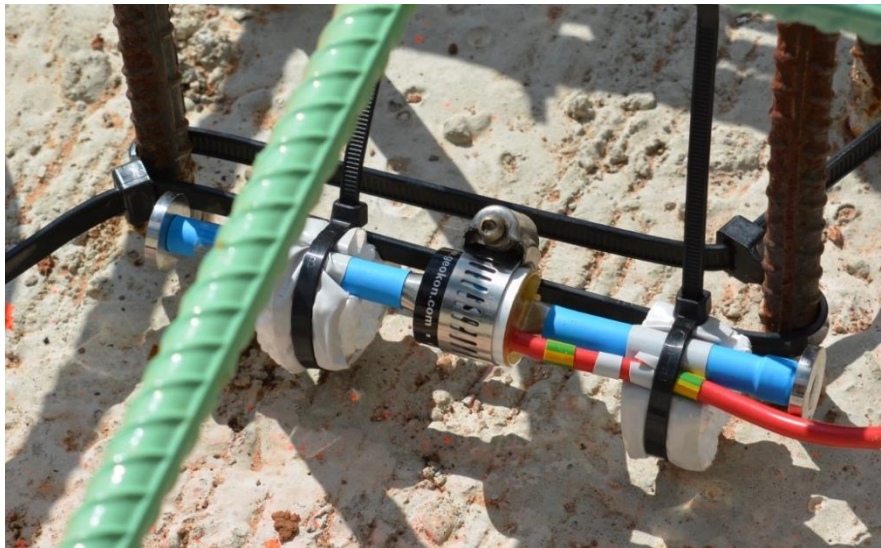
Figure B. 16: Identification of strain gauges using colored tapes as binary ID code

each sensor/cable does not carry a unique serial number tag. In order to keep track of the cables and position of the sensors attached to them, a binary codebook was designed to help with this task. An example of the binary code applied is shown in Figure B. 16 where yellow/green tape represent ones and gray tape represents zeros. The same code is applied to the other end of the cable which is routed through a small gap to the top of the abutment cap (Figure B. 17) which helped identify which cable belongs to which sensor. In the end, these cables were coiled and routed through a block of wood (Figure B. 18) with pre-drilled holes in a specific order, in case the tape is removed due to weathering or a possible flood event. In the end, baseline values for each strain gauge were recorded using the handheld GK-404 logger.

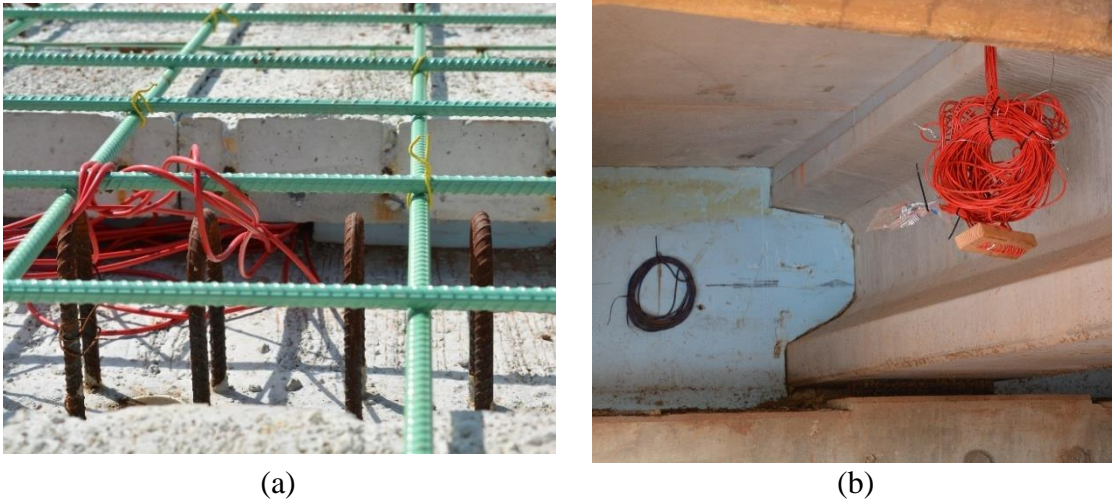
Figure B. 17: Installation of strain gauges: (a) cables of the strain gauges were routed through a small gap between the foam boards to underneath the bridge, and (b) coiled up wires coming from the strain gauges (red) and earth pressure cell (blue).

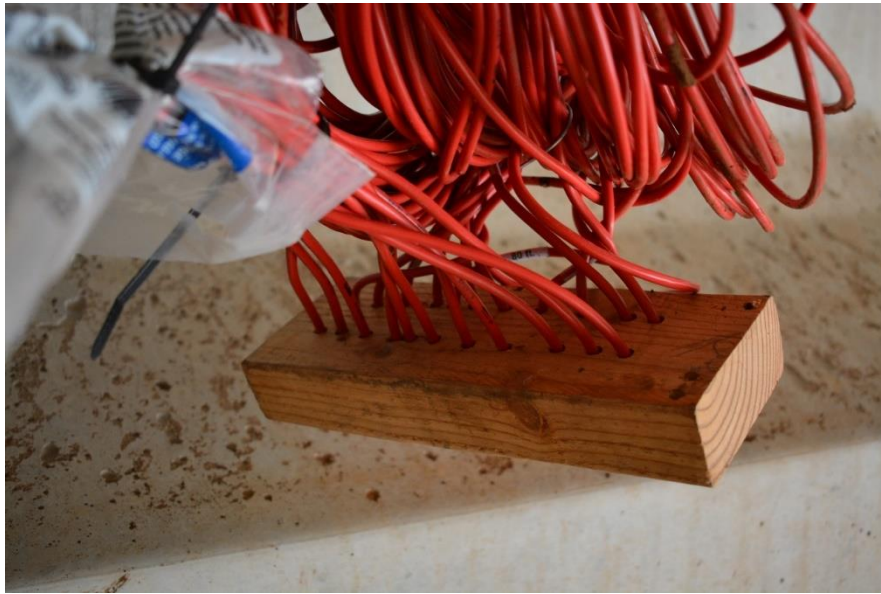
Figure B. 18: Predrilled block of wood used to help keep track of the cables coming from embedded strain gauges

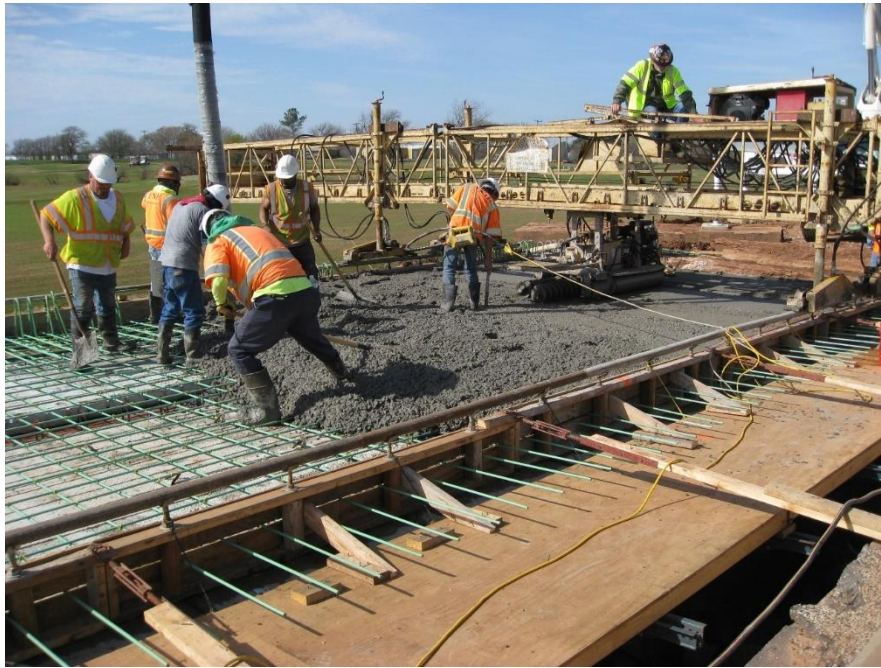
Figure B. 19: Concrete placement on the deck, Phase 1, March 2020

In late March 2020, the research team was notified that deck concrete was successfully placed and the sensors appear to have stayed in place (Figure B. 19 to Figure B. 21). Due to the issued guidelines by the University of Texas at Austin regarding travel authorization considering COVID-19 pandemic, the research team was not able to make subsequent visit in order to oversee this task and record the sensor outputs after the concrete placement, or while the concrete sets. As a result, the time-rate of deformations and early shrinkage rate was not captured during this time.
