**FIELD STUDY OF THERMALLY-INDUCED SOIL-STRUCTURE
INTERACTIONS IN SEMI-INTEGRAL BRIDGE STRUCTURES**

Dissertation

The University of Texas at Austin

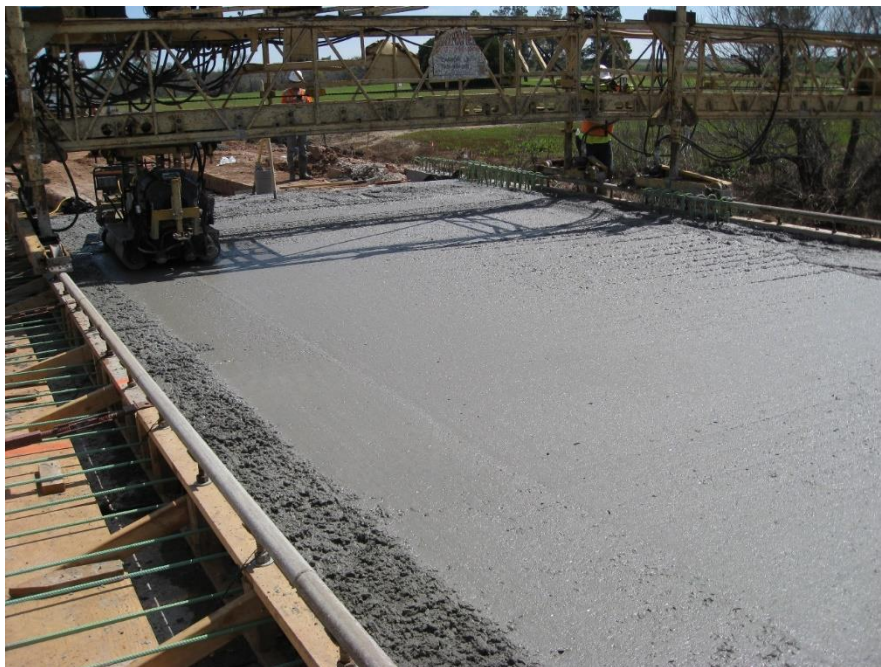
Figure B. 20: Finished surface of the deck, Phase 1, March 2020

In late March 2020, the research team was notified that deck concrete was successfully placed and the sensors appear to have stayed in place (Figure B. 19 to Figure B. 21). Due to the issued guidelines by the University of Texas at Austin regarding travel authorization considering COVID-19 pandemic, the research team was not able to make subsequent visit in order to oversee this task and record the sensor outputs after the concrete placement, or while the concrete sets. As a result, the time-rate of deformations and early shrinkage rate was not captured during this time.

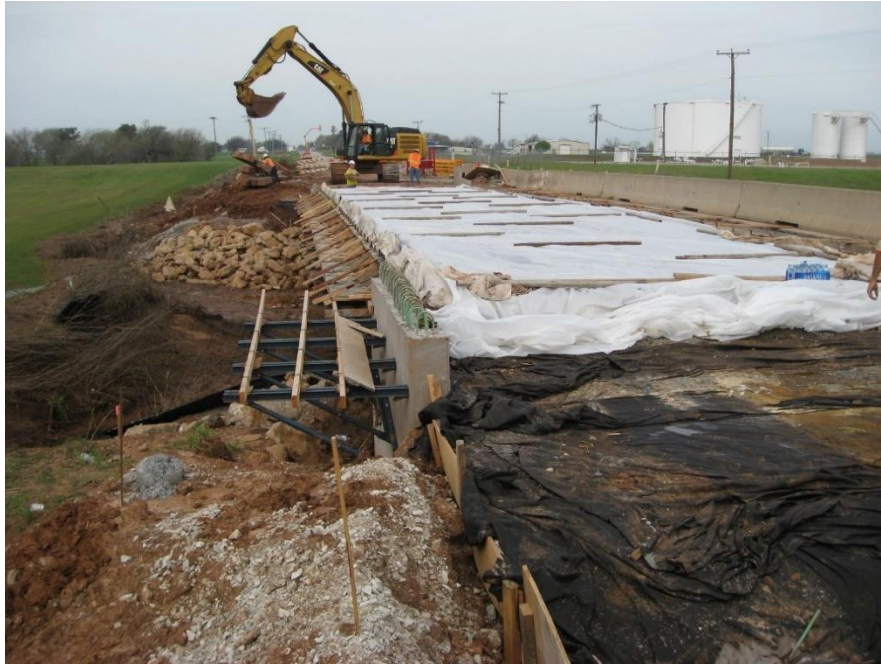
Figure B. 21: Covered deck surface after concrete was placed, Phase 1, March 2020

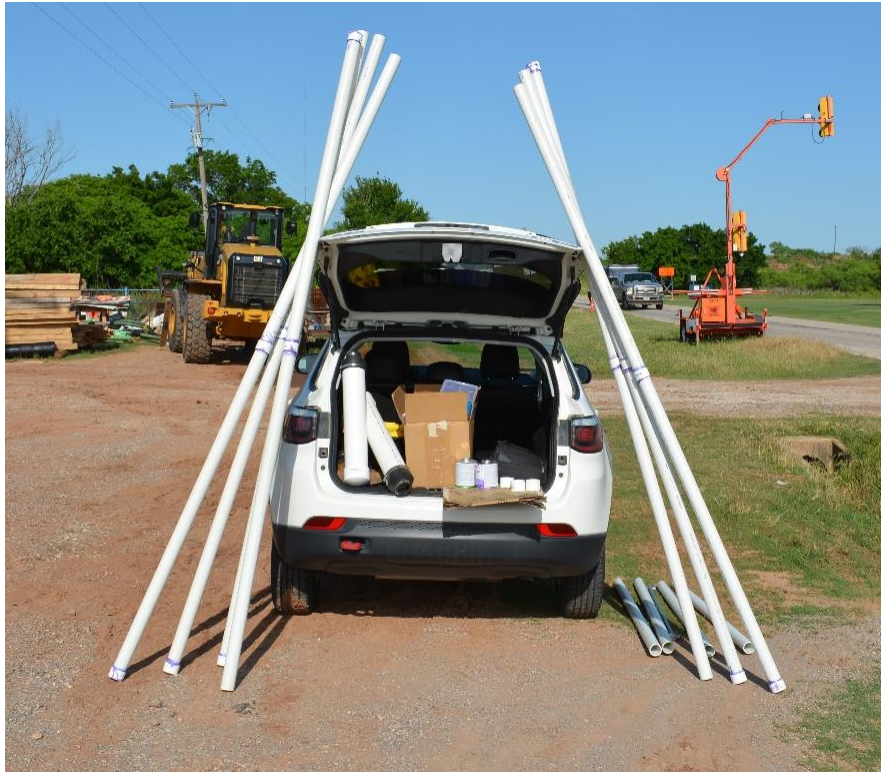
Figure B. 22: 1.5 m PVC conduits transported to China Creek Bridge to house SAAV sensors in the drilled shafts. In this picture, 1.5 m conduits are already assembled into 3 m sections using PVC cement and couplers

To alleviate the transportation of PVC conduits, the pipe sections were cut into shorter sections that could be easily carried by a car from Austin to Wichita Falls (Figure B. 22). The day before the excavation, these pipe sections were assembled at the location using PVC cement and various types of couplers to ensure the finished conduit does not collapse during the installation phase (Figure B. 23). Because the rebar cage was to be lifted only from one end by the crane prior to installation in the hole, a significant amount of bending was expected to occur in the cage and the conduit attached to it. Therefore, several methods of reinforcement were used to ensure the joints were just as strong as the uncut portions of the conduit by using heavy duty PVC cement and hose clamps as shown in Figure B. 24.

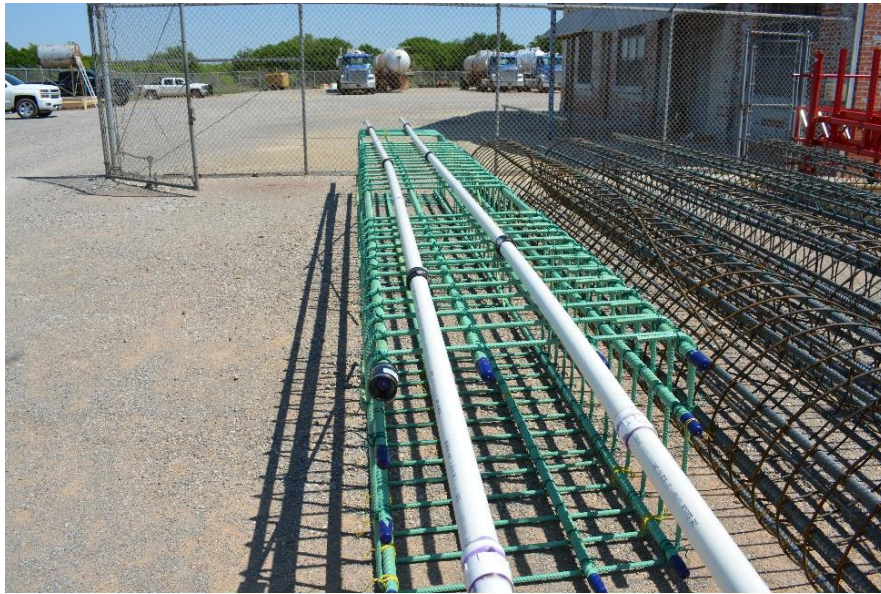
Figure B. 23: PVC conduits assembled into 11 m sections using additional couplers and joint reinforcement.

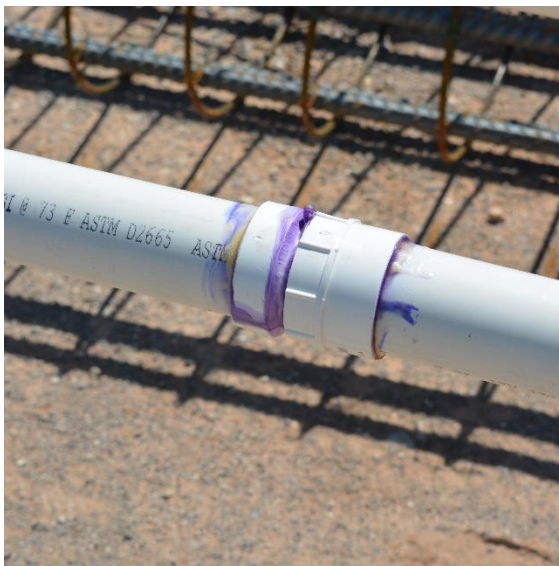
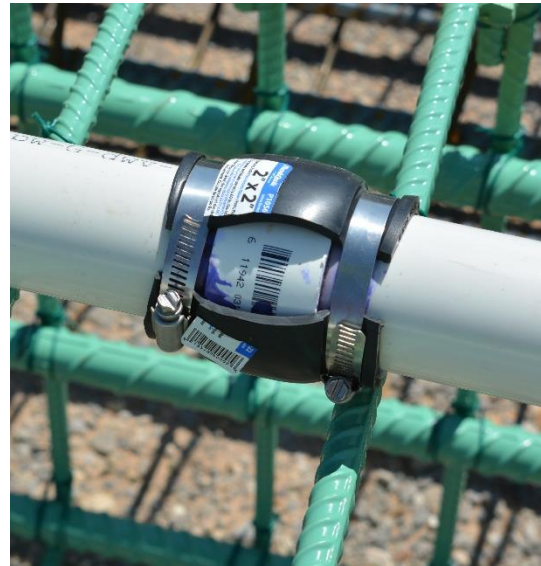
Figure B. 24: Reinforcement of PVC conduit joints: (a) Threaded couplers + Heavy Duty PVC cement (b) Compression couplers + Flexible couplers + Hose clamps

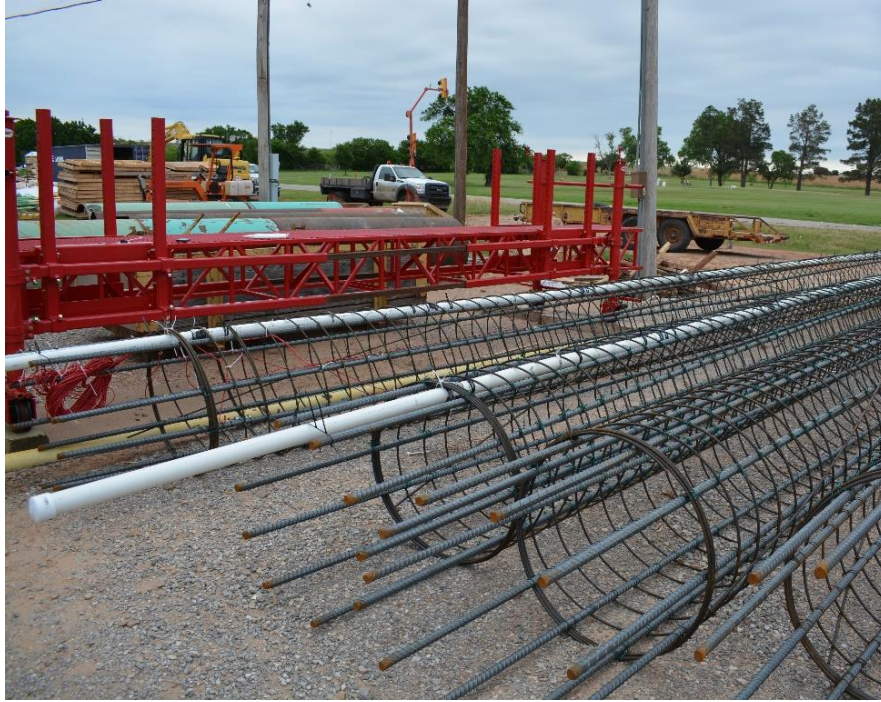
Figure B. 26: Assembled PVC conduits attached to drilled shafts to serve as SAAV housing

As it appears in Figure B. 26, the conduit is slightly longer than the drilled shaft. This extra length was to account for the height of the abutment cap, after the construction of which, the SAAV sensors were to be installed.

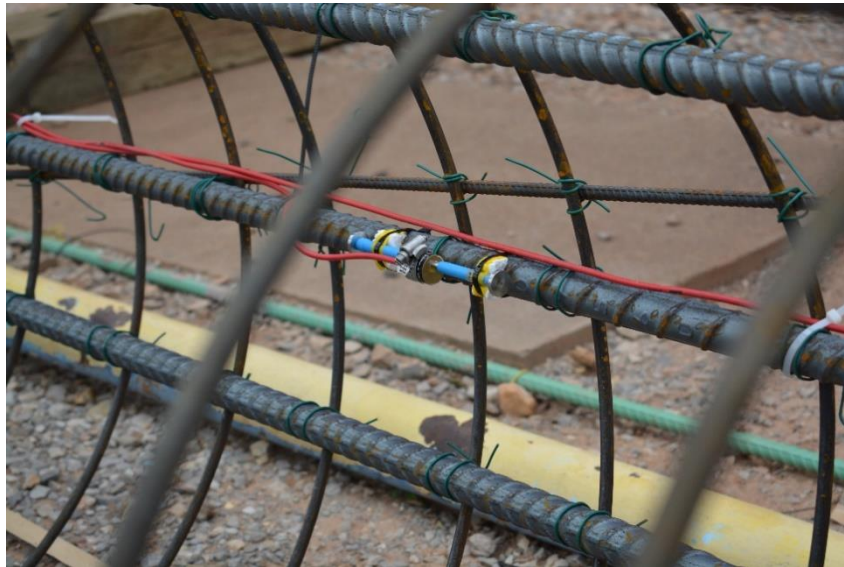
Figure B. 27: Strain gauges attached to the long. rebars of drilled shafts

A close-up view of the instrumented rebar cage which was used for the center drilled shaft on the east abutment is shown in Figure B. 27 and Figure B. 28. The strain

gauges were installed in pairs according to the expected direction of bending in order to decouple compression from bending strains.

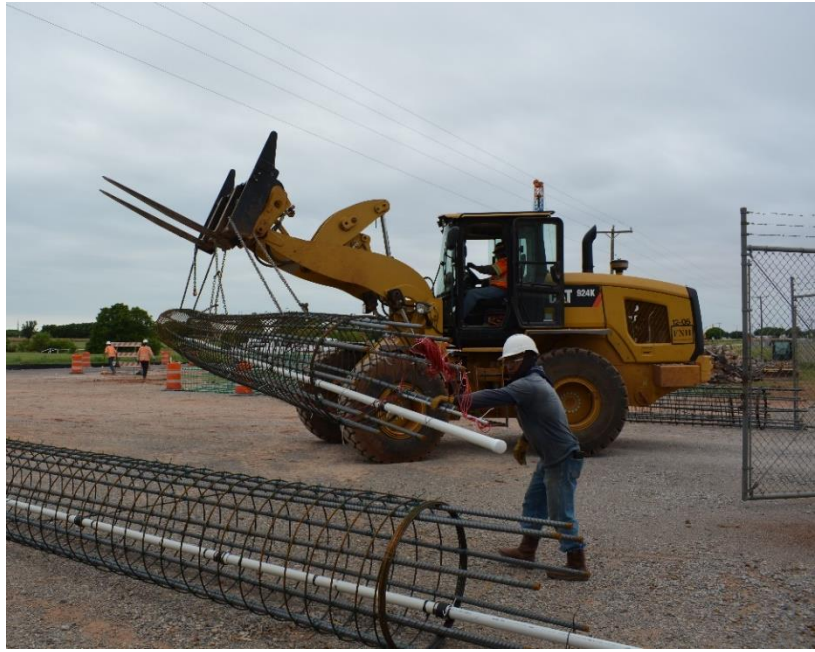
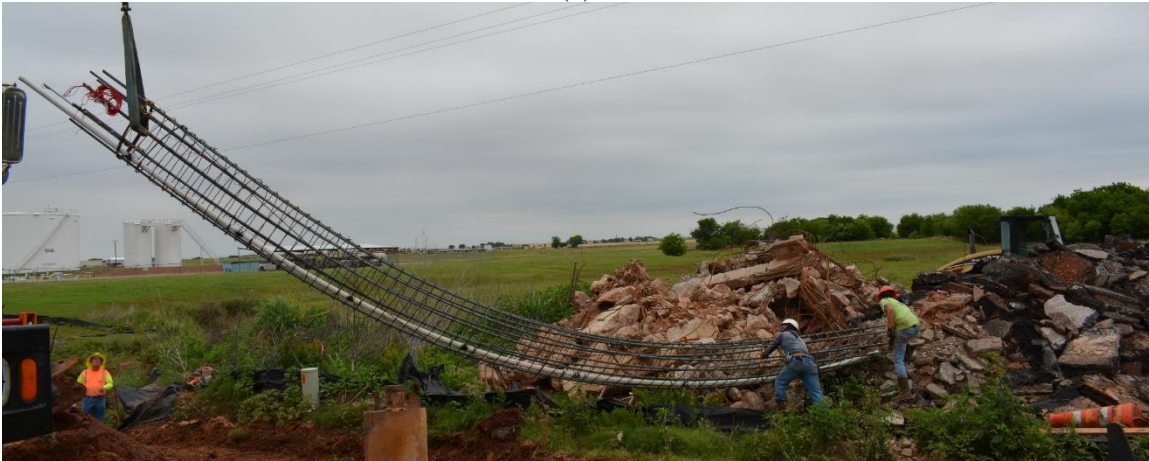
Figure B. 29: Installation of east abutment instrumented drilled shaft: (a) lift and transportation of the rebar cage using a front loader to the drilled shaft location (b) lifting of the rebar cage from the top using a crane (note the bending of the rebar cage and PVC conduit)

After the completion of instrumentation tasks intended for rebar cages, the construction crew proceeded to carefully lift the rebar cages using cranes and front loaders and put them in place (Figure B. 29).

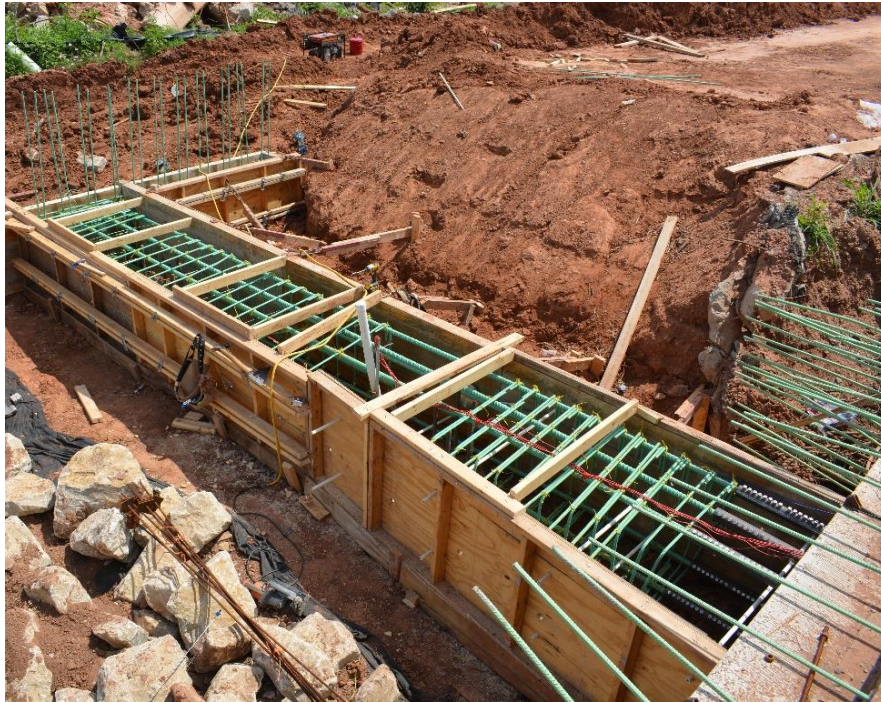
Figure B. 31: Formwork for construction of abutment caps and wing walls

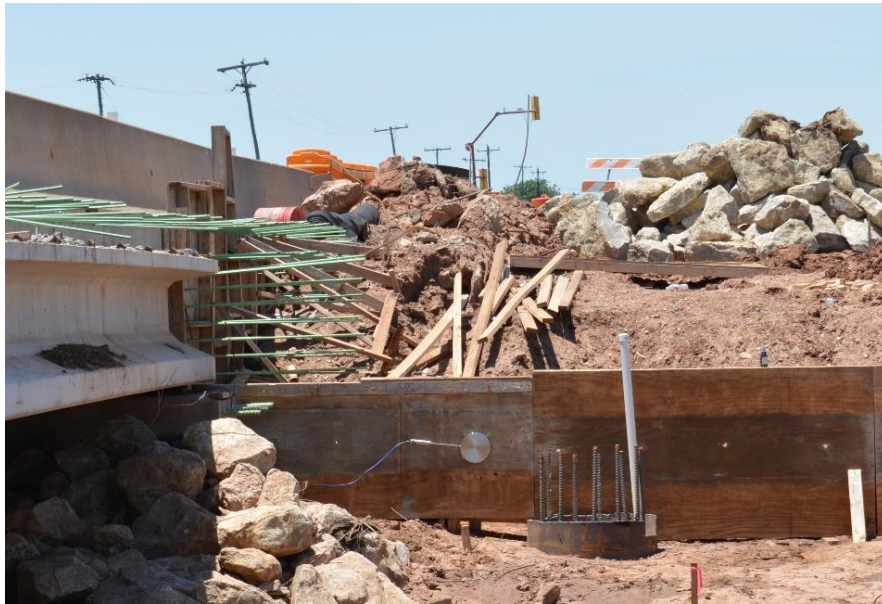
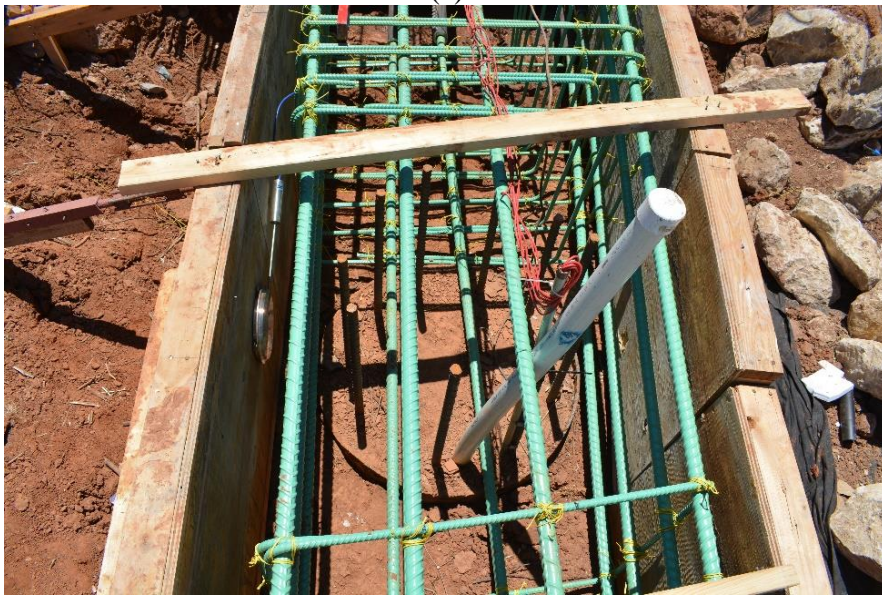
Figure B. 32: Instrumentation of the abutment caps: (a) west abutment cap pressure cell (before formwork is completed) (b) east abutment pressure cell (after formwork is completed)

As can be seen in Figure B. 32, earth pressure cells were mounted on the inside of the form at the mid-height of the abutment cap and near the location of the center drilled shafts. Upon completion of formwork, installation of abutment cap sensors and routing the sensor wires to a suitable location, the abutment cap concrete was poured using a concrete tremie (Figure B. 33). Also, it can be seen in Figure B. 33 (a) that once the abutment cap was poured, the SAAV conduit stuck out of the top by roughly 0.3 m, leaving enough room to lower the SAAV into the conduit and clamp it at the top, per installation requirements.

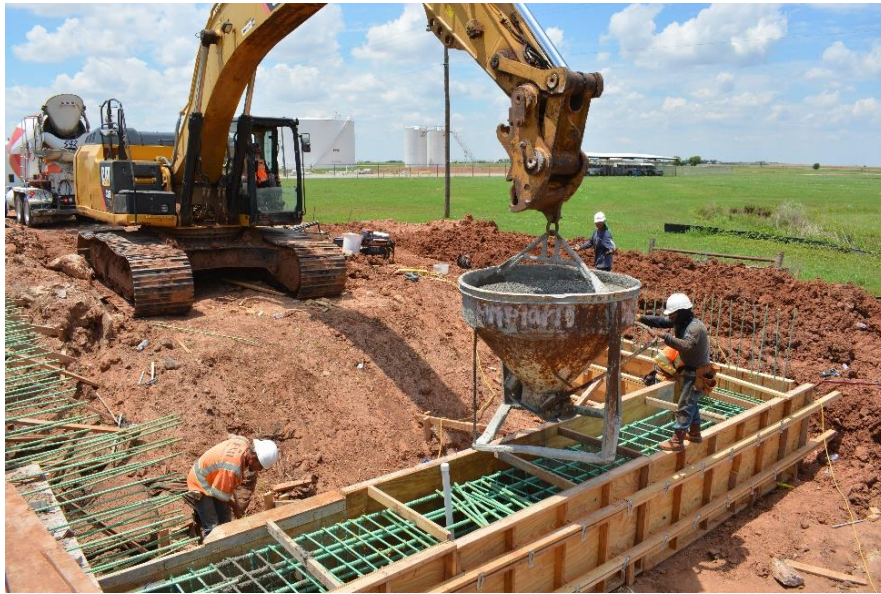
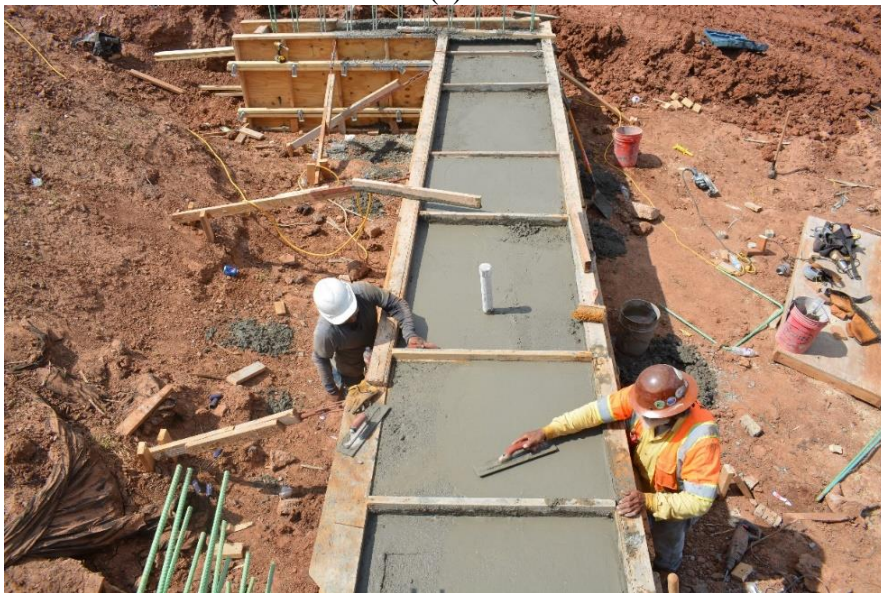
Figure B. 33: Construction of the west abutment cap: (a) Pouring concrete for abutment cap using a concrete tremie (west abutment) (b) finishing the surface of the abutment cap, notice SAAV conduit sticking out between the two girder pedestals

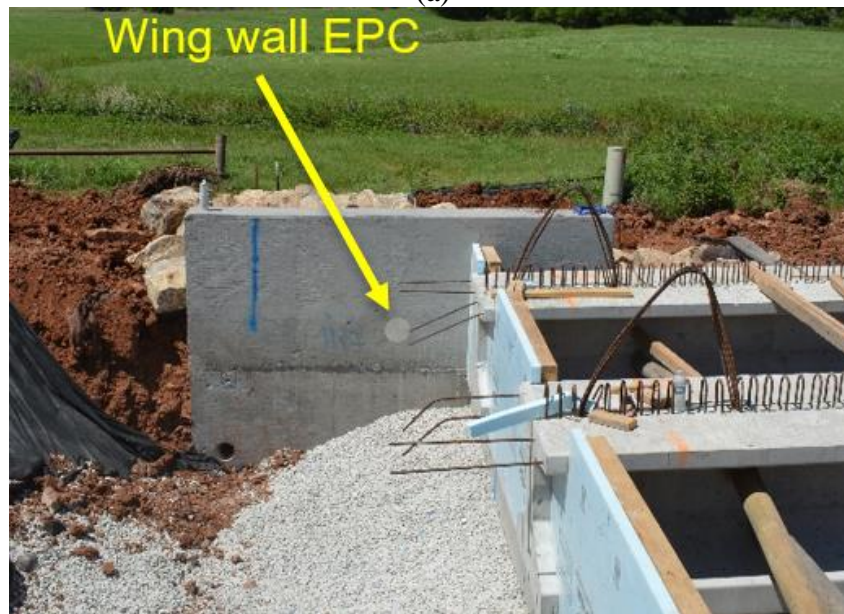
Figure B. 34: Installation of EPCs on wing wall forms to measure backfill pressure acting on the wing walls: (a) EPCs mounted on the wing wall forms (b) west abutment wing wall after form removal

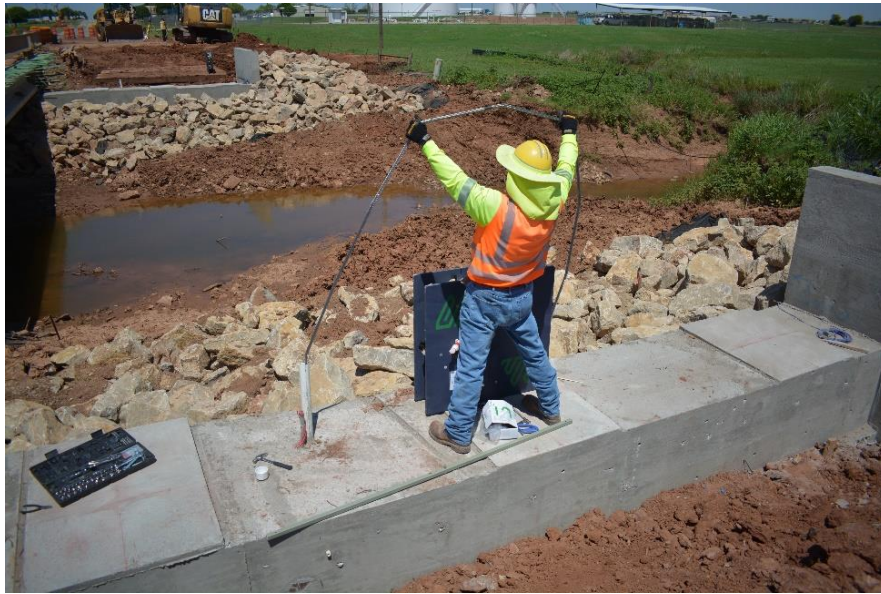
Figure B. 35: Installation of SAAV in the east abutment center drilled shaft

Upon the completion of abutment cap and wing wall construction, another visit was made to the site in order to install the SAAV sensors before the girders were placed. As can be seen in Figure B. 35, the SAAV was shipped on a reel which required to be carefully unloaded by rotating the reel as the sensor was fed into the conduit. This installation is best done with at least two people in order to ensure SAAV segments do not bend too much to avoid getting damaged during installation, as the joints are vulnerable to snapping if bent too much. Once the SAAV was fully lowered into the conduit, the extension fiber glass tube was attached to the top, and the whole sensor was lifted several times and rammed into the conduit (pumping motion) to ensure that the sensor had fully settled into the conduit and all joints were compressed against the walls. This step was very important because if the sensor is not fully settled into the conduit, SAAV may slowly settle over the

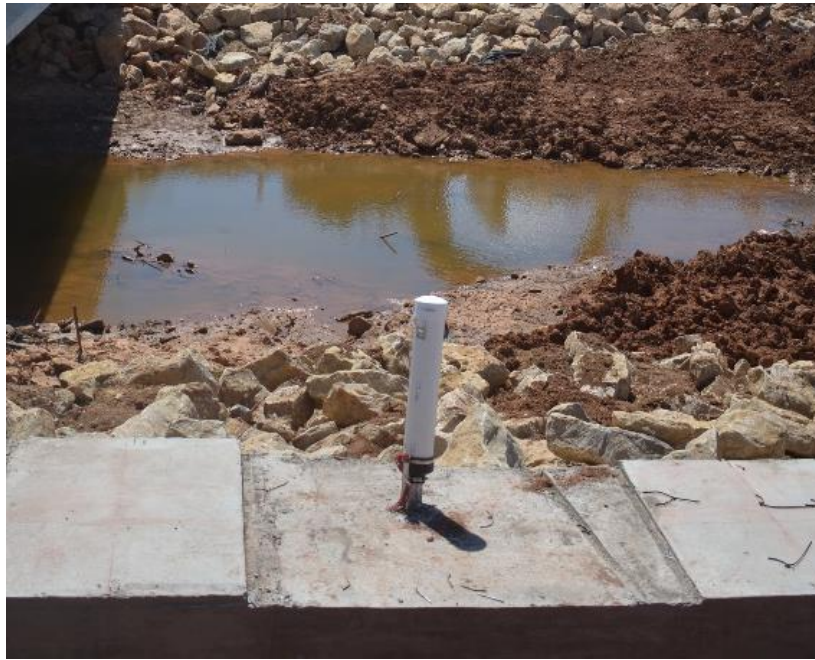
Figure B. 37: Capped SAAV conduit on east abutment

Once the installation was completed, SAAV conduits were capped using 10 cm diameter PVC conduits to prevent water and debris from entering the conduits and interfering with the performance of the system (Figure B. 37). This is very important because if water enters the conduits and freezes over the cold season, the pressure due to expansion of water can cause serious harm to the sensors.

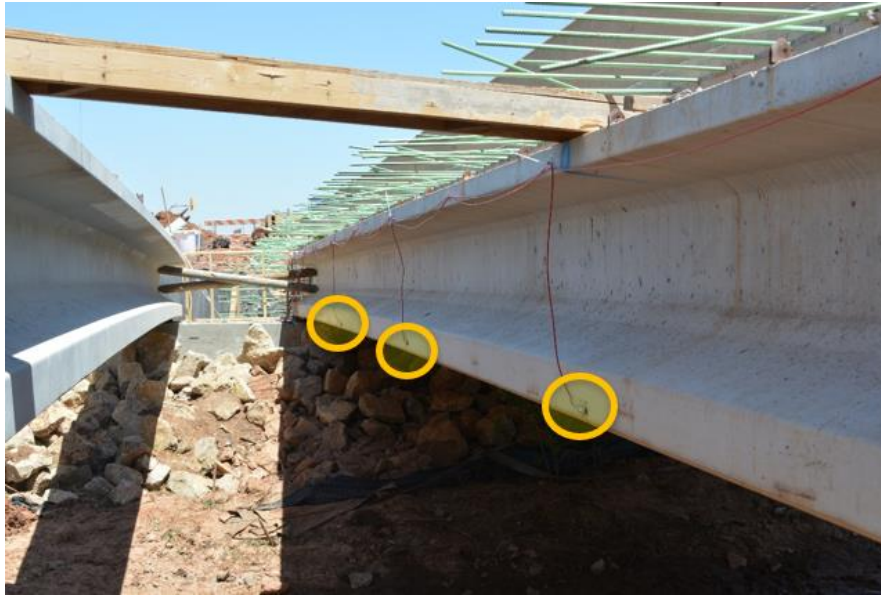
Figure B. 40: Mounted miniature strain gauges on the bottom flange of the middle girder

After the girders were placed, a set of 5 VW miniature strain gauges were mounted on the bottom flange of the middle girder of the bridge with the spacing of 4.5 m. For the installation of these sensors, a drilling guide (Figure B. 38) was used to make shallow holes in the bottom flange of the girder that were the same distance as the pegs on the strain gauges. For drilling, extra care was taken to not drill holes deeper than necessary in order to minimize the risk of damaging prestressed reinforcement in the girders. Next, these holes were cleaned using canned air and filled with quick-setting epoxy before setting the strain gauges. The strain gauges were held in place using a piece of duct tape until the epoxy set (Figure B. 39). In the end, a metallic cover was epoxied on top of these gauges to protect them from potential flood debris. The finished installation can be seen in Figure B. 40.

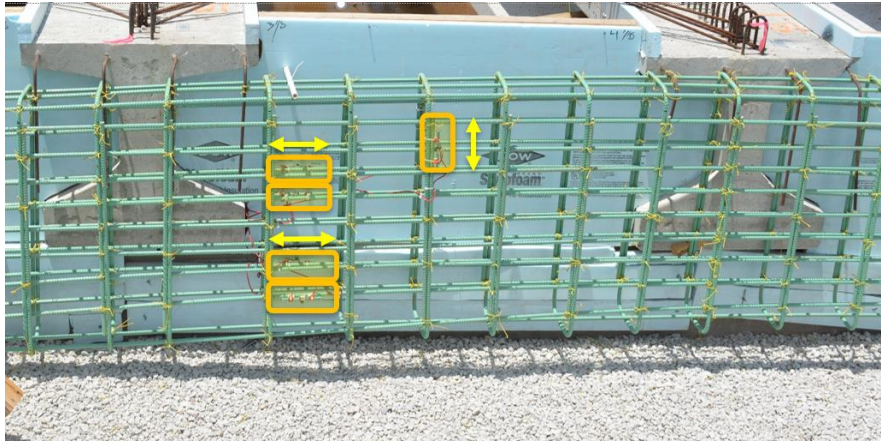
Figure B. 41: Location of the 3 pairs of concrete embedded strain gauges on the east abutment wall

As the abutment walls were formed, it was decided to attach 3 pairs of strain gauges to the rebars in different locations and orientations in order to record strains in the abutment wall due to changes in backfill pressure as well as have a measure of heat flow in the abutment wall using the thermistors of these sensors (Figure B. 41). In addition to the strain gauges, two pairs of earth pressure cells were also mounted to the back of the forms intended for each abutment wall to complement the measurements made by the EPCs mounted during the phase 1 of the construction (Figure B. 42).

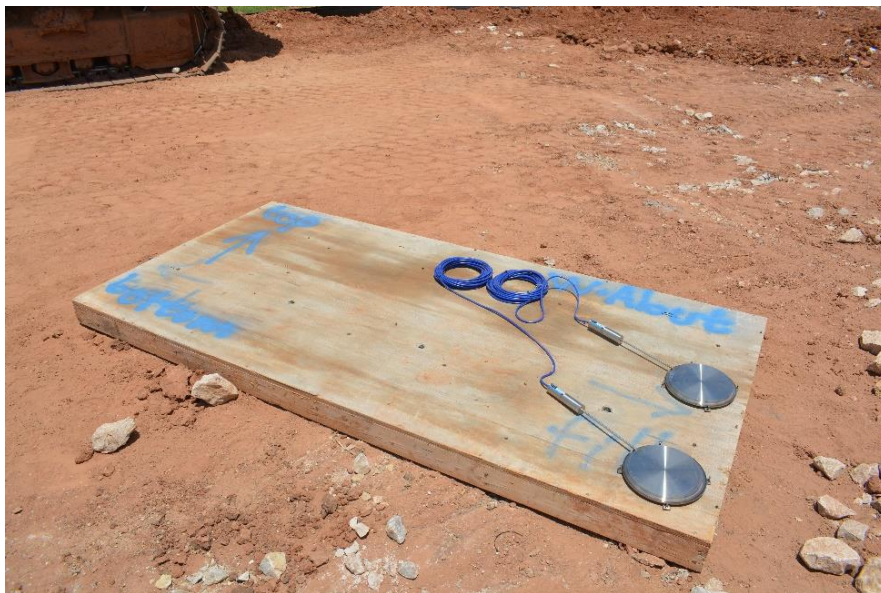
Figure B. 42: A pair of earth pressure cells mounted on the back of the form intended for the west abutment wall

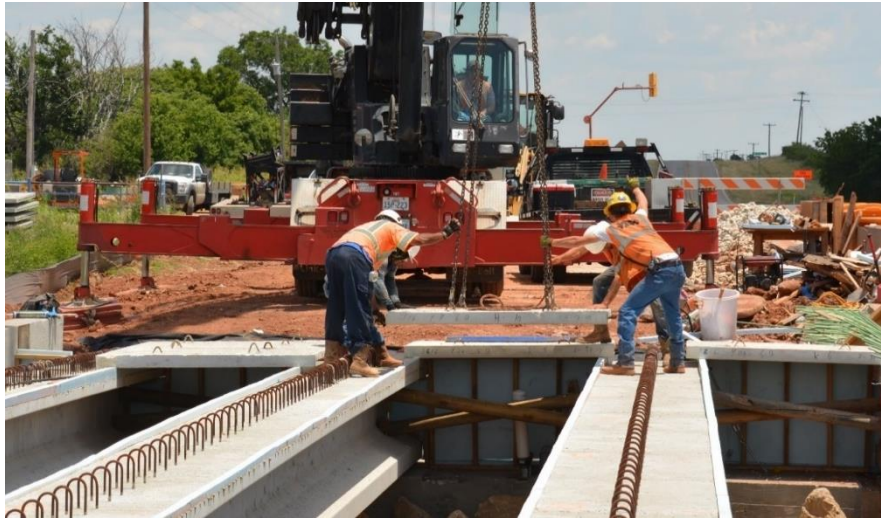
Figure B. 43: Placement of precast concrete panels on the deck

Once the abutment walls were formed, precast concrete panels were placed in between the girders using a crane as shown in Figure B. 43. Upon completion of this task, the rebar for the deck was placed and the concrete for the deck and abutment walls was placed on the same day (Figure B. 44).

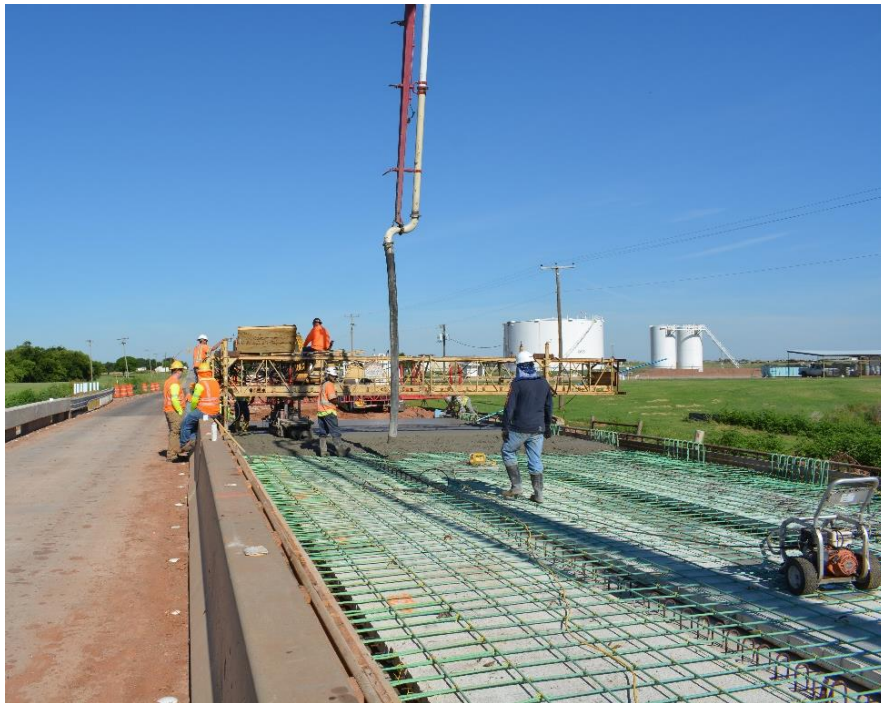
Figure B. 44: Phase 2 deck concrete placement

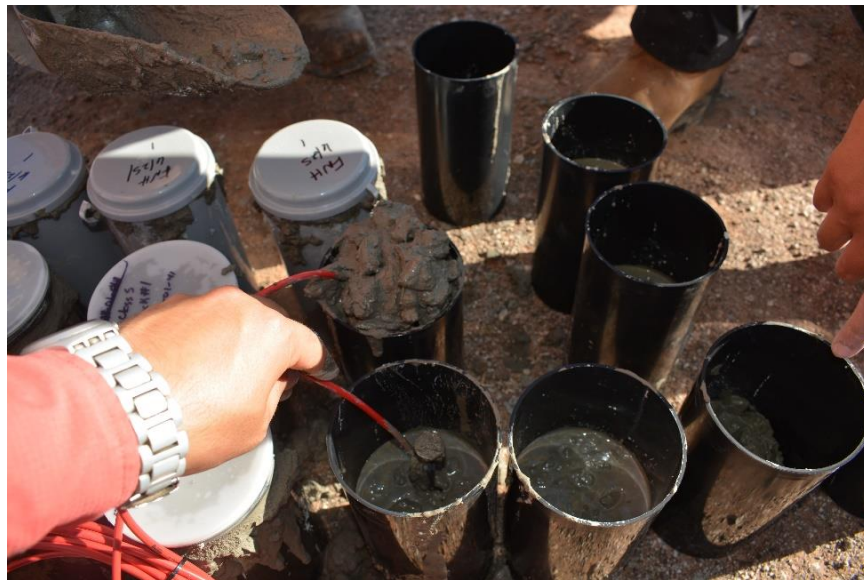
Figure B. 45: Instrumented concrete sample cylinders

As the concrete for the deck was delivered, the research team prepared two instrumented fresh concrete sample cylinders using low modulus VW strain gauges (Figure

B. 45). The goal of this task was to monitor thermal and shrinkage strains occurring in the deck concrete without the influence of other live or dead loads as well as structural constraints. One of these cylinders was intended to be placed on a wing wall to be exposed to direct sunlight and the other was placed under the bridge to be only influenced by the ambient temperature changes. It was hoped that the data collected from these two instrumented cylinders would help the researchers better define the coefficient of thermal expansion as well as shrinkage of the concrete used in this bridge.

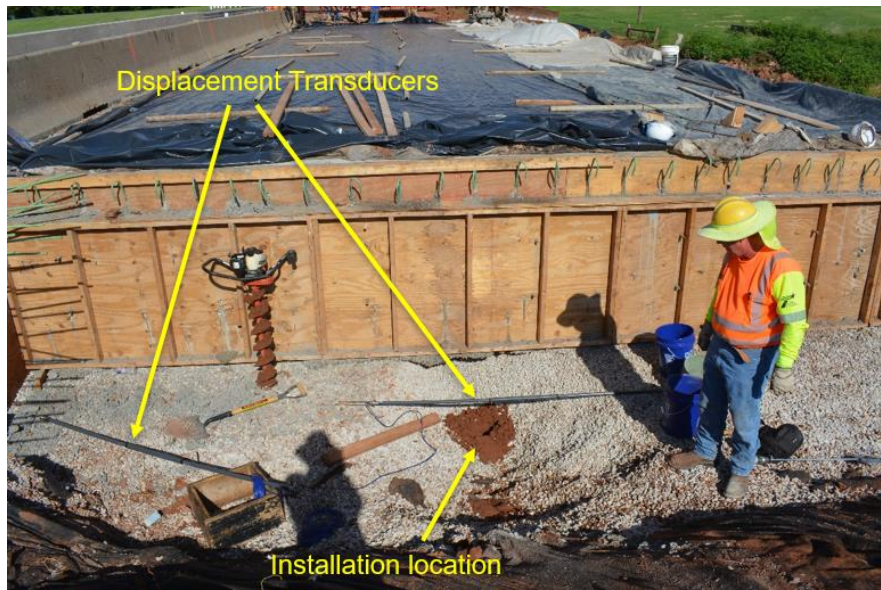
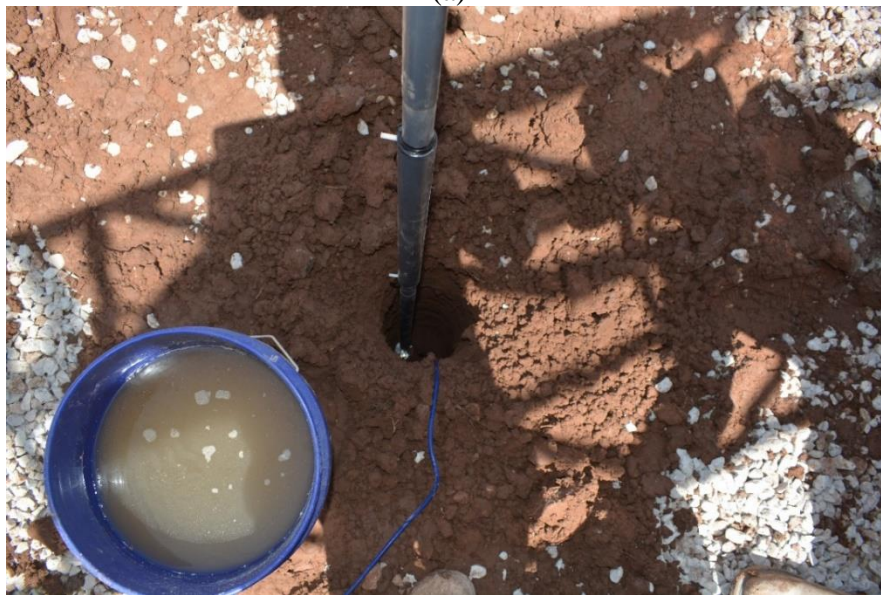
Figure B. 46: Installation of VW displacement transducers to be used as backfill settlement sensors: (a) excavation of the hole using auger (b) vertical placement of the sensor in the hole

After the completion of the bridge deck, the research team began work on the installation of backfill sensors which include backfill settlement sensors and soil extensometers which are both made of VW displacement transducers housed in a Sch. 40 PVC conduit and measure the distance between their flanges. The installation of the settlement sensor was one of the trickiest installations in this project as it required several

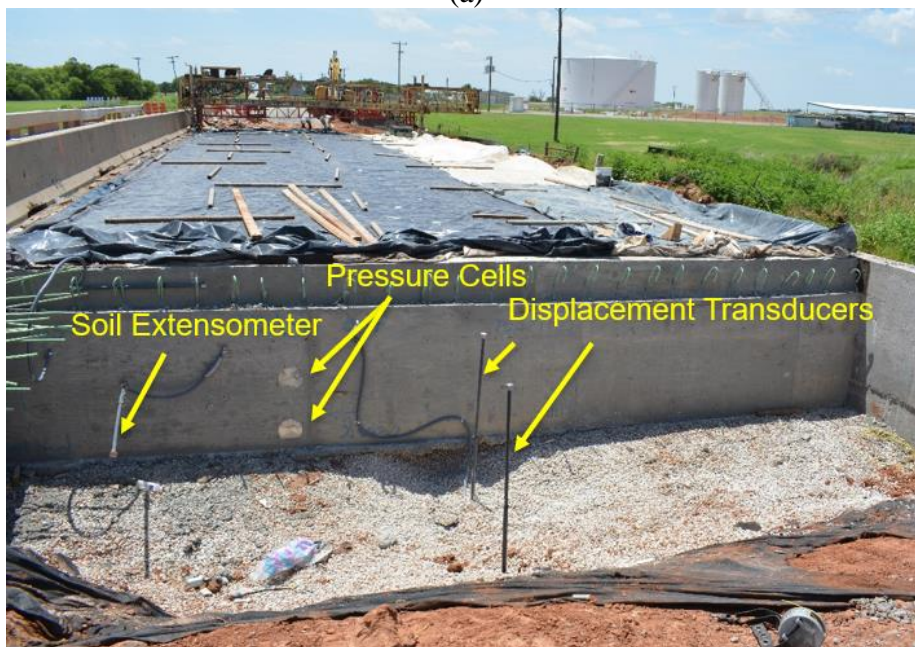
Figure B. 47: Settlement sensor installation locations: (a) west abutment (b) east abutment

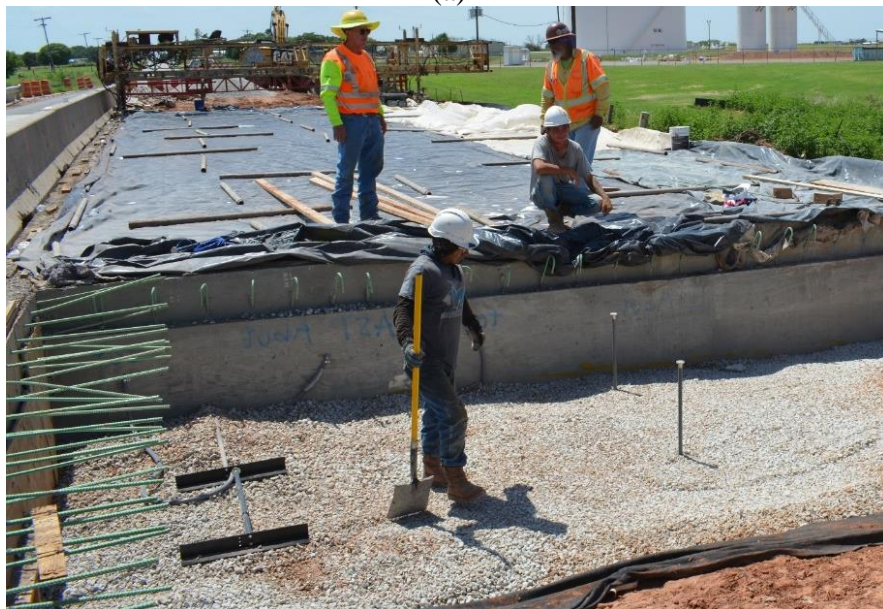
Figure B. 48: Installation of soil extensometers in the backfill: (a) west abutment (b) east abutment

In order to monitor horizontal movements and horizontal extension/compression in the backfill due to expansion/contraction of the bridge deck, two daisy-chained extensometers were installed in each backfill as well. Each of these extensometers was attached to a pre-machined angle iron flange which would extend or compress the displacement transducer due to interaction with the surrounding backfill soil.

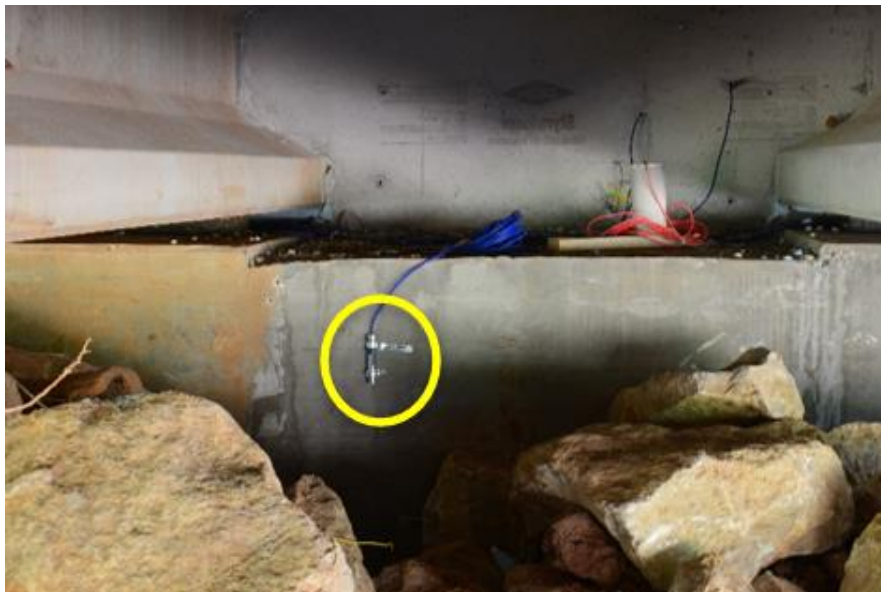
Figure B. 54: Creekside piezometer installed on the abutment cap

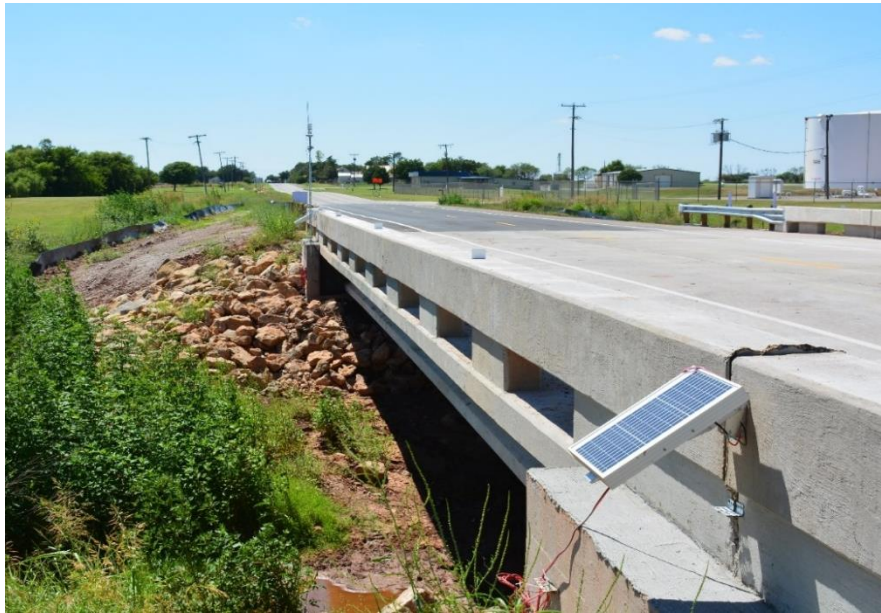
Figure B. 56: Solar panel mounted on the south railing of the east end of china creek bridge

To power the datalogger system, two 40W solar panels equipped with 12V charge controllers were installed on the south railing of the bridge, with one on each end (Figure B. 56). Installing these solar panels on the south side enabled them to produce maximum amount of electricity and ensure continuous operation of the dataloggers with the help of sealed lead acid batteries placed inside the datalogger enclosures.

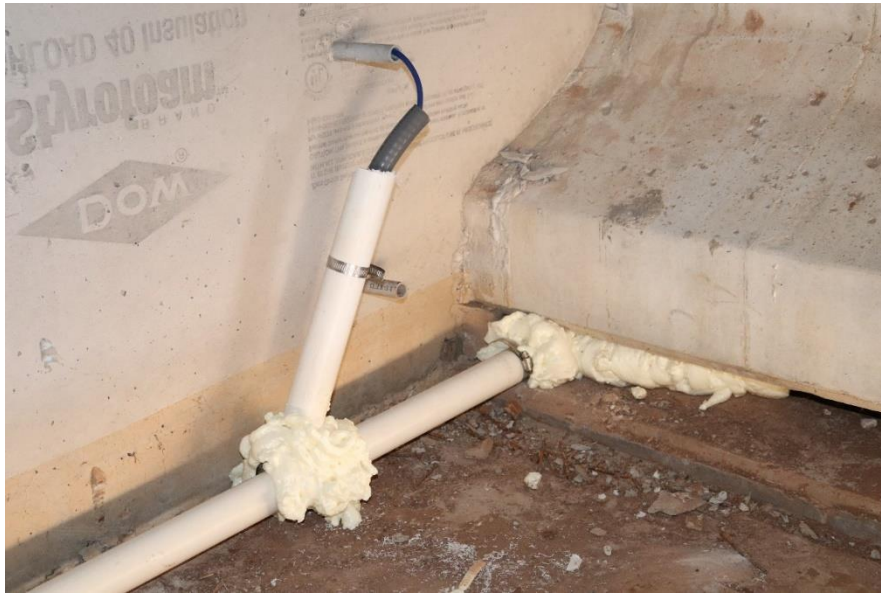
Figure B. 60: PVC pipes used for protection of cables routed on top of abutment caps

After talking with other professionals experienced with outdoor wiring, it was decided to use a harder material to protect the cables from rodents as there has been instances of rodents chewing through flexible conduits and even aluminum. For this purpose, Sch. 40 PVC pipes were cut in half lengthwise using a bandsaw and carried to the bridge site. The two halves of the PVC pipe were then placed around the cables and clamped together using hose clamps (Figure B. 60). The majority of cables were covered using this method, except for the locations of cable entry or behind the bearing pads which were protected by adding a thick layer of expandable foam. It is worth noting that no sign of damage to the sensor cables has been observed after 2 years of operation and therefore the modifications were considered successful.
