Behavior of NiTi Shape Memory Alloy- and Steel-Reinforced Shear Walls Repaired with Engineered Cementitious Composite

by Michael A. Soto-Rojas, Anca C. Ferche, and Dan Palermo

ACI Structural Journal, V. 120, No. 4, July 2023.

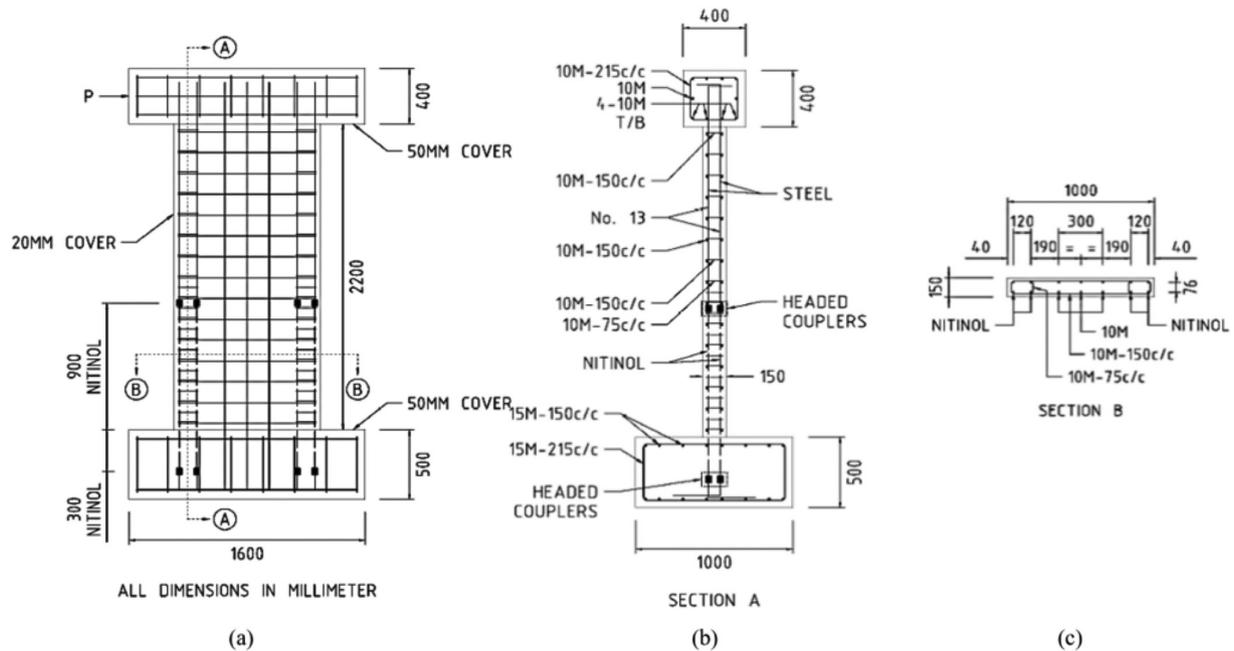
Fig. 1—Nominal dimensions and reinforcement details for Wall SWN: (a) elevation view; (b) section A-A; and (c) section B-B. (Taken from Morcos.¹⁹)

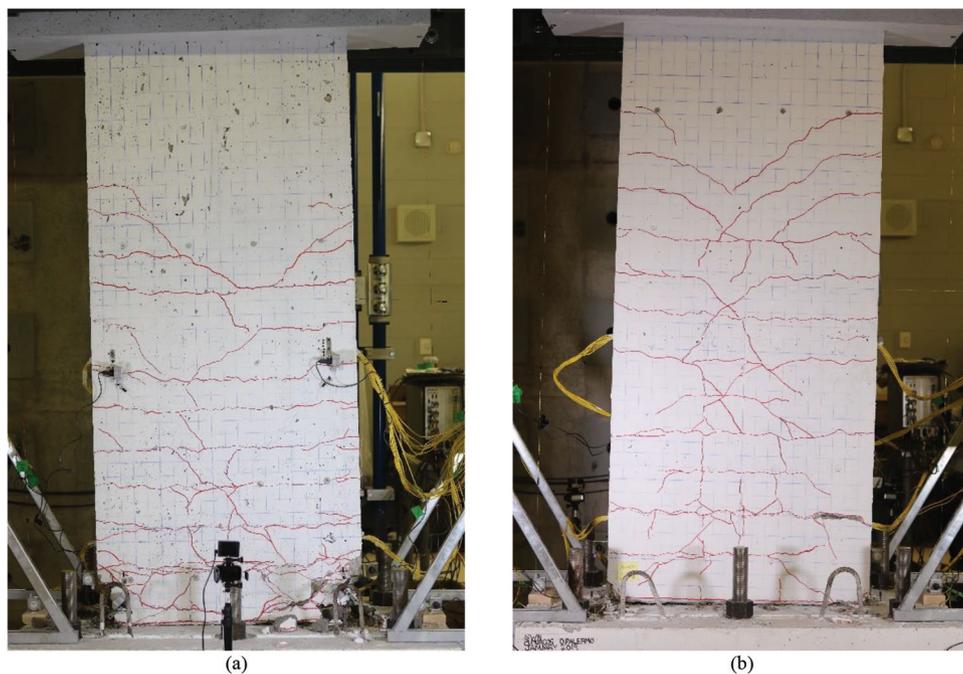
Fig. 2—Conditions of original walls after testing: (a) SWS-R; and (b) SWN. (Taken from Morcos.¹⁹)

Wall SWN developed a crack pattern that was noticeably different compared to SWS-R, as shown in Fig. 2(b). One dissimilarity pertains to the propagation of flexural cracks, some of which did not extend over the entire length of the wall and remained confined to the web region. The spacing of the cracks within the web region was similar to that observed for SWS-R. Within the boundary zones, however, over the height of the plastic hinge region, the crack spacing was approximately twice the distance, approximately 300 mm. Additionally, three vertical cracks developed in the web, aligned with

Figures 2 and 10 depict the crack patterns of the original and repaired walls at the end of testing. The influence of the ECC mixture is evident when comparing the state of the walls at failure. For the repaired wall, widespread cracking did not surface as was observed in the original walls (Fig. 2), and the formation of a more localized damage zone was evident (Fig. 10).

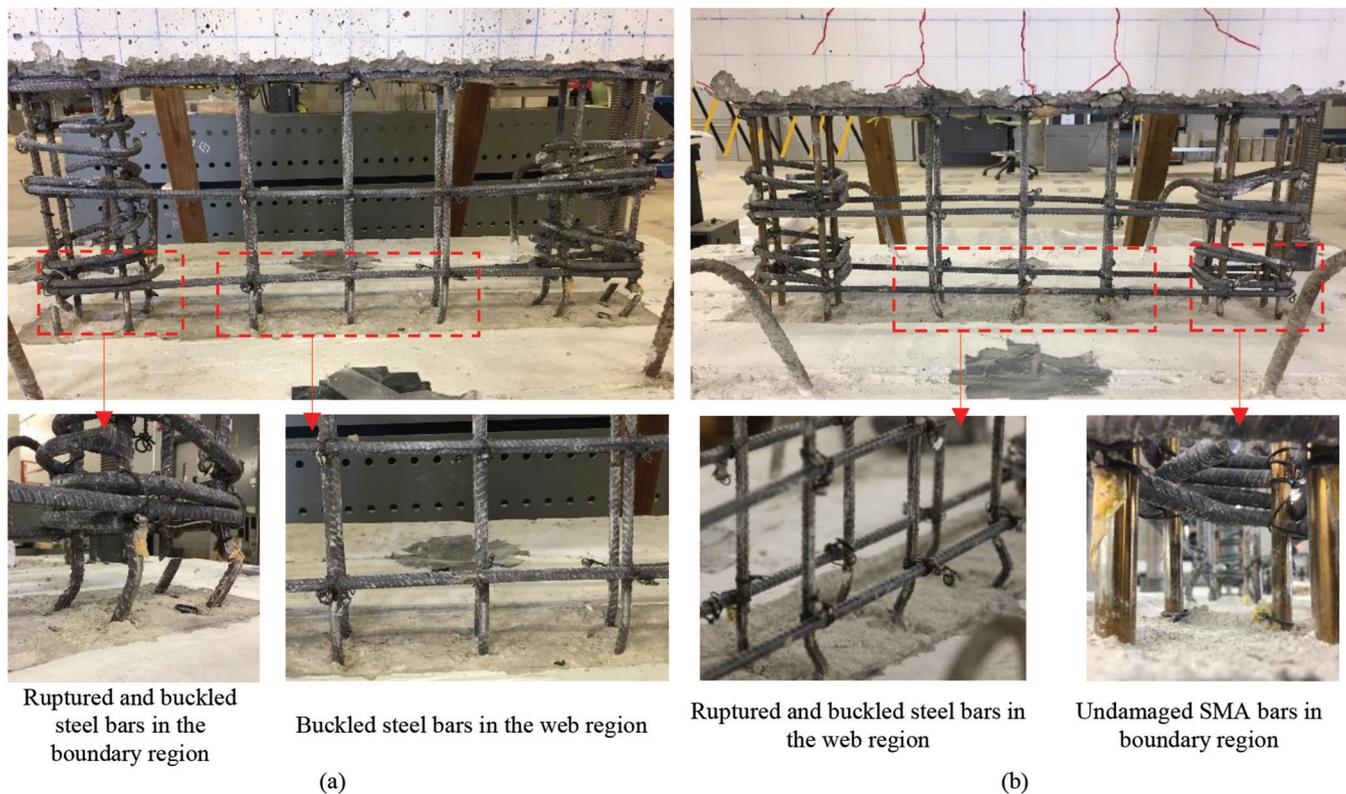
Fig. 3—First stage of concrete removal and damage of reinforcing bars: (a) SWS-R; and (b) SWN.

Concrete removal—Concrete removal was performed in three stages that allowed for a progressive investigation of the extent of the damage. The initial stage consisted of removing concrete over a height of 300 mm, as shown in Fig. 3, which revealed extensive damage experienced by the steel reinforcement in the form of buckling and fracture, and no observable damage for the SMA bars. The second stage involved removing concrete from the boundary regions over the entire plastic hinge length (900 mm in height from the base). No additional damage to the reinforcing bars was observed over this length for either of the walls. In addition, the coupling mechanism that connected the SMA bars to the No. 13 bars had no visible damage. During the third and final stage, the concrete was removed from the entire plastic hinge region and over a depth of approximately 60 mm into the foundation beam, as shown in Fig. 4. The concrete removal from the foundation was necessary to provide sufficient height to couple the remaining existing bars with the replacement segments, and for the repair ECC to penetrate the foundation to form a shear key.

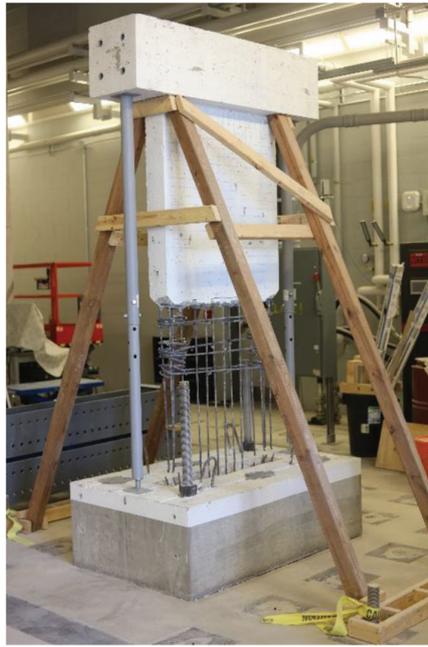
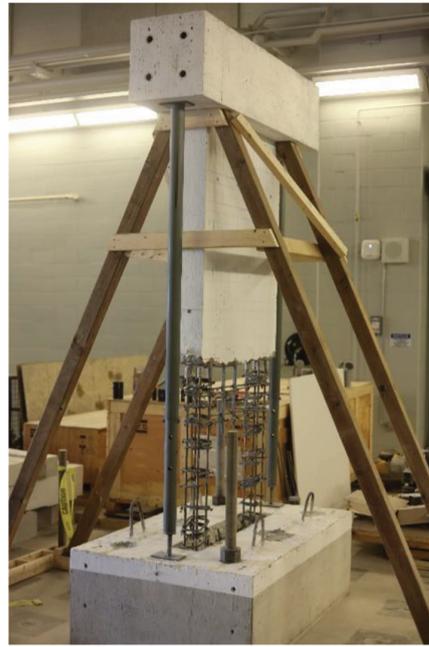
Fig. 4—Final stage of concrete removal: (a) SWS-R; and (b) SWN.

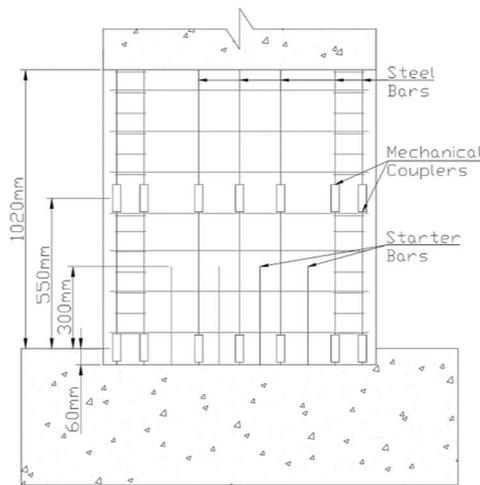
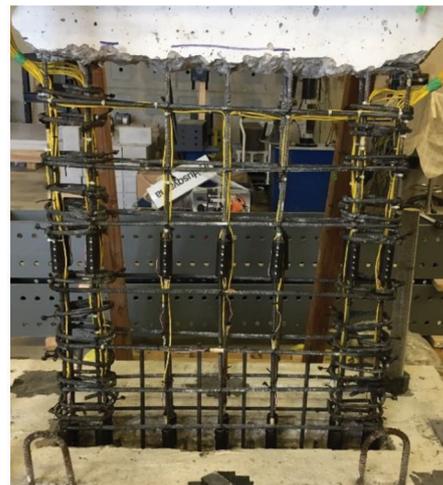
Fig. 5—Reinforcement layout of Wall RSWS-R in plastic hinge region.

Replacement and addition of reinforcing bars—The damaged vertical steel reinforcing bars were removed and replaced with new segments of identical 10M bars. Shear-off mechanical couplers were used to connect the replacement segments to the remaining bars. In addition, four 10M starter bars, spaced at 150 mm along the base of the wall and extending 300 mm from the base, were provided in both walls to address the rocking and sliding observed at the base of the wall during testing of the original walls. Shown in Fig. 5 and 6 is the reinforcement layout within the repaired regions for RSWS-R and RSWN, respectively. For RSWS-R, all vertical bars were replaced, while for RSWN,

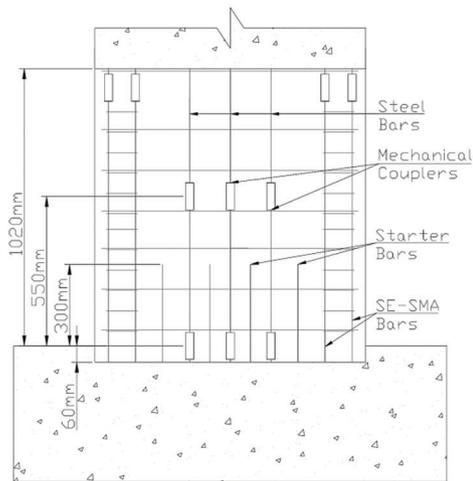
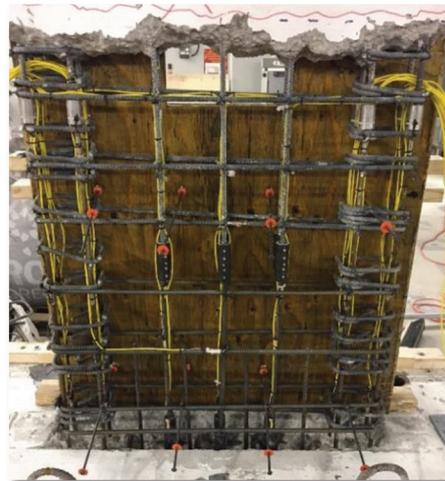
Fig. 6—Reinforcement layout of Wall RSWN in plastic hinge region.

only the vertical reinforcement in the web needed replacement as the SMA bars were undamaged. The ties in the boundary regions and the shear reinforcement of both walls were reused as no damage was observed.

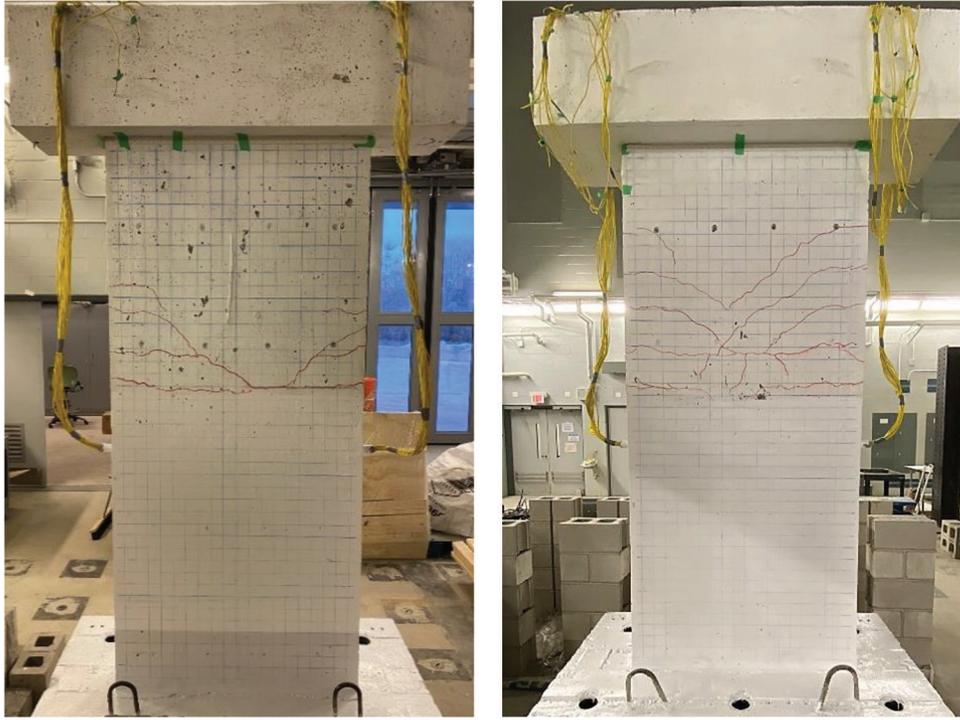
Fig. 7—Repaired walls prior to testing: (a) RSWS-R; and (b) RSWN.

wet burlap sheets and a vapor barrier and watering every day until the end of the curing period. Figure 7 illustrates the repaired walls prior to testing.

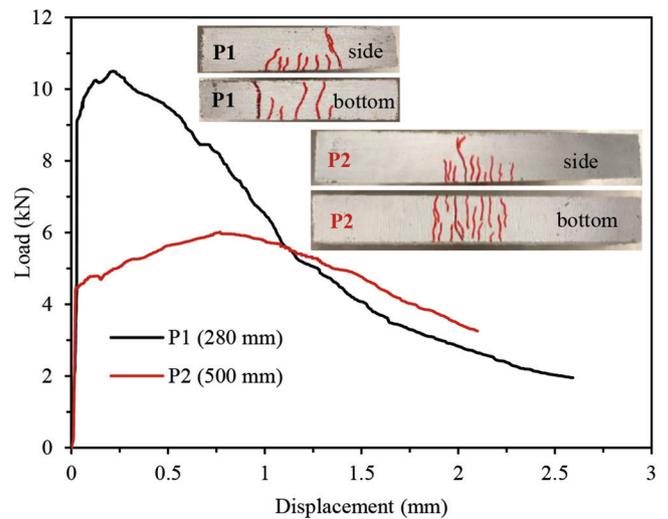
Fig. 8—Load versus midspan displacement of ECC flexural prisms and crack patterns at end of testing.

Four-point bending tests were performed to characterize the flexural strength of the ECC on two prism specimens: Prism P1 with the dimensions of 75 x 75 x 250 mm, and Prism P2 with the dimensions of 75 x 75 x 500 mm. The prisms were cast from the ECC batch for Wall RSWS-R and were tested at the age of 28 days. The corresponding average 28-day compressive strength of three cylinders for the ECC was 49 MPa. Shown in Fig. 8 are the load-displacement responses, exhibiting a noticeable ductile behavior, characterized by a plateau stage at the initiation of cracking and prior to reaching the peak load. The descending branch of

both prisms followed a gradual softening behavior. Additionally, both prisms developed a stiff initial response, where the first crack developed at 85% of the peak load for Prism P1 and 75% for Prism P2. The presence of the PVA fibers prevented a brittle failure mode; both prisms developed a localized dominant crack within the constant moment region and additional multiple finer cracks, as shown in Fig. 8. The fibers were able to bridge through and control the opening of the dominant crack, leading to the formation of other finer cracks. The maximum equivalent flexural strengths were 5.60 MPa for P1 and 6.42 MPa for P2; the corresponding midspan displacements were 0.22 mm for P1 and 0.77 mm for P2. (Note that the equivalent strengths were based on the gross section properties [Soto Rojas²⁴]).

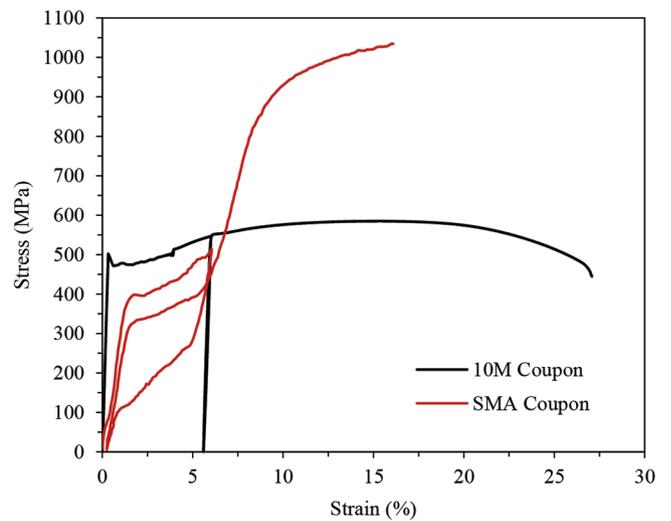
Fig. 9—Stress-strain response with 6% strain cycle of 10M steel and SMA bars. (Adapted from Morcos.¹⁹)

To assess the recovery capacity of the SMA bars, Morcos¹⁹ performed a hybrid monotonic loading with a 6% strain cycle on an SMA bar used in Wall SWN. Shown in Fig. 9 is the comparison between the stress-strain response for the SMA bar and a 10M reinforcing bar used in the original walls. The superelasticity property of the SMA bar is evident; at a 6% strain, the SMA developed a stress of 495 MPa, and thereafter, when unloaded to zero stress, the SMA experienced a negligible plastic offset of 0.18% strain prior to reloading to failure. The SMA failed prematurely by rupture of the top conical head of the mechanical coupler used in the original SWN wall at a stress of 1034 MPa and a corresponding 16% strain.¹⁹ At a 6% strain, the 10M steel bar was in the strain-hardening phase and at a stress level of 534 MPa. Unloading to zero stress, the steel bar experienced a residual strain of approximately 6%. Thereafter, the steel bar was loaded to failure, reaching a maximum tensile strength of 584 MPa at a corresponding strain of 16.6%.

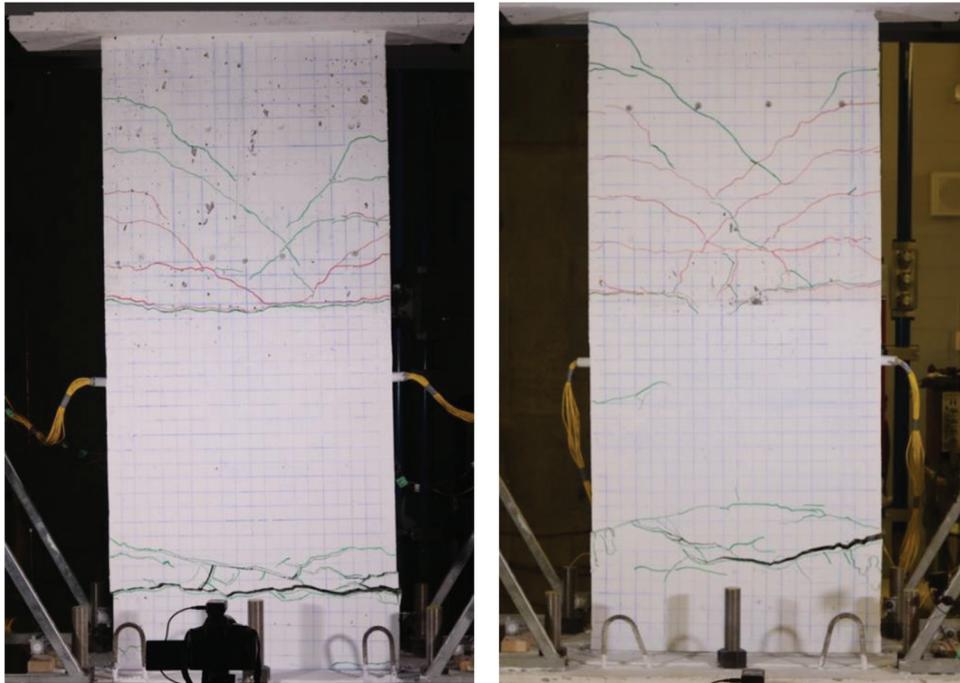
Fig. 10—Repaired walls after testing: (a) RSWS-R; and (b) RSWN.

Figure 10 illustrates the cracking patterns after testing Walls RSWS-R and RSWN. The existing cracks from the initial testing are highlighted with red and the new cracks are marked with green. At 4.8 mm displacement (0.2% drift) Wall RSWN developed the first flexural crack in the repaired region, 425 mm above the base; the crack was 0.3 mm wide and 300 mm long. During the last repetition at 4.8 mm in the negative direction, a previously existing flexural crack located above the repaired region, 1250 mm from the base, widened and reached 0.25 mm in width. RSWS-R developed no cracks in the repaired region at this displacement level and the existing cracks did not experience growth.

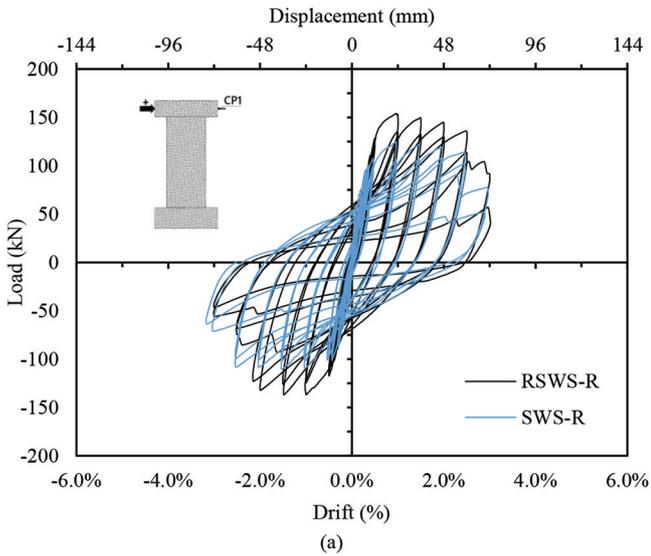
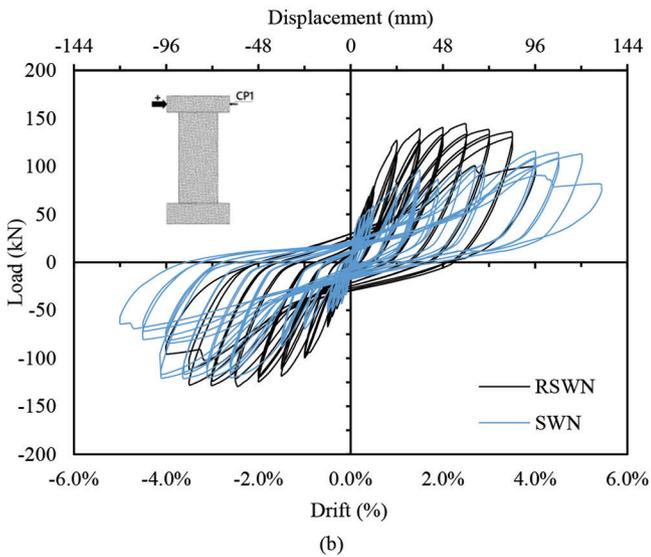
Fig. 11—Lateral load-displacement response of walls: (a) SWS-R and RSWS-R; and (b) SWN and RSWN.

The lateral load-displacement responses of the walls pre- and post-repair are illustrated in Fig. 11. The displacements were based on readings from the cable potentiometer installed at the midheight of the loading beam, which recorded measurements relative to the foundation. The

performance of the repaired walls is marked by a higher lateral load resistance in comparison to the original walls and comparable displacement capacity. Wall RSWS-R dissipated more energy than Wall SWS-R, with slightly wider hysteretic curves characterized by the development of higher loads for the same displacements, as shown in Fig. 11(a). Similarly, a significant increase in the lateral strength was observed for Wall RSWN (Fig. 11(b)). Wall RSWN experienced a reduction in drift capacity relative to the original wall. No significant difference in pinching was observed in the repaired SMA wall in comparison to the original SMA wall.

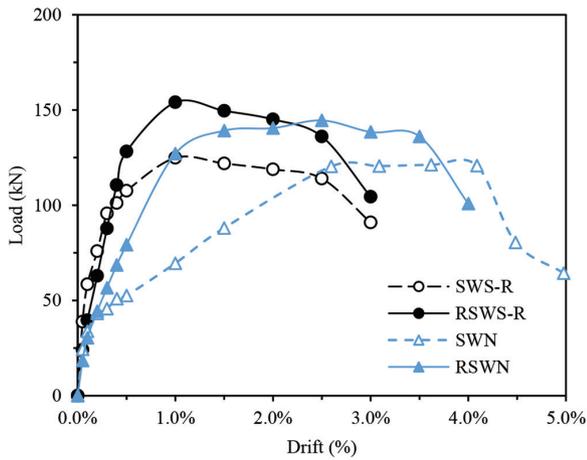
Fig. 12—Lateral load-drift envelopes of Walls SWS-R, RSWS-R, SWN, and RSWN.

It may be observed that the repaired steel wall experienced global yielding at a larger drift relative to the original wall. Conversely, the repaired SMA wall experienced a yield drift that was smaller than the original wall. However, the repaired walls exhibited a significant increase in the corresponding lateral strength at yielding. In the post-yielding regime, the repaired specimens, Walls RSWS-R and RSWN, sustained increased lateral loads in comparison with the original walls. The trend continued up to failure. It is noteworthy that, as shown in Fig. 12, the shapes of the envelopes are similar for RSWS-R and SWS-R. The envelope of RSWN exhibits a

response that can be satisfactorily characterized by bilinear behavior, whereas SWN provides a more pronounced trilinear response.

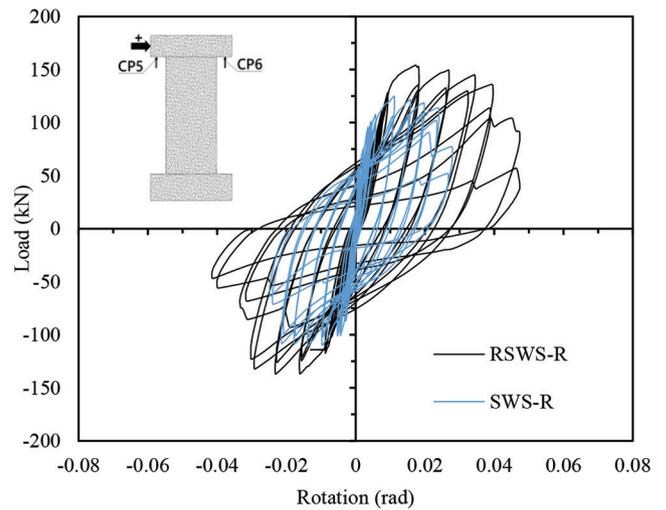
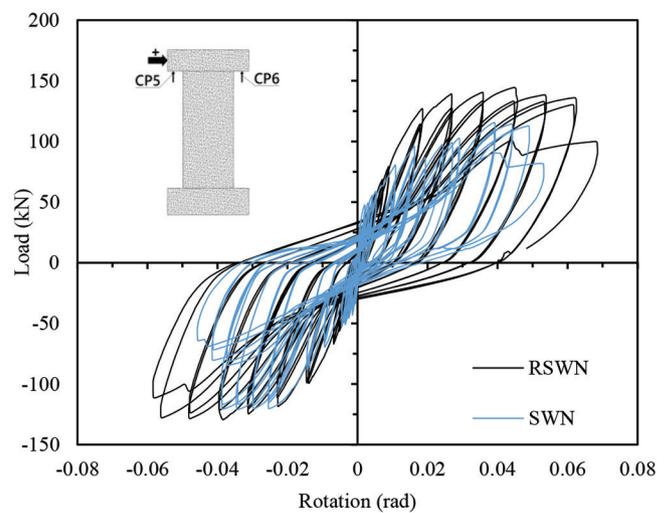
Fig. 13—Load-rotation responses of walls: (a) SWS-R and RSWS-R; and (b) SWN and RSWN.

The rotation responses were calculated from the vertical displacements recorded from the soffit of the top loading beam relative to the top of the foundation. The load-rotation behaviors are shown in Fig. 13. Overall, the SMA-reinforced walls exhibited larger rotations compared to the steel-reinforced walls. This behavior was observed for the original and repaired walls and is primarily attributed to the lower stiffness of the SMA bars and the development of dominant cracks. In addition, the SMA-reinforced walls were able to recover large rotations to a greater extent compared to the steel-reinforced walls due to the self-centering capacity of the SMA bars. The average rotation from the positive and negative loading cycles at yielding for Wall SWS-R was 5.5×10^{-3} rad, while the average rotation for SWN was 19.9×10^{-3} rad. The repaired Walls RSWS-R and RSWN exhibited 10.7×10^{-3} rad and 28.7×10^{-3} rad average rotations, respectively.

Wall RSWS-R sustained noticeably larger rotations compared to Wall SWS-R in the final loading cycles. This was due to the influence of ECC on the overall response, which led to the formation of a dominant crack in the repaired region and thus facilitated increased rotations. Repaired Wall RSWN also developed larger rotations compared to the original SWN wall, primarily due to the ECC material. At peak, Walls SWS-R and SWN developed average rotations of 12.3×10^{-3} rad and 36.7×10^{-3} rad, respectively. Repaired Walls RSWS-R and RSWN had average rotations of 20.1×10^{-3} rad and 45.6×10^{-3} rad, respectively. At ultimate, the original Wall SWS-R had a rotation of 21.7×10^{-3} rad, while SWN's rotation was 41.1×10^{-3} rad. The repaired Walls RSWS-R and RSWN at ultimate sustained 34.1×10^{-3} rad and 58.6×10^{-3} rad rotations, respectively.

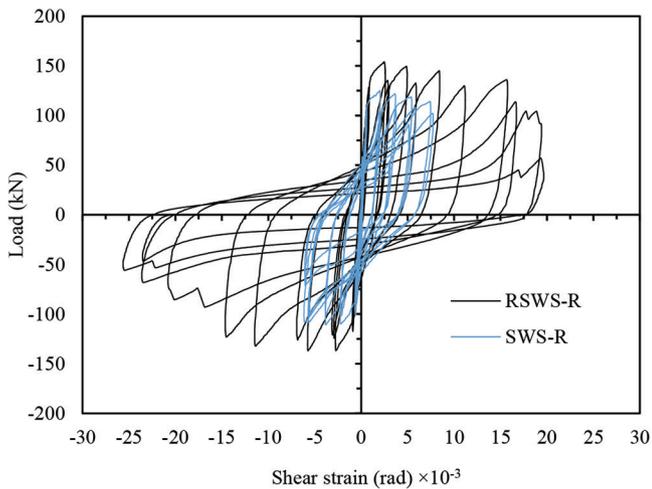
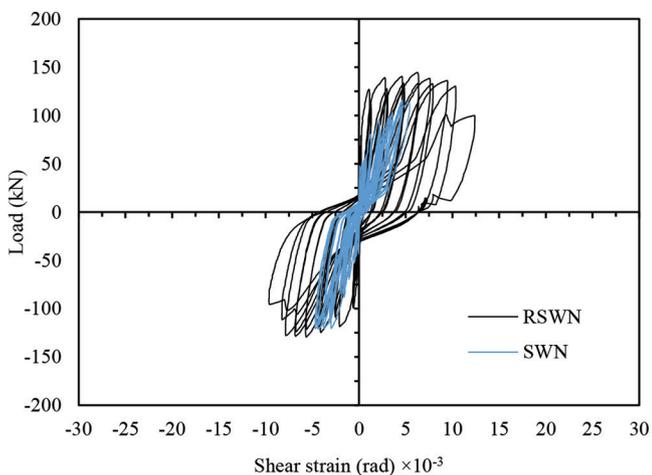
Fig. 14—Load-shear strain responses of walls: (a) SWS-R and RSWS-R; and (b) SWN and RSWN.

where γ is the shear strain; d_1 and d_2 are the reference lengths of the cable potentiometers installed diagonally in the plastic hinge; δ_1 and δ_2 are the change in length of the diagonal cable potentiometers; and h and l are the vertical and horizontal projections of the cable potentiometers. The dimensions were the same for all walls, d_1 and d_2 were 1130 mm, and h and l were 800 mm. Figure 14 depicts the load-shear strain responses.

At yielding, the repaired walls experienced average shear strains of 1.5×10^{-3} rad for Wall RSWS-R and 4.4×10^{-3} rad for Wall RSWN. The original walls, SWS-R and SWN, developed at yielding average shear strains of 0.5×10^{-3} and 2.4×10^{-3} rad, respectively. At peak lateral load, Wall RSWN developed average shear strains of 6.75×10^{-3} rad compared to 4.0×10^{-3} rad for Wall RSWS-R. The original Walls SWN and SWS-R exhibited average shear strains at peak loads of 4.50×10^{-3} and 2.9×10^{-3} rad, respectively. As the lateral displacements increased, Wall RSWS-R experienced larger

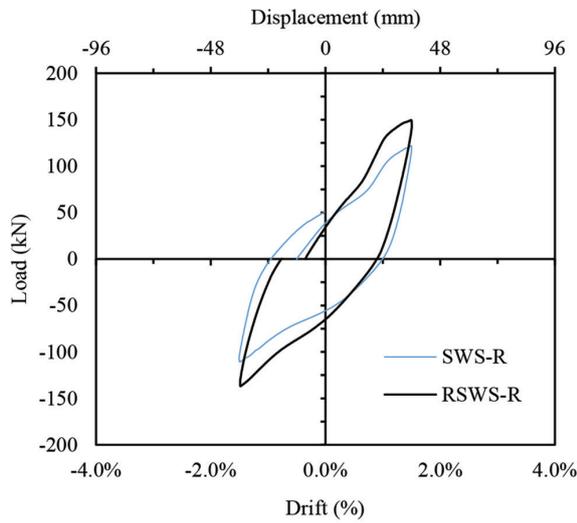
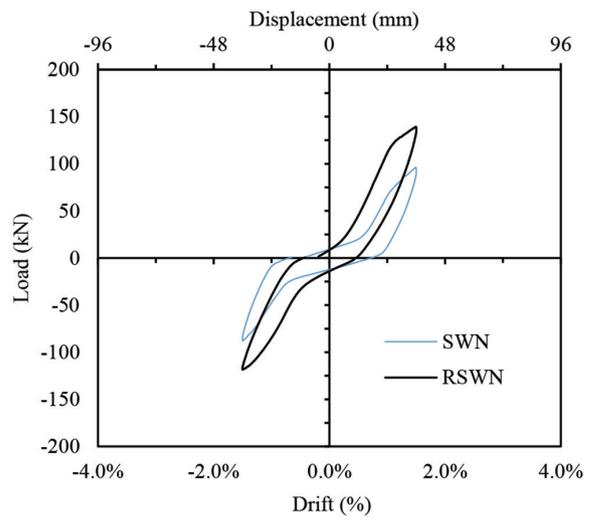
Fig. 15—Hysteretic response at 36 mm displacement (1.5% drift) of walls: (a) SWS-R and RSWS-R; and (b) SWN and RSWN.

Figure 15 provides the load-displacement response of all walls at 36 mm (1.5% drift). The characteristics of the responses between each set of walls are similar, with the exception of higher loads measured for the repaired walls. The dissipated energy was calculated as the area encompassed by the loop of the first repetition of loading. At this displacement level, the energy dissipated by Wall RSWS-R was 6240 N·m, which represented 8% more energy than SWS-R, with a dissipated energy of 5765 N·m. Similarly, Wall RSWN dissipated 2700 N·m, a 22% increase over Wall SWN, with 2130 N·m of energy dissipated. The ECC used for the repaired walls contributed to a strength enhancement in the walls, leading to higher dissipated energy throughout testing. In addition, the starter bars shifted the critical section above the base of the wall, effectively reducing the lever arm and resulting in increased strength.

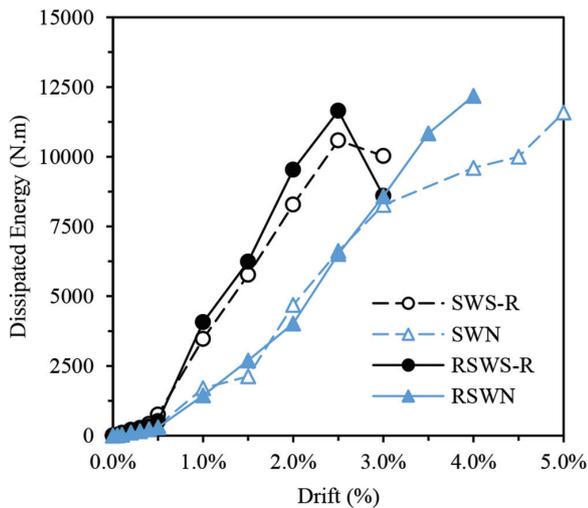
Fig. 16—Energy dissipated at different drift levels.

Figure 16 illustrates the energy dissipated at each drift level for the original and repaired walls. Up to a 0.5% drift, the energy dissipation for all the walls was comparable. Thereafter, it is evident that the repaired steel-reinforced wall dissipated more energy compared to the original wall. For the SMA walls, the difference in energy dissipation became more pronounced in the final loading cycles, with the repaired wall dissipating significantly more energy.

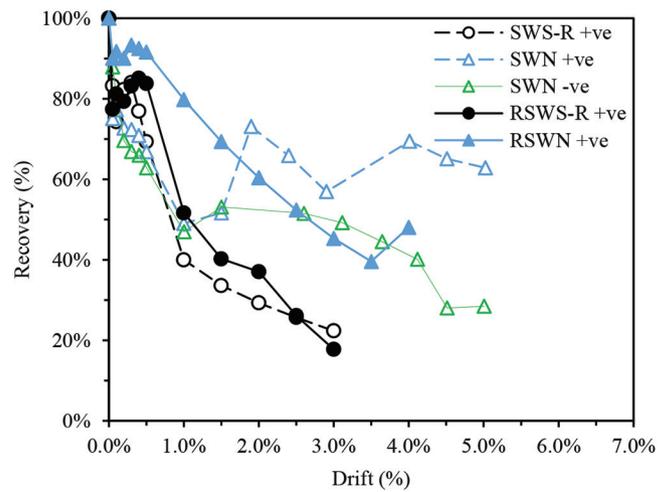
Fig. 17—Displacement recovery capacity-drift responses of walls: SWS-R and RSWS-R; and SWN and RSWN.

At the onset of testing, up to a 0.3% drift, the original and repaired steel-reinforced walls behaved in a similar manner. At a 0.4% drift, Wall SWS-R recovered 76% from the imposed displacement, while Wall RSWS-R recovered 85.4%. Similar behavior was experienced throughout testing; at a 1% drift, Wall SWS-R recovered 40.2%, whereas Wall RSWS-R recuperated 51.6%. At a 2% drift, Wall SWS-R recovered 29%, while Wall RSWS-R was able to retrieve 37.6%. The difference of approximately 10% in recovery capacities decreased as the walls approached failure.

The repaired SMA wall, RSWN, exhibited an improved recovery capacity up to a 1.5% drift, compared to both the

positive and negative responses of the original SWN wall. Thereafter, Wall SWN provided an enhanced recovery capacity in the positive loading direction compared to the repaired wall, which was maintained until failure. Compared to the recovery capacity of Wall SWN measured in the negative direction, the repaired wall exhibited a preferred response; the difference in recovery, however, was diminished as the walls approached failure, similar to the trend observed for the steel-reinforced walls. The primary reason behind the dissimilarity between the positive and negative loading responses for Wall SWN is attributed to the pronounced sliding at the base and rocking of the wall. Note that the increase of recovery for Wall RSWN at a 4% drift was the result of the fracturing of the longitudinal web bars, reducing the resistance to recovery.

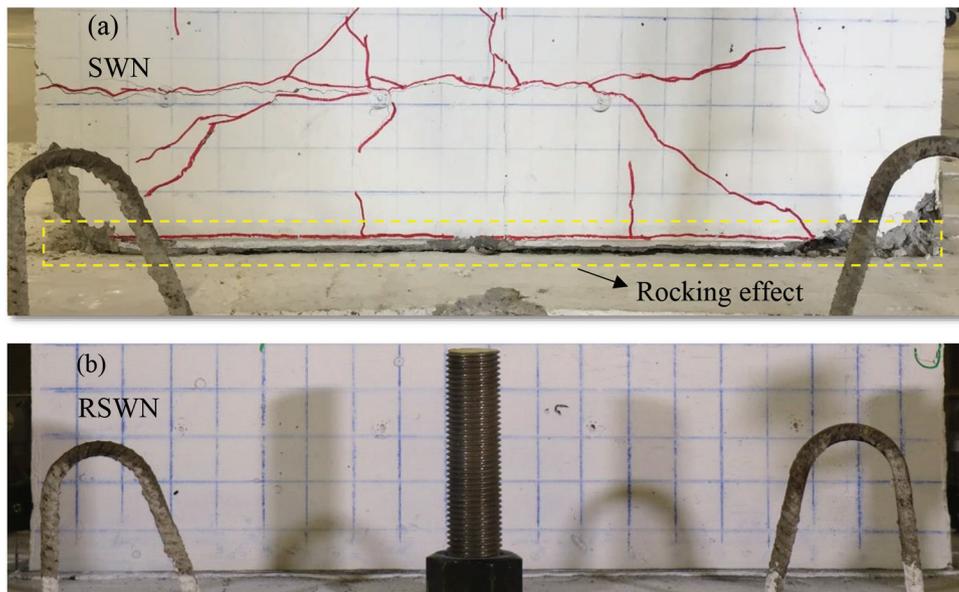
Fig. 18—State of base of walls at end of testing: (a) SWN; and (b) RSWN.

the existing concrete at the foundation level. In addition, the starter bars were used to prevent the rocking of the walls experienced by the original walls along their base. Controlling sliding and rocking resulted in a response that was controlled within the wall panel. This, in turn, ensured that the benefits of the ECC were realized. A cable potentiometer was installed 50 mm above the base of the walls to monitor the horizontal displacements throughout testing. The maximum lateral displacement was 0.38 mm for Wall RSWN and 0.31 mm for Wall RSWS-R. The negligible displacements validated that the addition of the starter bars eliminated sliding along the base of the walls. Furthermore, the starter bars eliminated the damage experienced by the original walls at the base. Figure 18 illustrates the state of the base of Walls SWN and RSWN at the end of testing. No significant cracking surfaced in the repaired walls along the height of the starter bars (300 mm) due to the high concentration of steel in this region, which created a rigid section, shifting the failure mode higher into the wall.

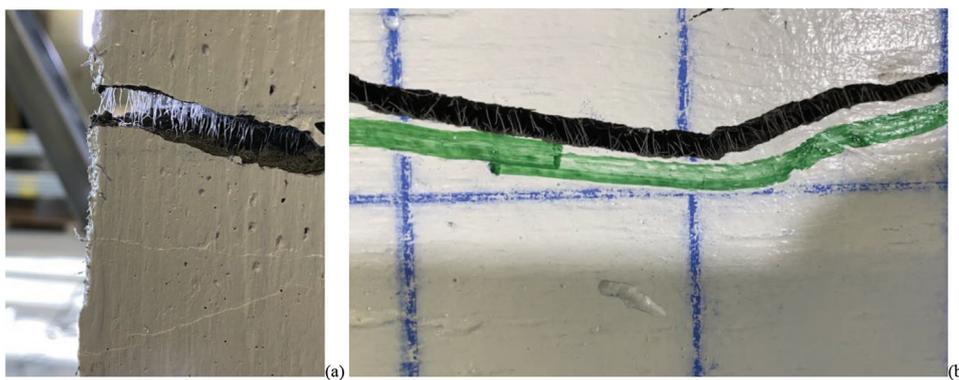
Fig. 19—Wall RSWN: Pulling out and fracturing of PVA fibers at localized cracks: (a) boundary zone; and (b) web region.

Replacing the conventional concrete with the ECC in the plastic hinge resulted in a delay in the damage experienced by the repaired walls at larger drifts. Moderate damage was detected up to a 1.5% drift for both repaired walls compared to a 0.5% drift for Wall SWS-R and a 0.3% drift for Wall SWN. This was associated with the effectiveness of the fibers in bridging the cracks at large displacements. The damage retention and crack recovery were sustained up to drifts of 2% for Wall RSWS-R and 2.5% for Wall RSWN. Thereafter, the fibers began pulling out from and fracturing at the localized major crack. The PVA fibers pulled out once the crack width exceeded the anchorage length of the fibers, approximately 6 mm. The major crack that formed in Wall RSWN at a height of 400 mm from the base illustrated the benefits of the fibers, which prevented the crack from widening up to drifts of 2.5%. Figure 19 is a close-up view of the PVA fibers

pulling out and fracturing at the localized cracks located in the boundaries and web region of Wall RSWN. Note that similar behaviors were observed in both repaired walls.

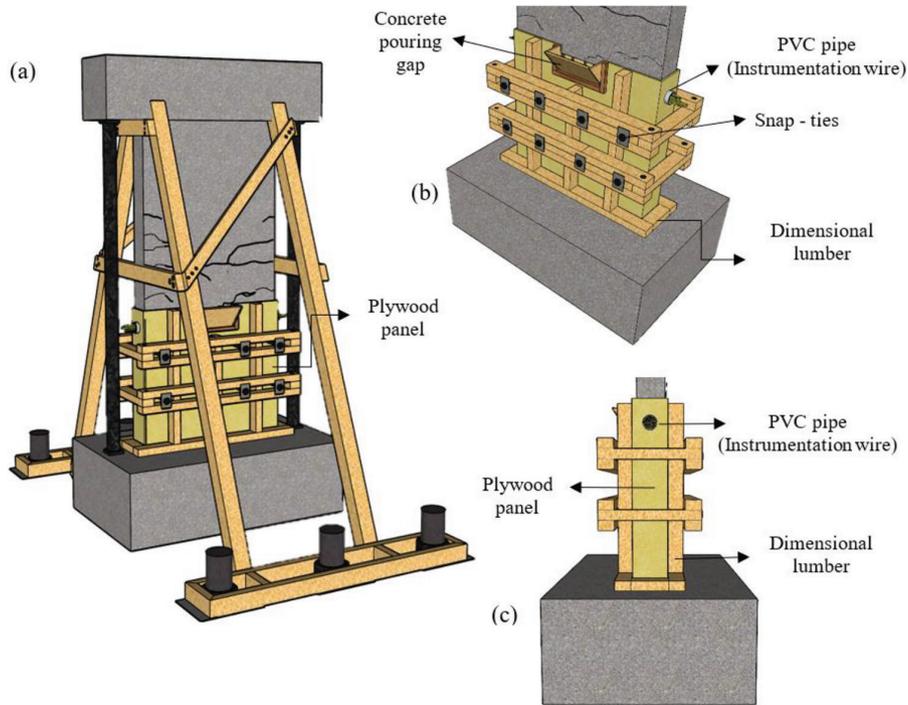
Fig. A1—Formwork design for plastic hinge.

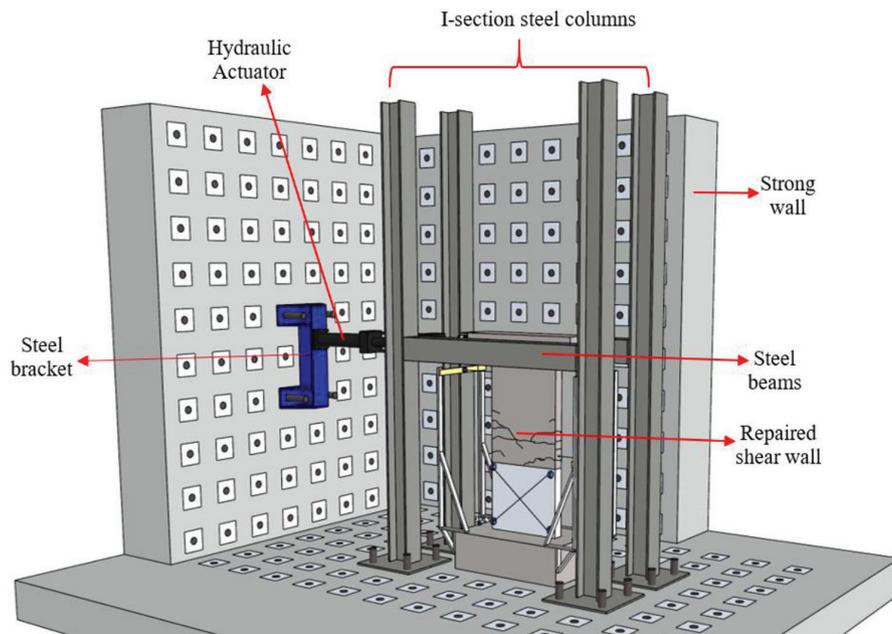
Fig. A2—Test setup assembly.
