**Corrosion of Stainless and Carbon Steel in Aqueous Piperazine for CO<sub>2</sub>  
Capture**

**Dissertation**

The University of Texas at Austin

**August 2022**

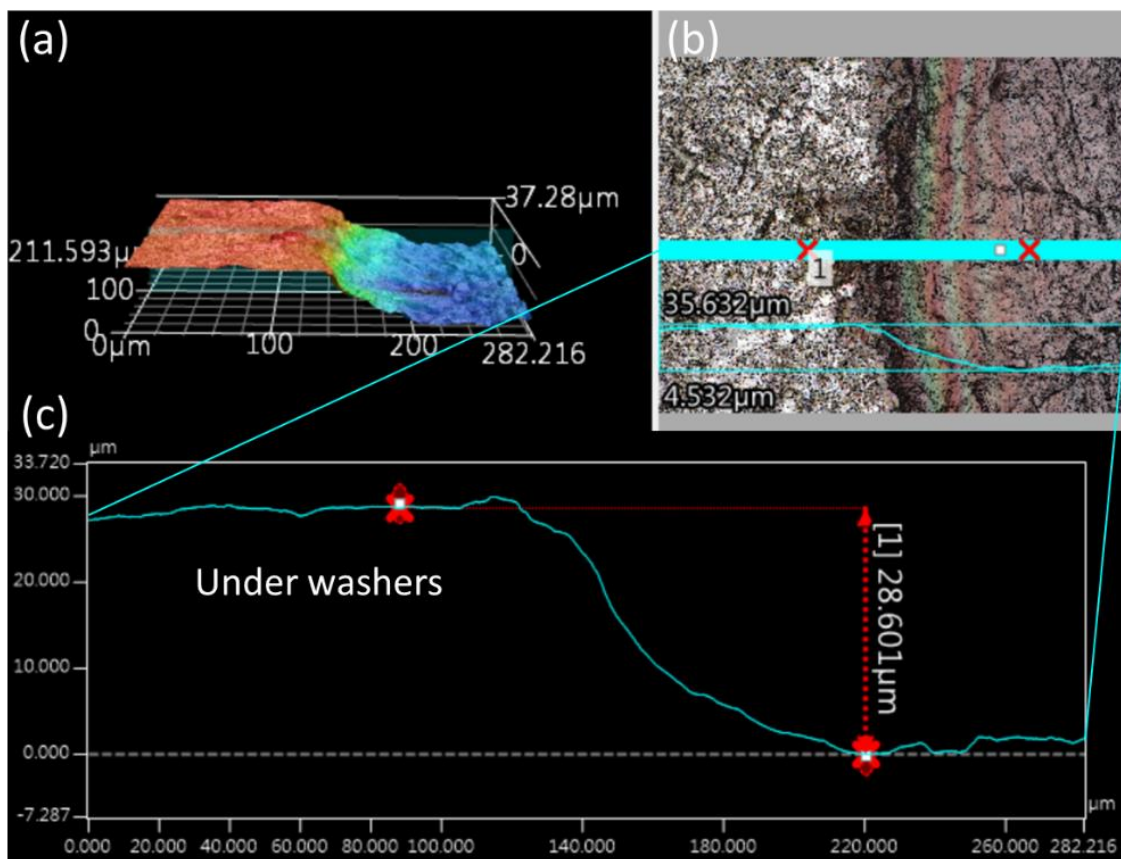
Figure 2-11: Surface profile of the C276 coupon in the hot rich stream during Batch 1 in the 2019 NCCC campaign. (a) 3D profile of the scanned surface, color-coded by height; (b) top-view optical image of the scanned surface, labeling the cross-section for (c) 2D profile analysis. (Liu et al., 2020)

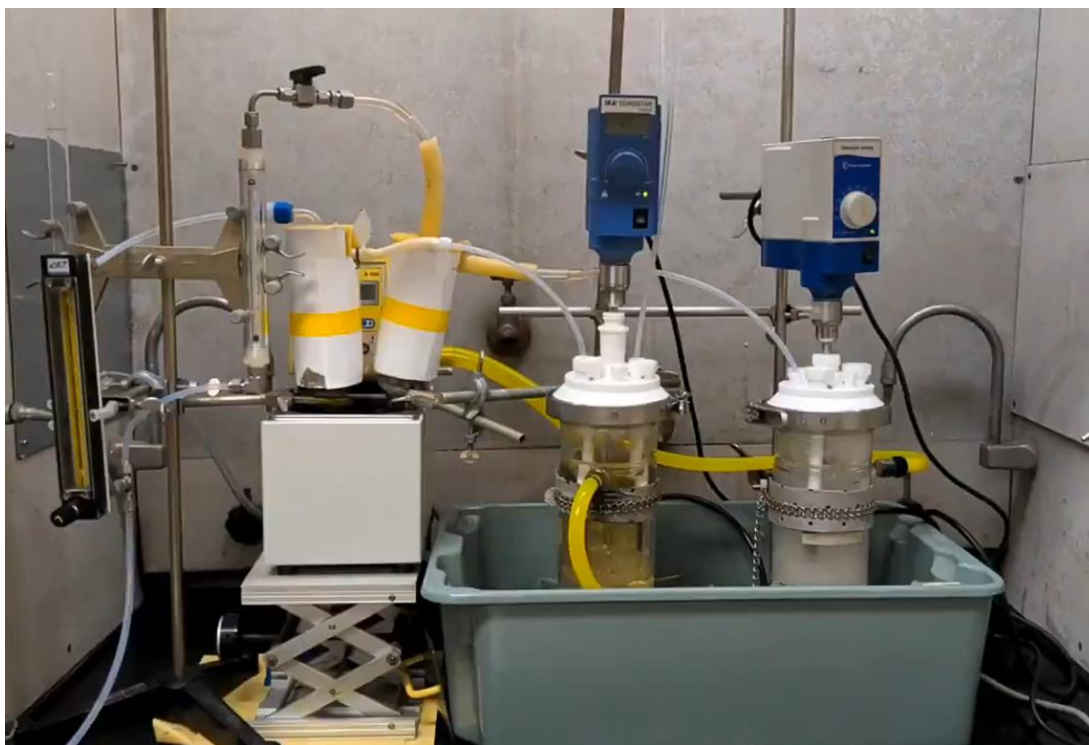
Figure 3-3: Low-gas flow reactor setup

Figure 3-3 shows the setup of the low-gas flow reactors. The design and dimensions of each part have been detailed by Freeman (2011). The inlet gas from a pre-mixed gas cylinder came in at a rate of 100 cc/min to a pre-saturator (wrapped with fiberglass pipe insulation) and was saturated with water to maintain the water balance in the reactors. Then the gas was bubbled into the solvent in the jacketed reactors. Two inlet gas mixtures were used in the experiments presented in this report: 1.5%  $\text{CO}_2$  in air and 18%  $\text{CO}_2$  in  $\text{N}_2$ . The current setup has two jacketed glass reactors with Teflon<sup>™</sup> lids. The jackets of the reactors were connected to an oil bath to control the temperature in the reactors. The solvent volume in each reactor was around 600 mL and was agitated magnetically or mechanically to simulate liquid flow in real pipes.

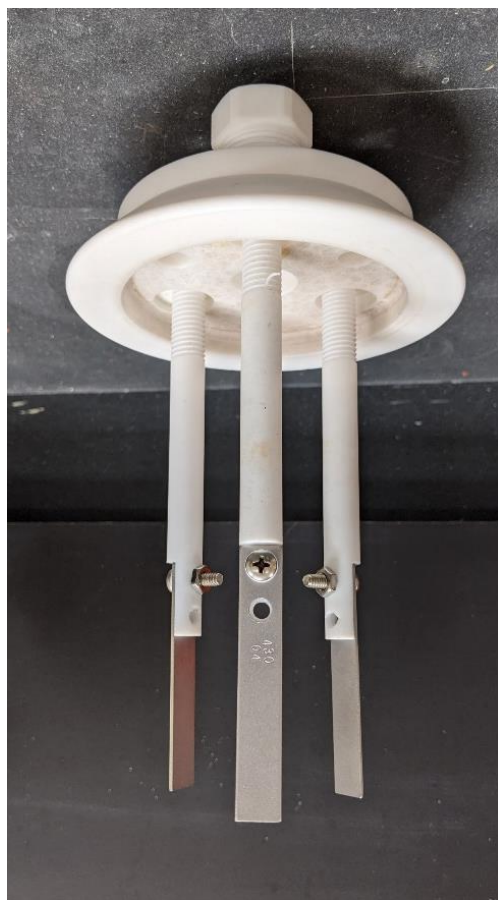
Figure 3-4: Teflon lid with three coupon holders

Each lid has three coupon holders also made of Teflon™ (Figure 3-4). The corrosion coupons are purchased from Metal Samples Company and used as received. The alloys tested include C1010 carbon steel, 430 stainless steel, 304L stainless steel, and 316L stainless steel. The coupons were weighed before being immersed in PZ solution. The experiments typically lasted 3 to 5 days. Once removed from the PZ, coupons were rinsed with deionized water, dried, photographed, wrapped in the original packaging, and placed in a glass desiccator until analysis could be performed. Coupons were mounted for imaging by a scanning electron microscope (SEM). Afterward, any corrosion product was scraped off and analyzed by powder x-ray diffraction (XRD). Any residual corrosion product was removed using concentrated HCl inhibited by N, N'-dibutylthiourea, and a final weight loss was calculated.

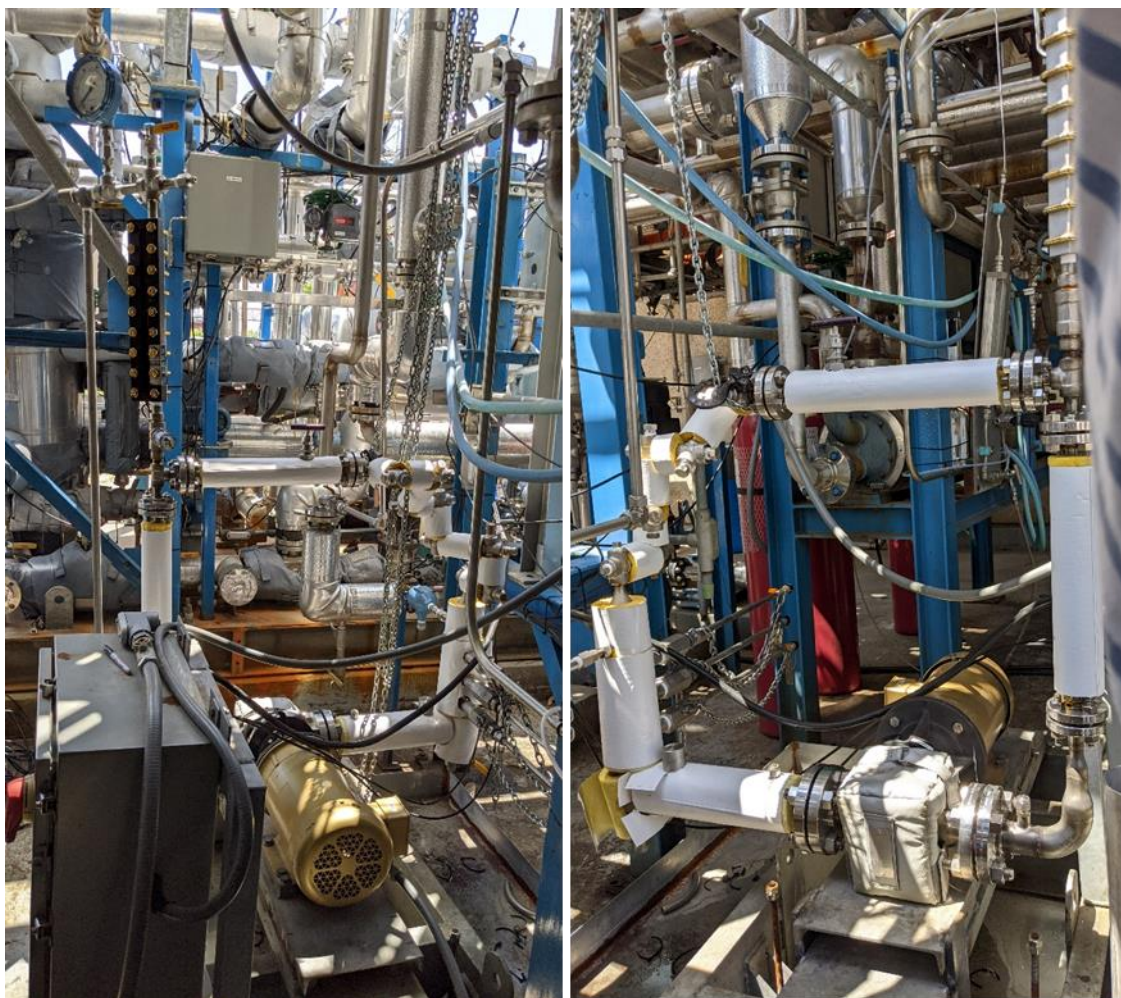
Figure 3-6: Front view (left) and back view (right) of the pump-around corrosion loop.

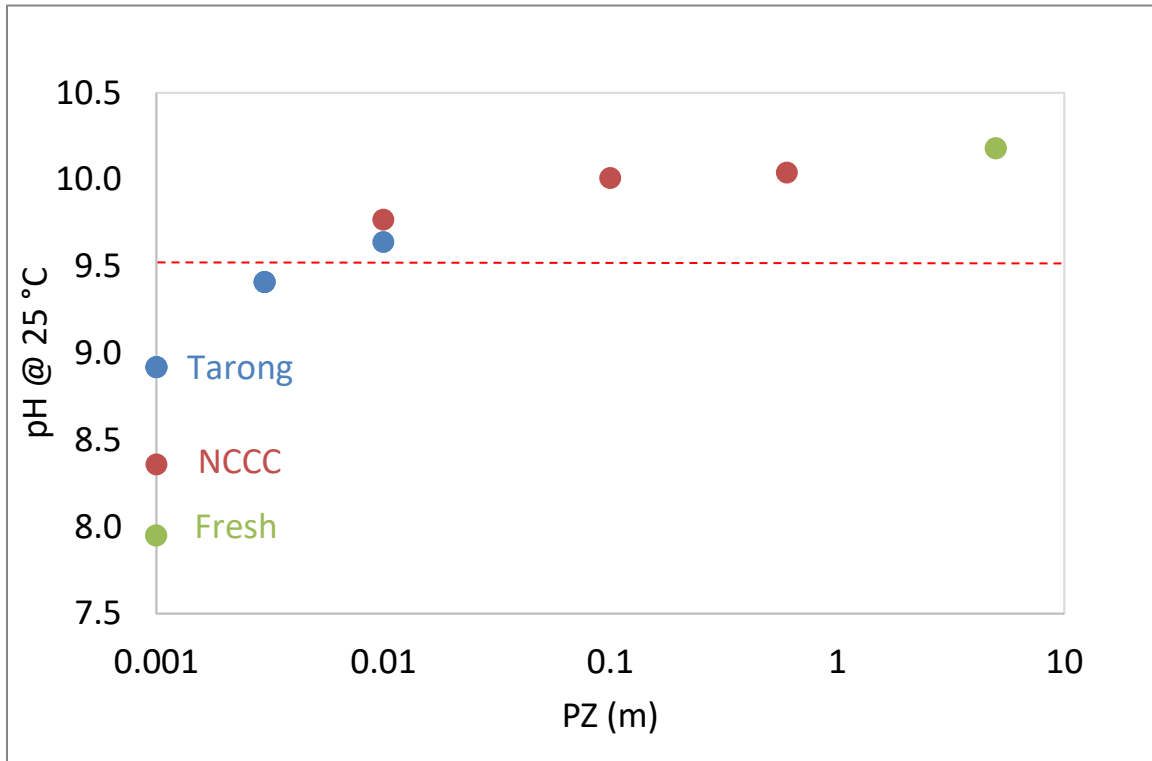
Figure 3-9: pH of PZ solutions from experiments with 1.5% CO<sub>2</sub> in air mixture as inlet gas at 60 °C; a critical pH marked by the red dashed line.

The pH of the PZ solutions was measured after each experiment at 25 °C (room temperature), and the results are given in Figure 3-9. The pH increased at higher PZ concentration, as expected. The lower corrosion rate in more concentrated PZ can be attributed to the reduced acidity by the addition of PZ. As the solution became less acidic, fewer protons were available for the cathodic corrosion reaction to occur, resulting in lower corrosion rates. The measurement of pH provides a simple way of differentiating between PZ solutions that are corrosive and non-corrosive to C1010. Below a critical pH value near 9 (represented by a red dashed line in Figure 3-9), C1010 corrosion was above the 300  $\mu\text{m}/\text{yr}$  standard and was unacceptable. As more PZ was added, and the pH was above the critical value, C1010 performed well. Therefore, from a technical viewpoint, pH measurement of the water wash solution can be an easy tool for monitoring CS corrosion in the water wash during operation.

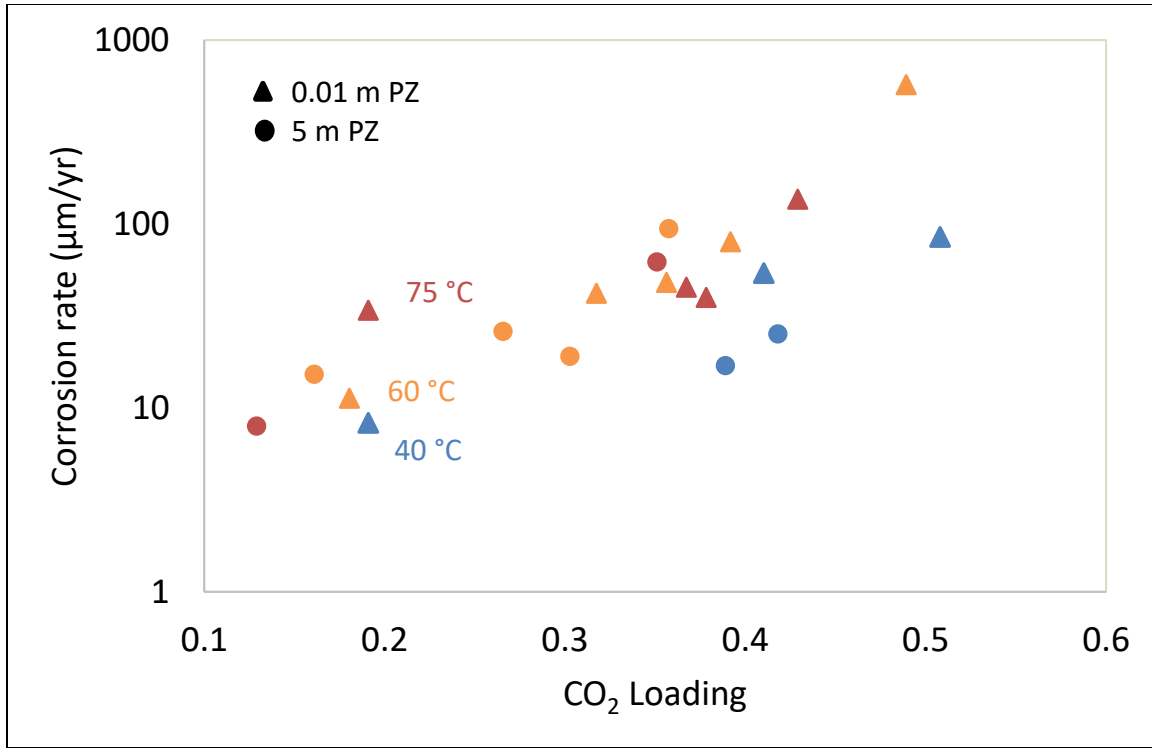
Figure 3-11: Effects of loading and temperature on C1010 corrosion at absorber and water wash conditions
