| 4. Title and Subtitle The Long-Term Performance of a Drilled Shaft Retaining Wall in an Expansive Clay | | | 5. Report Date October 2013 | | |

The Long-Term Performance of a Drilled Shaft Retaining Wall in an Expansive Clay

| CTR Technical Report: | 0-6603-2 |

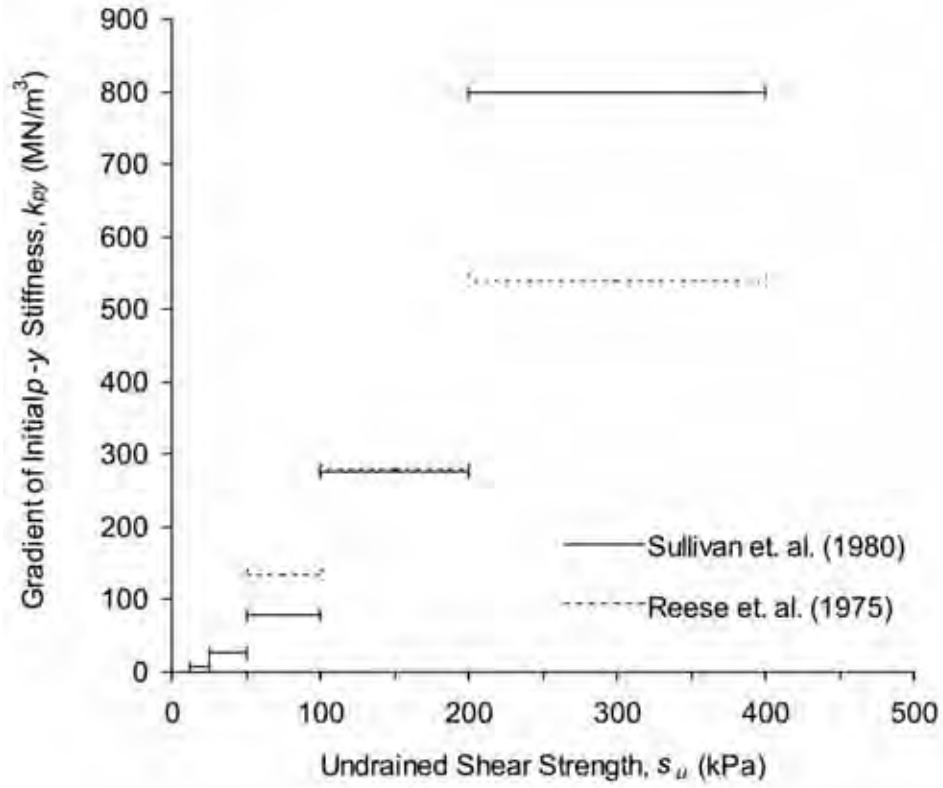
Figure 2.4: Typical k_{py} values for clays (after Dodds and Martin 2007).

If the long-term conditions of drilled shaft walls in expansive clays are governed by the development of drained conditions, the use of drained p-y curves developed for cohesionless soils may be appropriate. Because the initial stiffness of the clay in response to loading at small strains is governed by undrained behavior, the initial stiffness value k_{py} for the p-y curves is selected according to the undrained properties of the clay as shown in Figure 2.4. The use of default k_{py} values for modeling curves at low friction angles associated with expansive clay soils results in unrealistically low values of initial stiffness (Figure 2.5). The selection of unit weight is based on the expected hydrologic conditions on the project site to represent effective stresses. Strength reduction to account for close pile spacing is accounted for by reducing the p-y curve by a reduction factor (Figure 2.6) that is applied to all points along the curve.

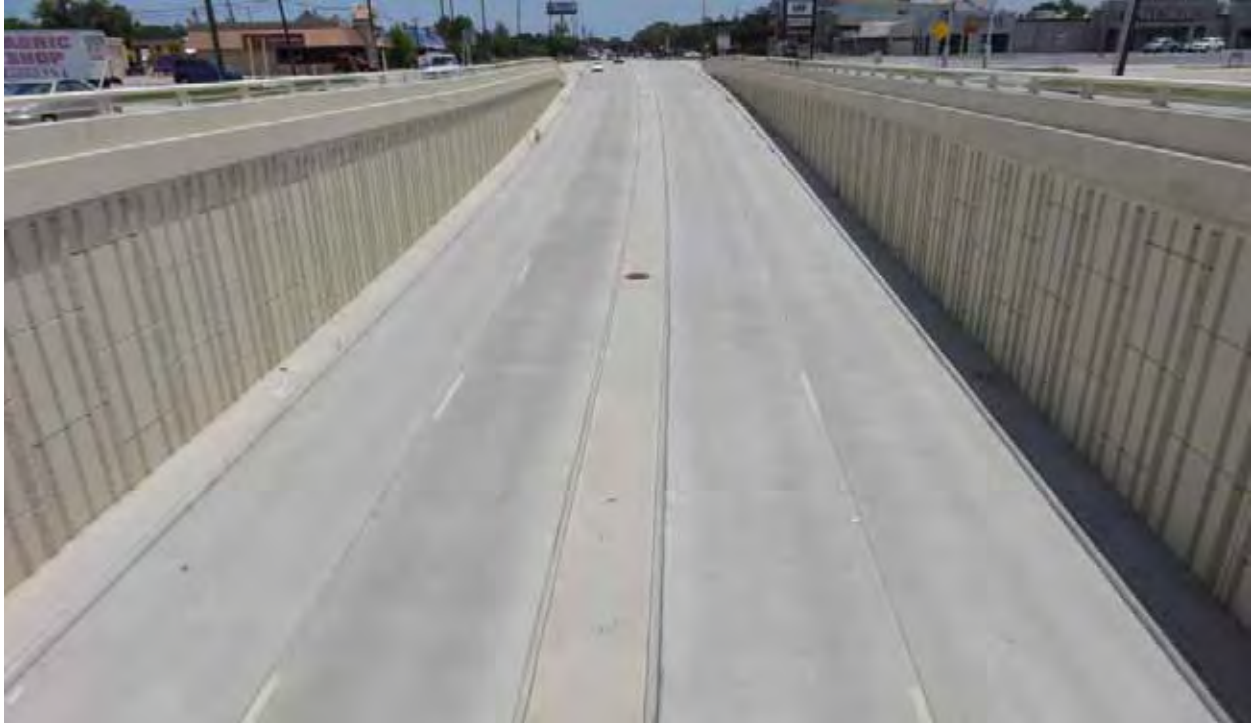
Figure 3.26: View of north and southbound walls from FM 1960 bridge (facing southeast).

From a distance, the wall appears to be in excellent condition (Figure 3.26). No obvious signs of distress were observed when walking along the top and base of the wall. A four-foot carpenter's level showed the panels to be vertical (Figure 3.27). This is consistent with the overall condition of the wall.

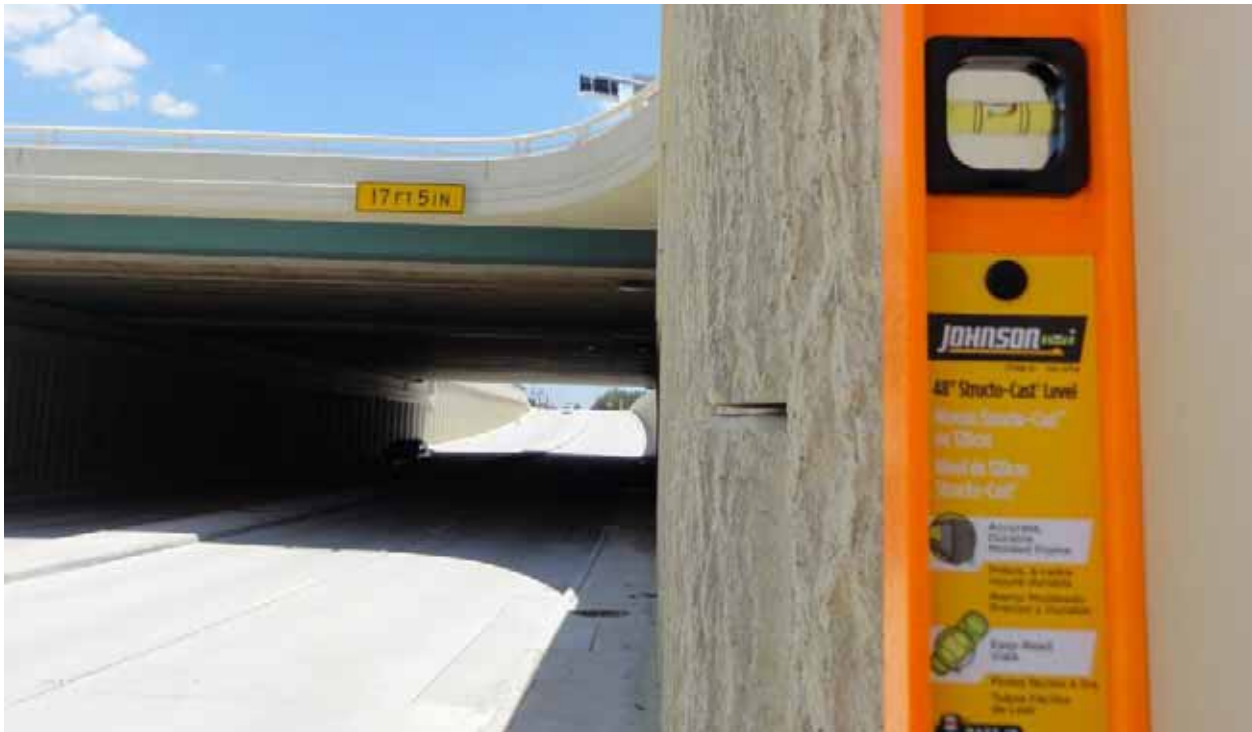
Figure 3.27: Wall facing was observed to be vertical and in good condition throughout the project area.

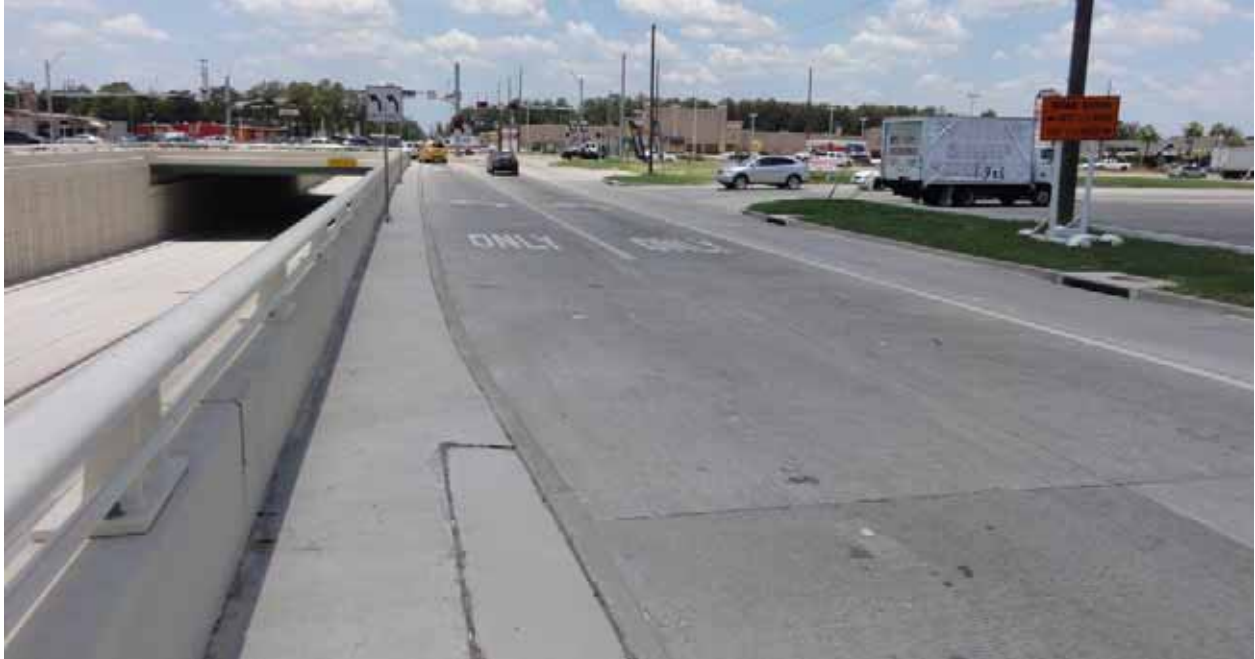
Figure 3.28: Paved area behind the wall. In all locations, pavement extends at least 30 feet behind the wall.

At all cantilever drilled shaft wall locations, the retained soil is covered with pavement for at least three traffic lanes (Figure 3.28). This could limit the potential for large moisture fluctuations near the wall. There are a few grass medians in the area with widths of approximately 4 feet. The nearest location for larger scale moisture infiltration is at the southeast corner of the intersection, at least 40 feet from the nearest shafts (Figure 3.29). A closer inspection of this unpaved area shows that some potential for water ponding exists, but offers no clear evidence that it has occurred near the wall (Figure 3.30). An inspection of the wall showed no indication of differential movements in the shafts nearest to the unpaved area.

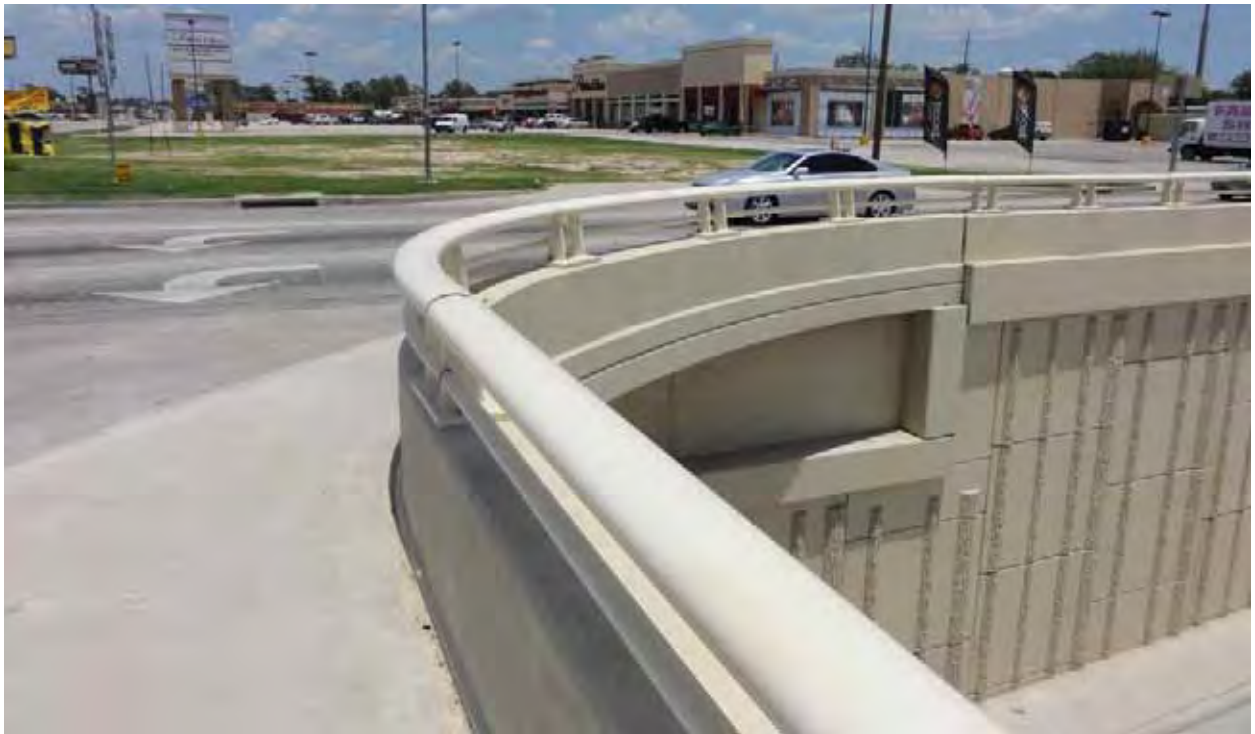
Figure 3.29: View of nearest location for moisture infiltration, at southeast corner of intersection.

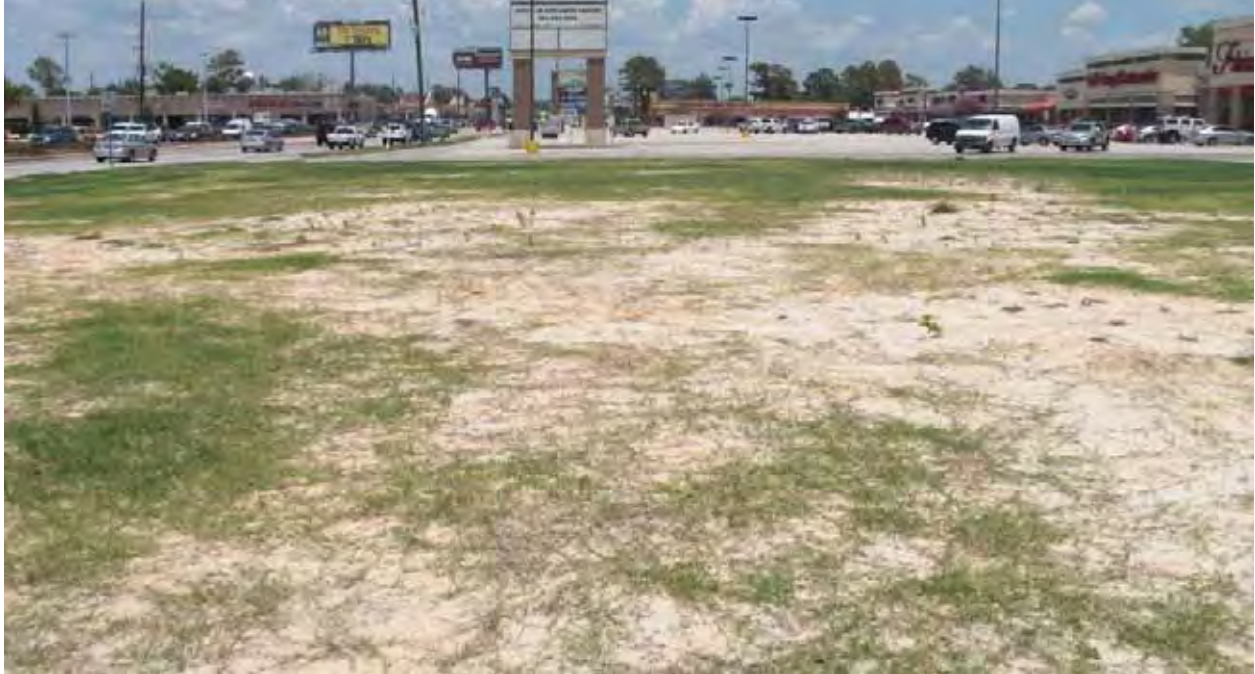
Figure 3.30: Unpaved area near southeast corner of intersection.

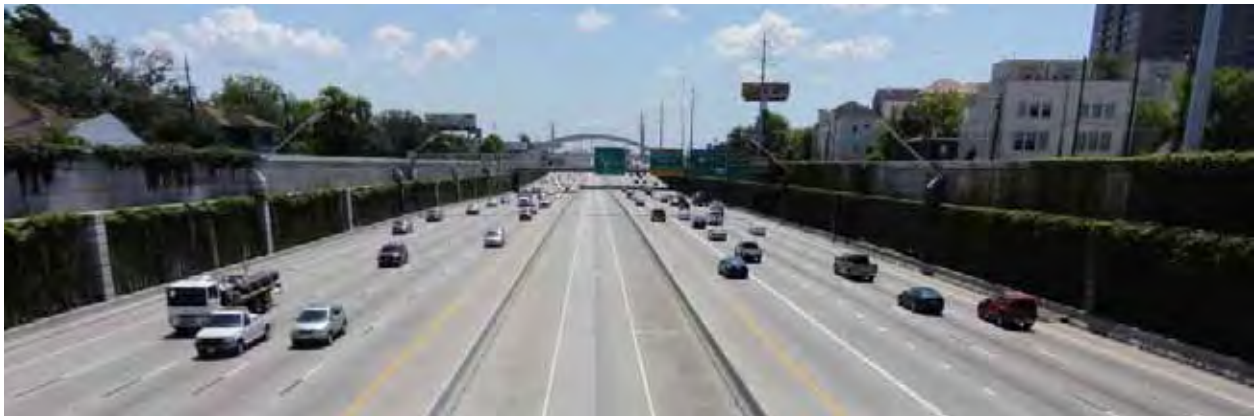
Figure 3.31: Large-scale view of project area (facing east). Sound wall is located above the main retaining structure.

A large scale view of the project area is presented in Figure 3.31. Because the facing was installed at an angle and is currently covered with dense vegetation, very little information about the shafts can be obtained from road level (Figure 3.32).

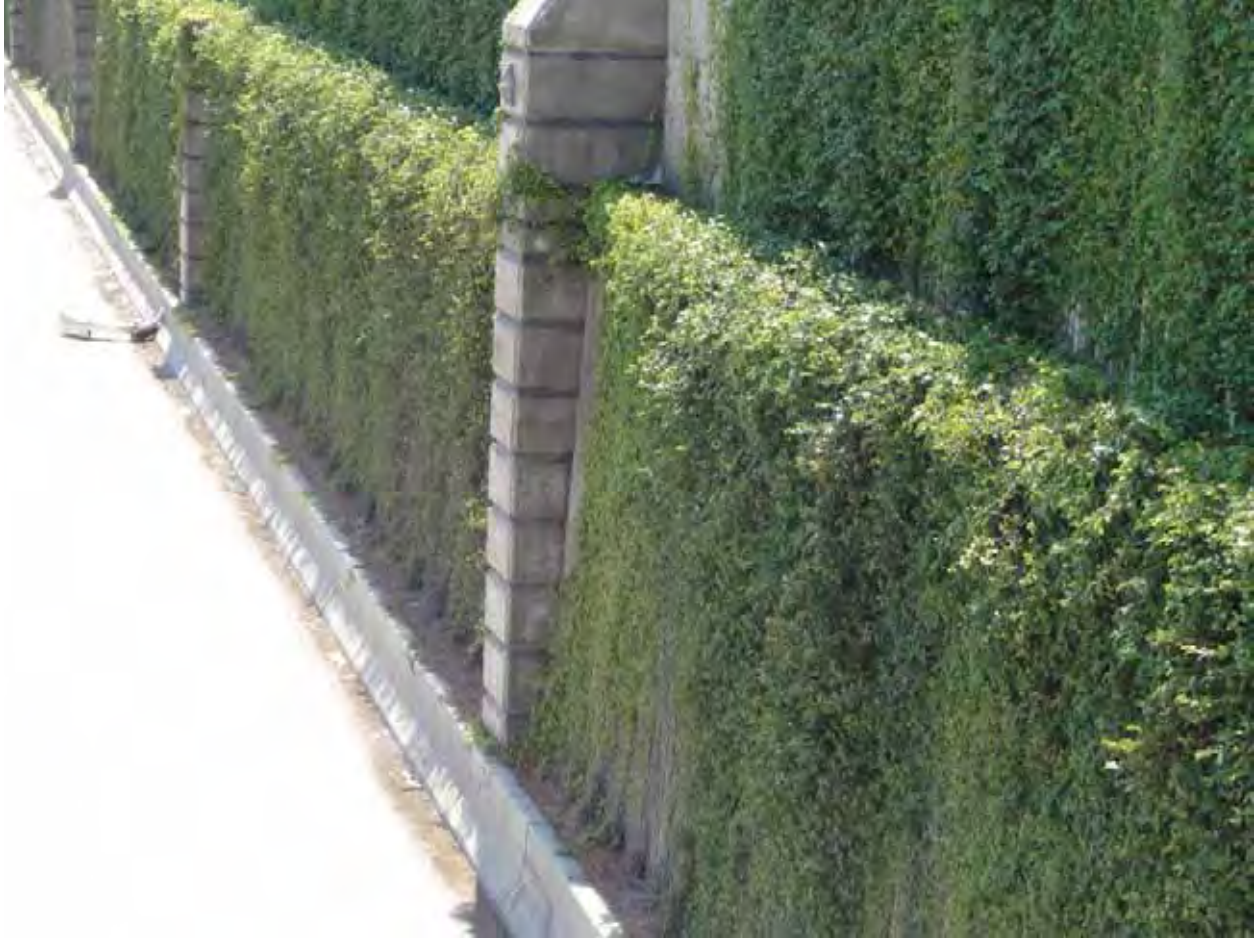
Figure 3.32: Dense vegetation and batter angle on concrete facing panels. Sound wall is located above main retaining structure.

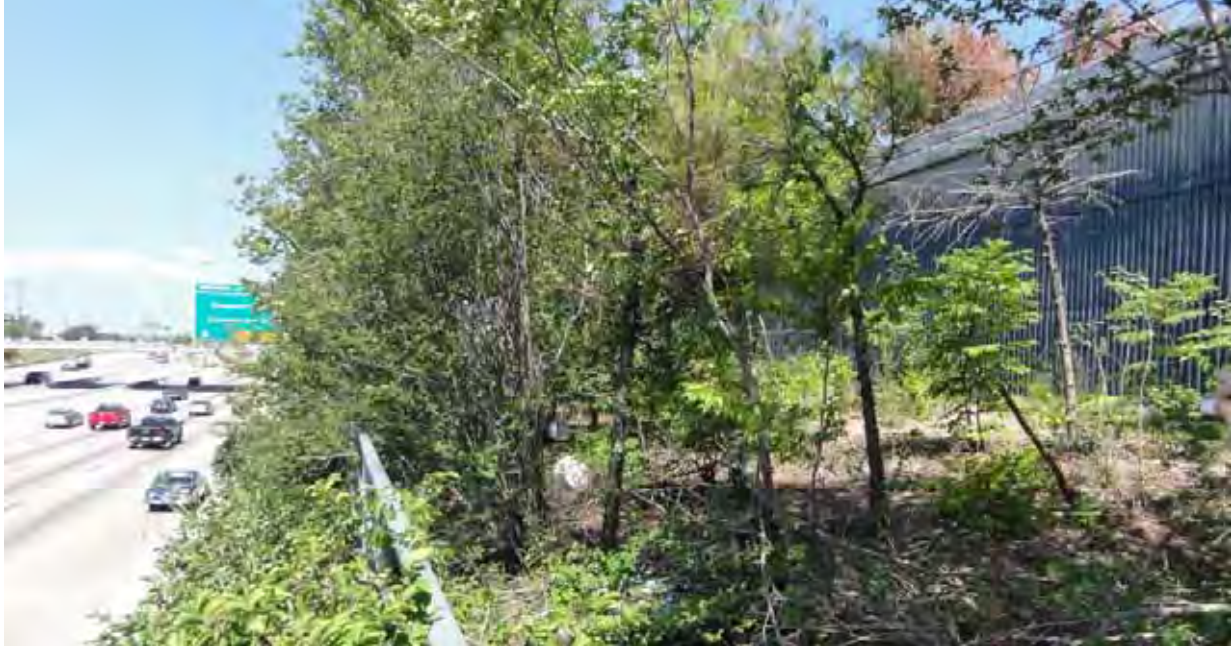
Figure 3.33: Approximately 40 feet of exposed soil behind the wall near Hazard Street (facing west).

An inspection of the area behind the north wall near Hazard Street showed approximately 40 feet of exposed soil between the drilled shaft wall and the sound wall (Figure 3.33). Along the length of the project site, the distance between the drilled shaft wall and the sound wall can range from 0 to approximately 50 feet. At several locations, gaps were observed between the retained soil and the shafts (Figure 3.34). Some of these gaps were up to 8 feet deep and 1 foot back from the wall. The potential for water to drain into these gaps during heavy rainfall seems high.

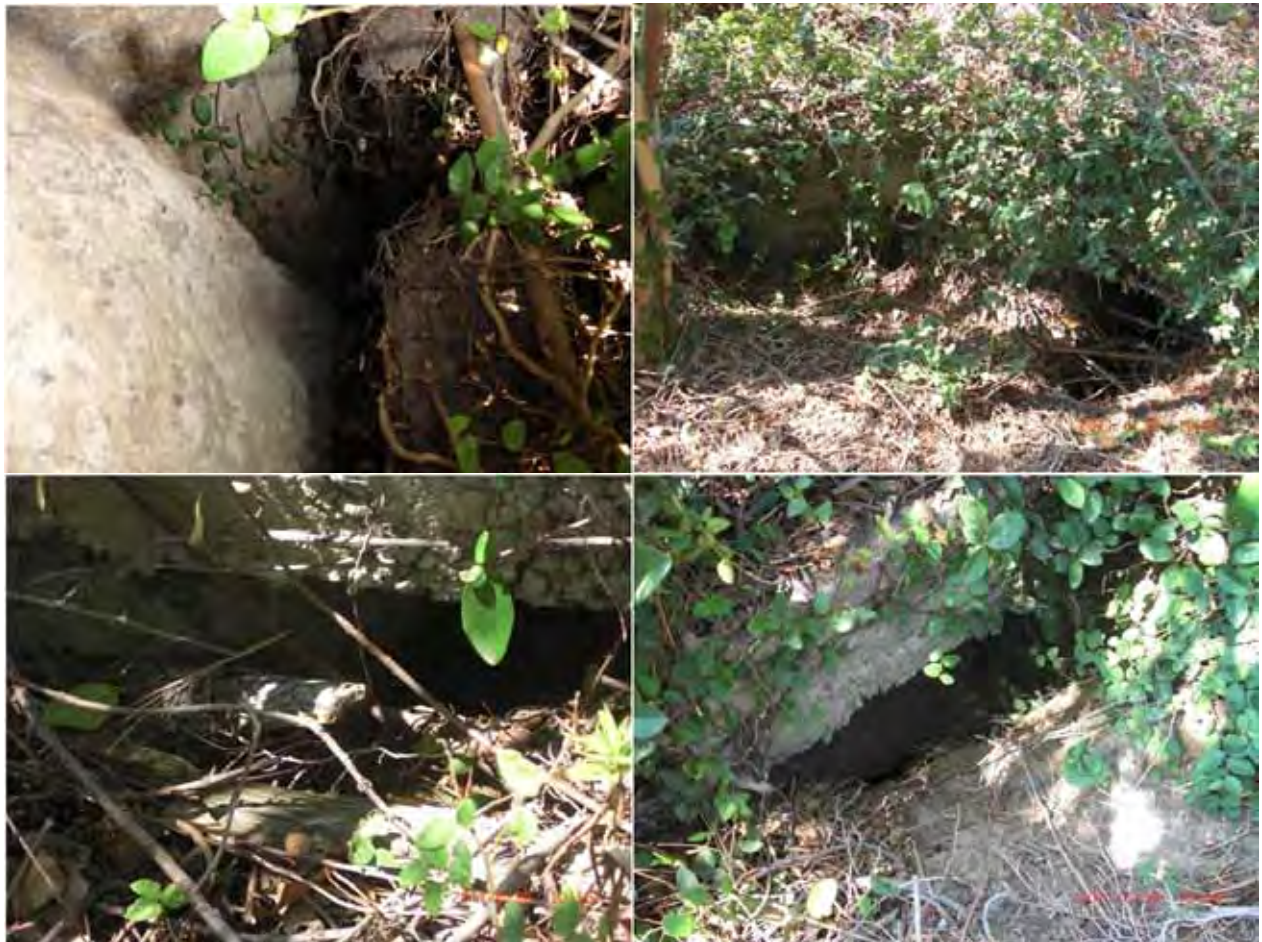
Figure 3.34: Several gaps were observed between the shafts and the soil behind the wall.

The soil behind the wall is well vegetated and water flow is directed to large grates leading to an underdrain system. Of the walls we studied, this wall appears to have the largest potential for moisture change. Despite this, every measurement that could be made indicated that the wall is vertical and no major red flags were observed (apart from the gaps between the soil and the wall).

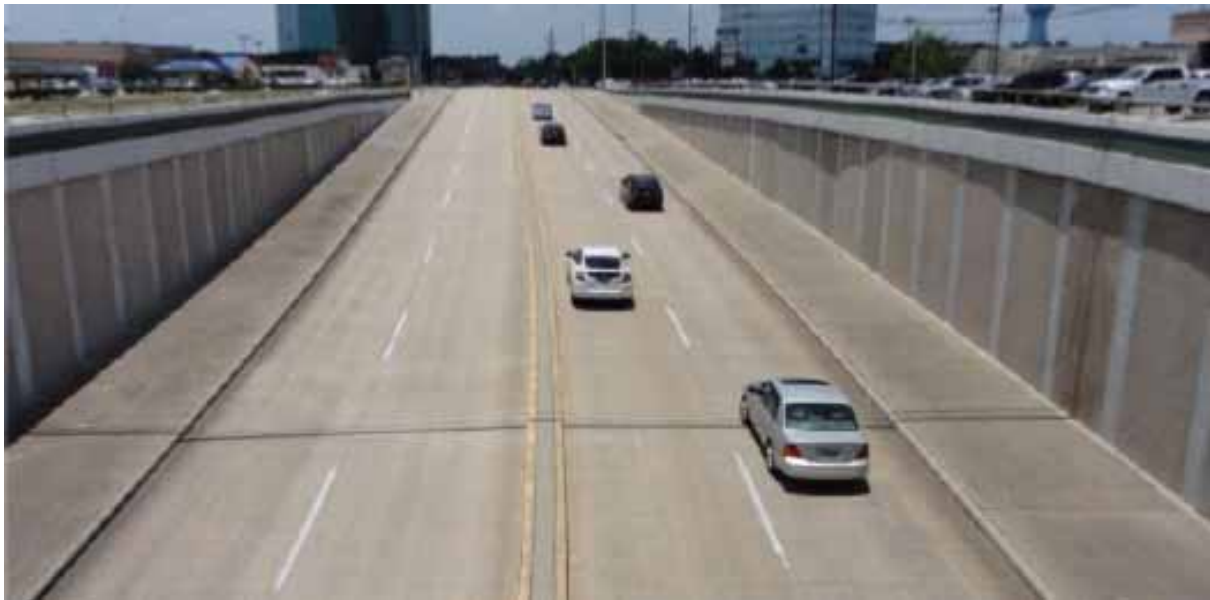
Figure 3.35: View of current wall conditions, facing west.

From a distance, the wall appears to be in good condition (Figure 3.35). No obvious signs of structural distress were observed when walking along the top and base of the wall, but some superficial facing damage was observed. Most of this damage appears to be age-related and not caused by any structural distress on the wall. Some imperfections in the white concrete facing appear to be caused by seams in the concrete formwork (Figure 3.36). Some cracking and differential settlement is present in the sidewalks near the wall, but no signs of corresponding wall distress were observed at these locations (Figure 3.37). Some concrete cracking was seen at the connection between two facing elements (Figure 3.38).

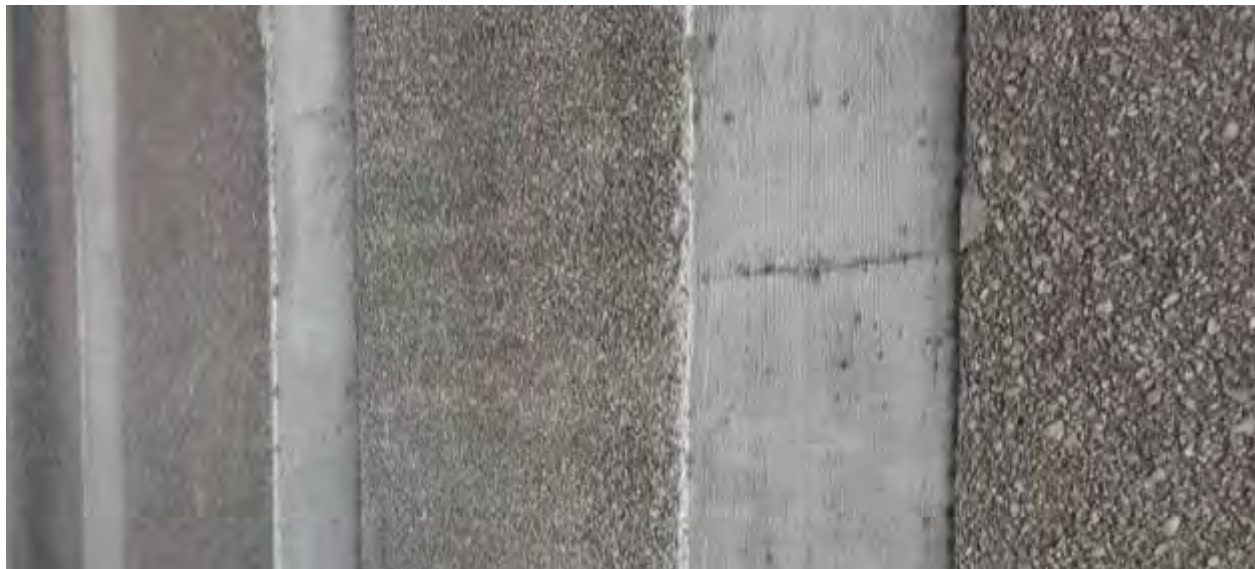
Figure 3.36: Example of imperfection in white concrete facing, possibly caused by a seam in the plywood formwork.

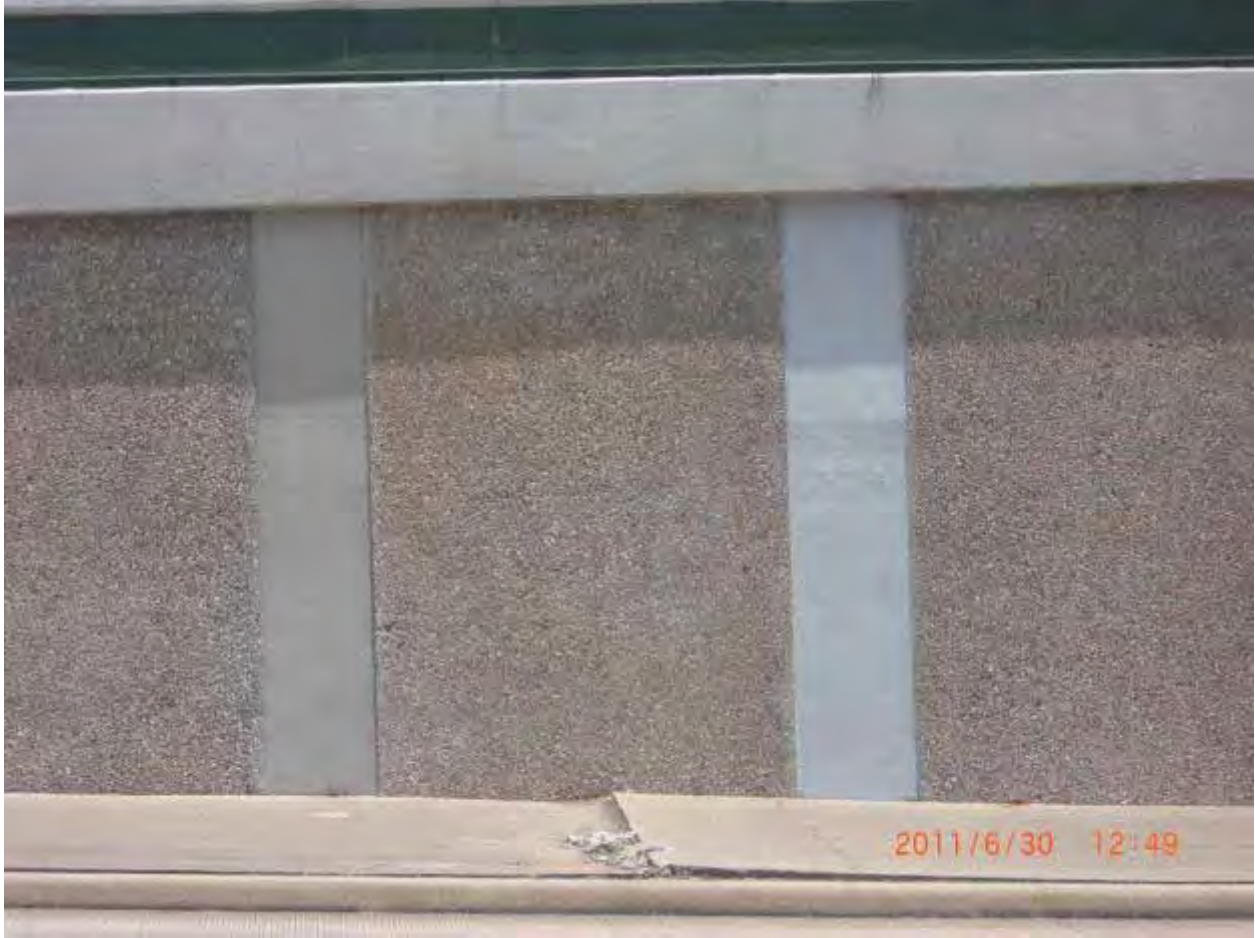
Figure 3.37: View of sidewalk damage along the base of the wall.

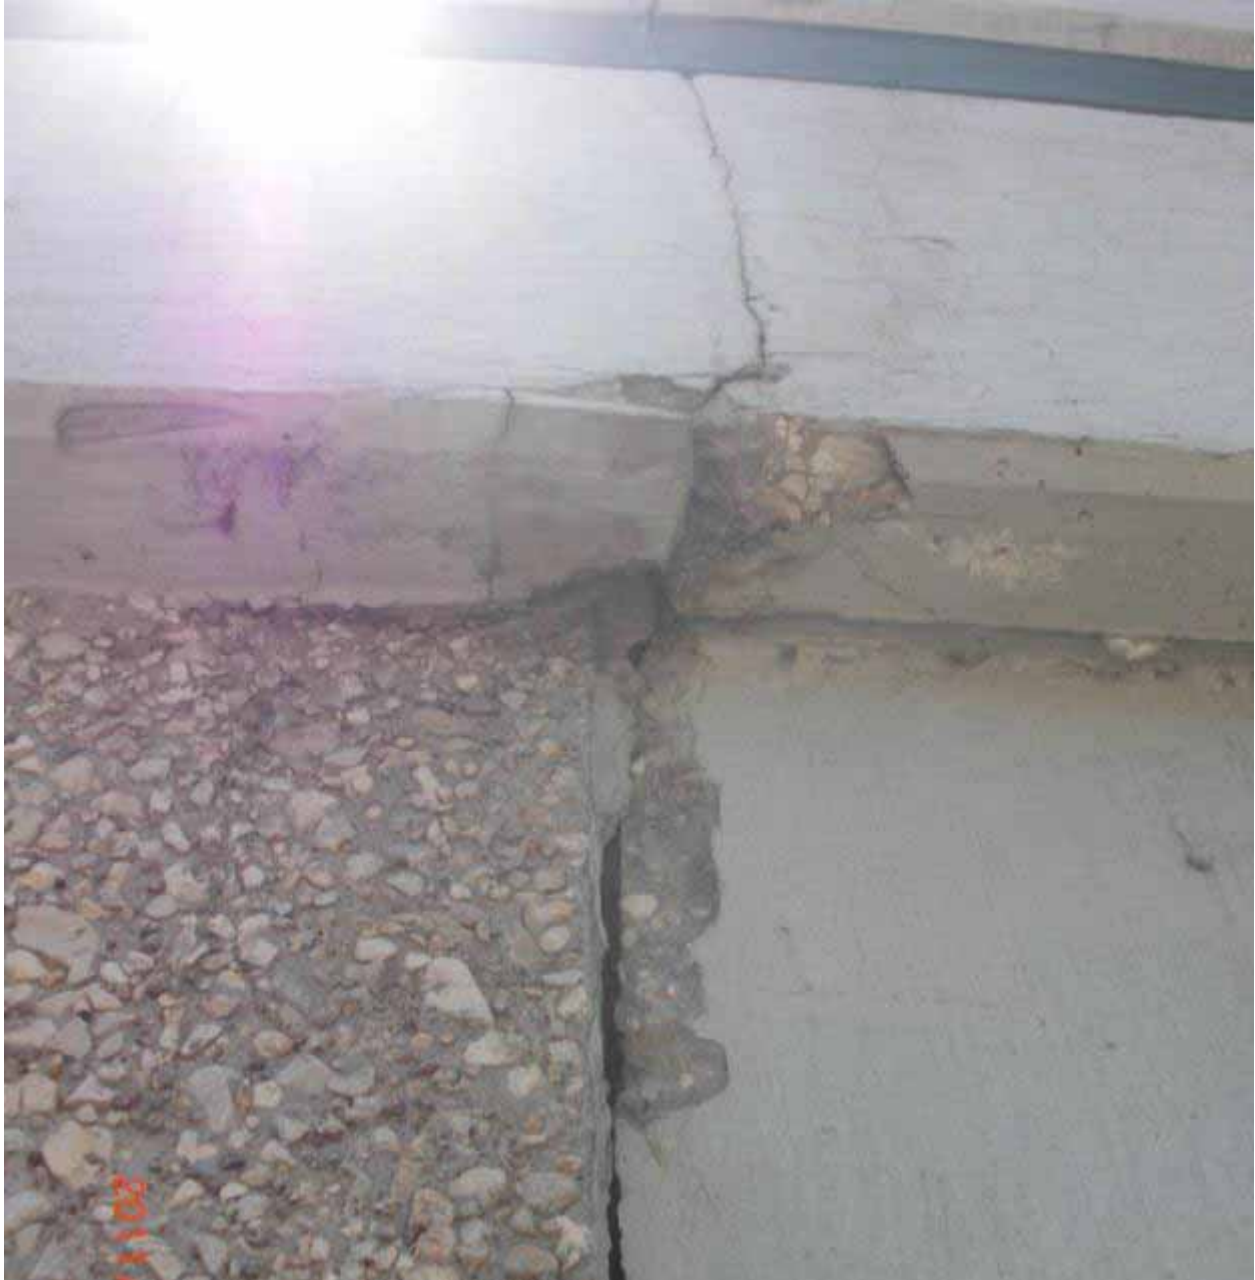
Figure 3.38: Some cracking was seen at the connection between two facing panels on the southwestern portion of the wall.

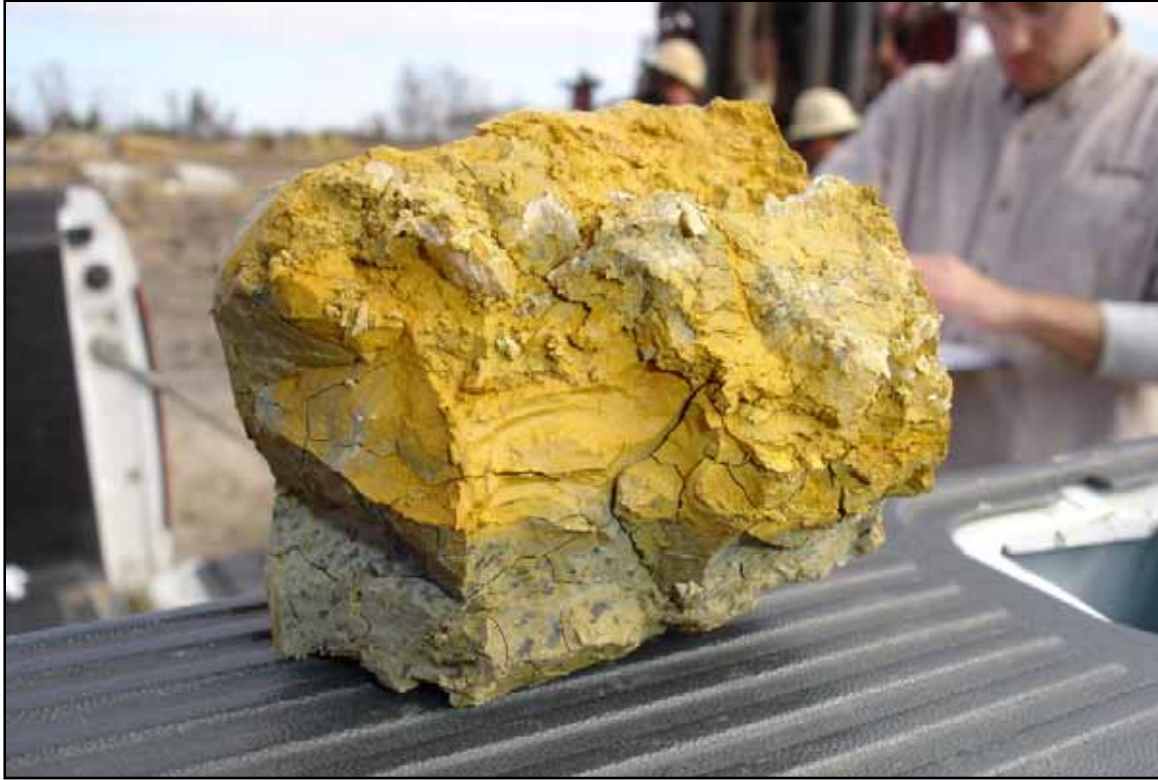
Figure 4.3: Unweathered Taylor Clay from the project site in Manor.

The test wall is underlain by approximately 50 feet of the Taylor Formation, a highly plastic, stiff, fissured clay. A sample of the Taylor Formation from the project site is pictured in Figure 4.3.

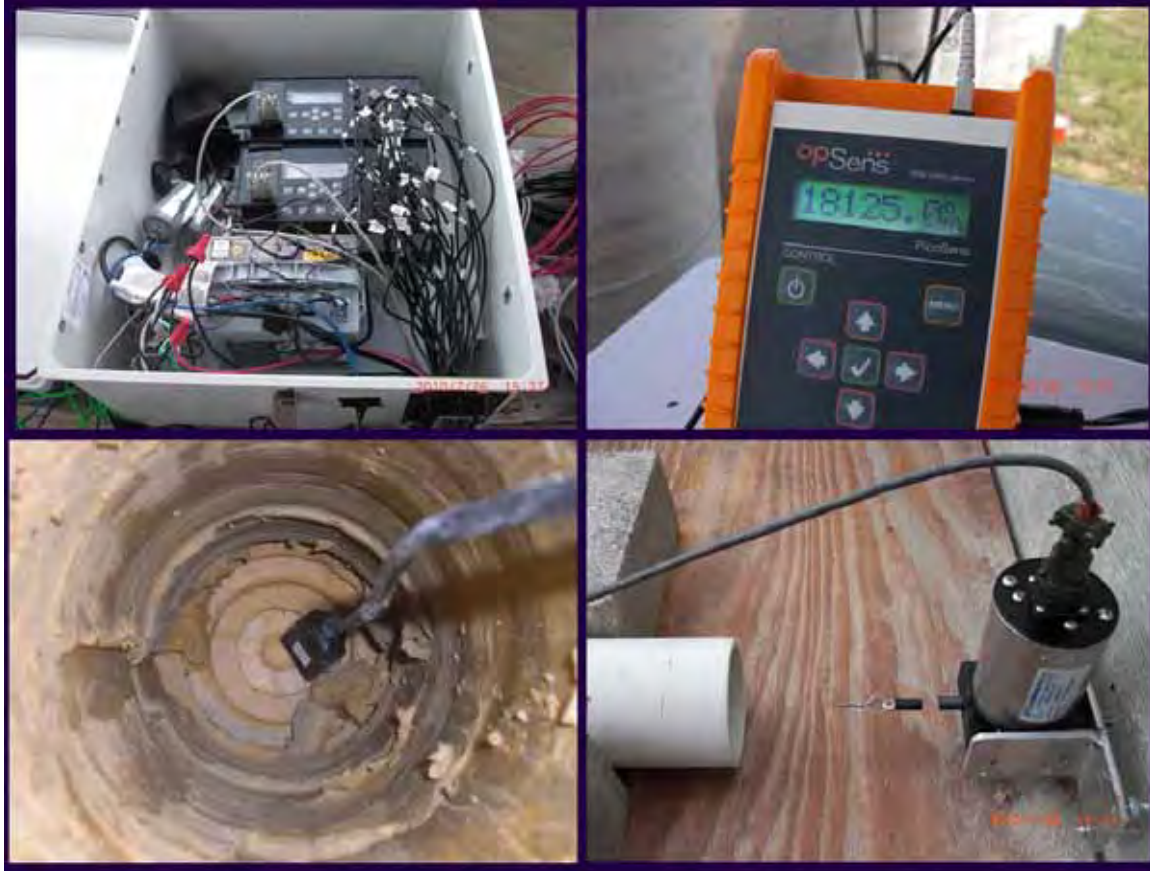
*Figure 4.13: Instrumentation on the project site.
 Clockwise from top left: temperature resistant datalogger and enclosure for continuous strain readings; signal conditioner for individual strain readings; linear potentiometer; TDR probe installed through facing.*

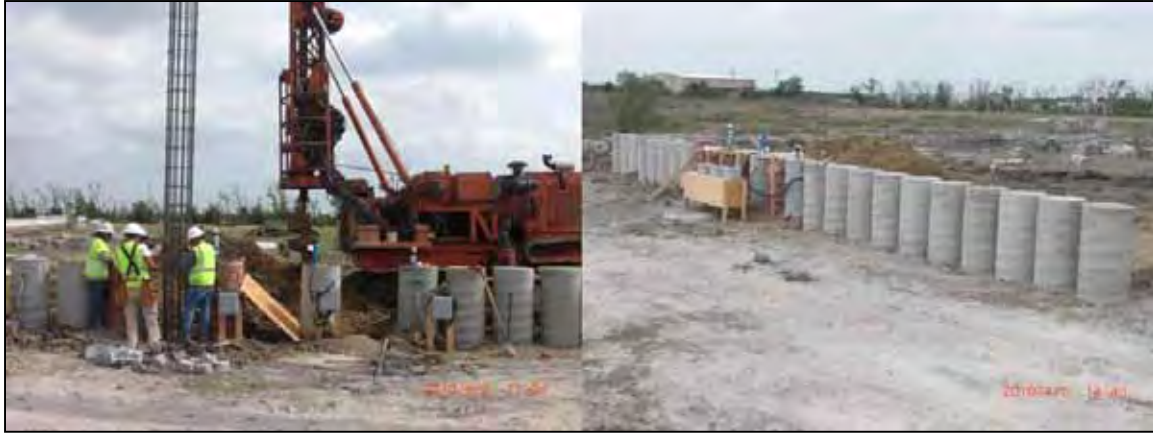
Figure 4.14: Construction of test wall, April 2010.

The drilled shafts and instrumentation were installed in early April 2010 by McKinney Drilling Company (Figure 4.14). In order to prevent excessive bending of the rebar cage and damage to the instrumentation, the instrumented cages were lifted with two cranes (Figure 4.15). To prevent sensor damage during concrete placement, cables were protected within slotted PVC pipes and concrete was directed down the center of the rebar cage with shovels. Initial sensor survivability was excellent, with 88 of 90 strain gauges and all inclinometer casings functional after rebar cage placement and concrete installation. A summary of wall construction activities and concrete strength data is provided in Table 4.2.

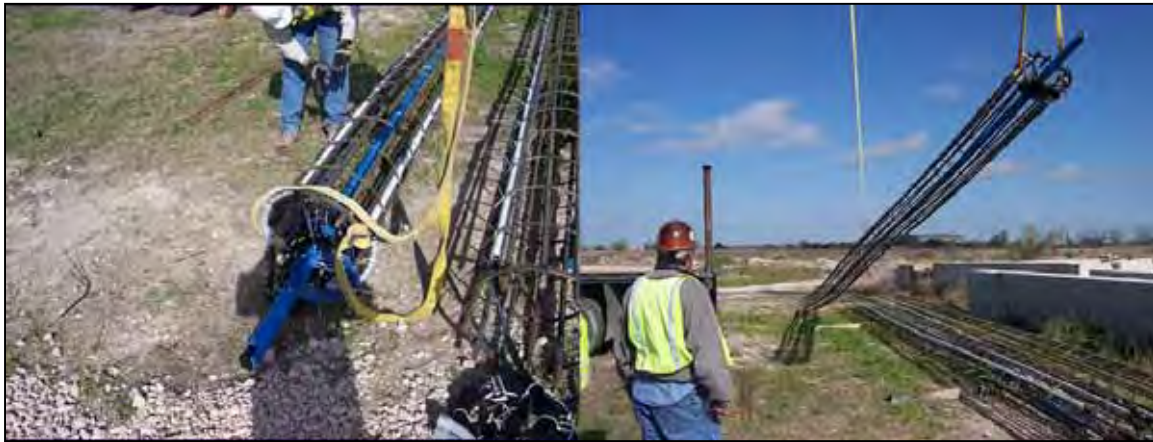
Figure 4.15: Lifting an instrumented cage with two cranes.

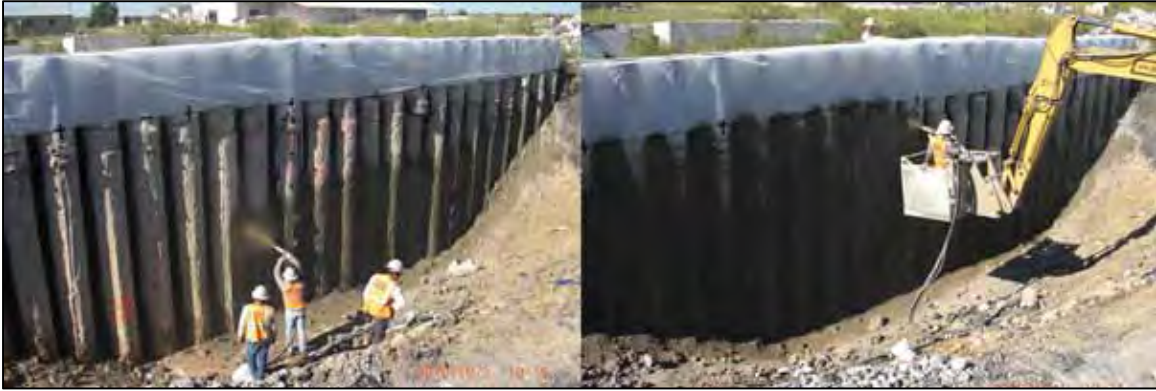
Figure 4.16: Installation of shotcrete facing on October 1, 2010.

To prevent soil erosion from between the shafts and provide consistency with design practice, shotcrete facing material was installed on October 1, 2010 (Figure 4.16).

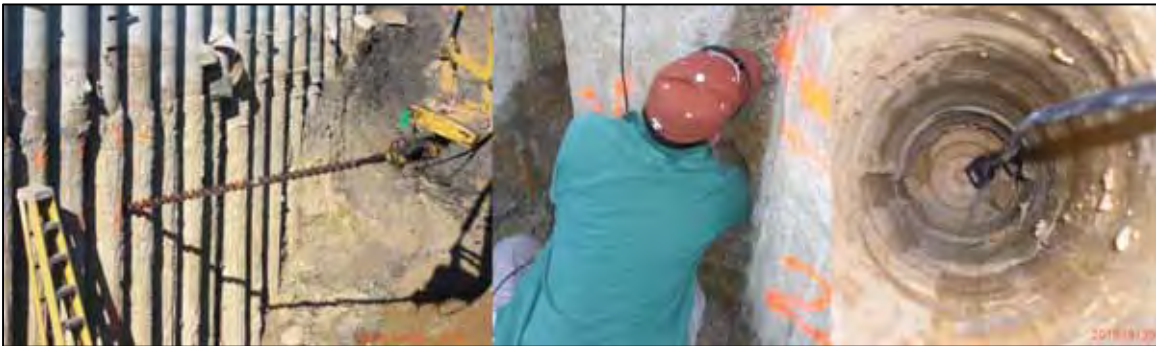
Figure 4.17: Installation of TDR moisture probes behind wall facing.

Prior to the application of shotcrete facing, time-domain reflectometry probes were installed. A total of 10 probes were installed through the wall facing on September 30–October 1, 2010 (as shown in Figure 4.17), and 10 were installed through the ground surface on October 14 (as shown in Figure 4.18). The approximate locations of all installed TDR probes are shown in Figure 4.19. Additional discussion of TDR probe installation, calibration, and data analysis can be found in Dellinger (2011).

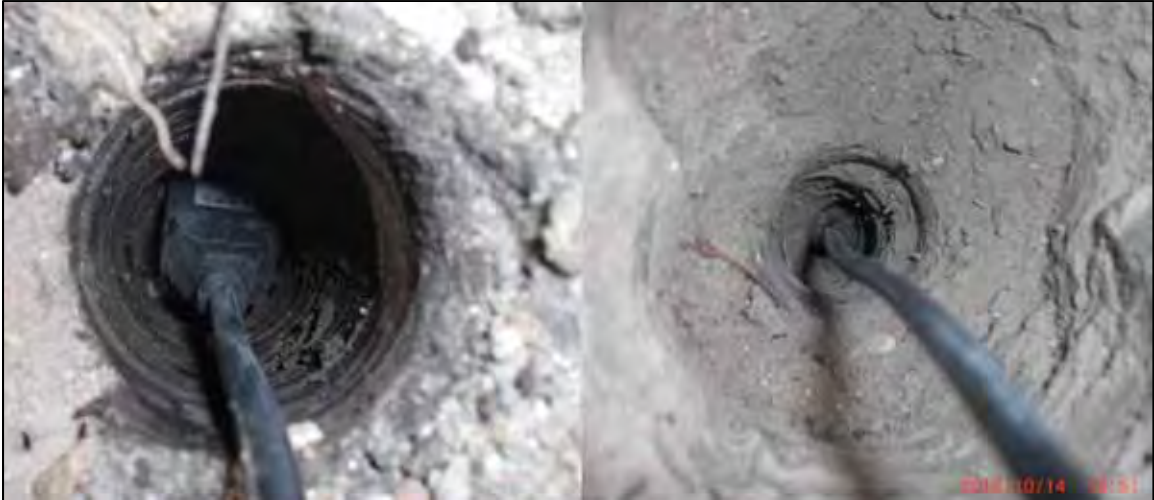
Figure 4.18: Installation of TDR moisture probes through ground surface.

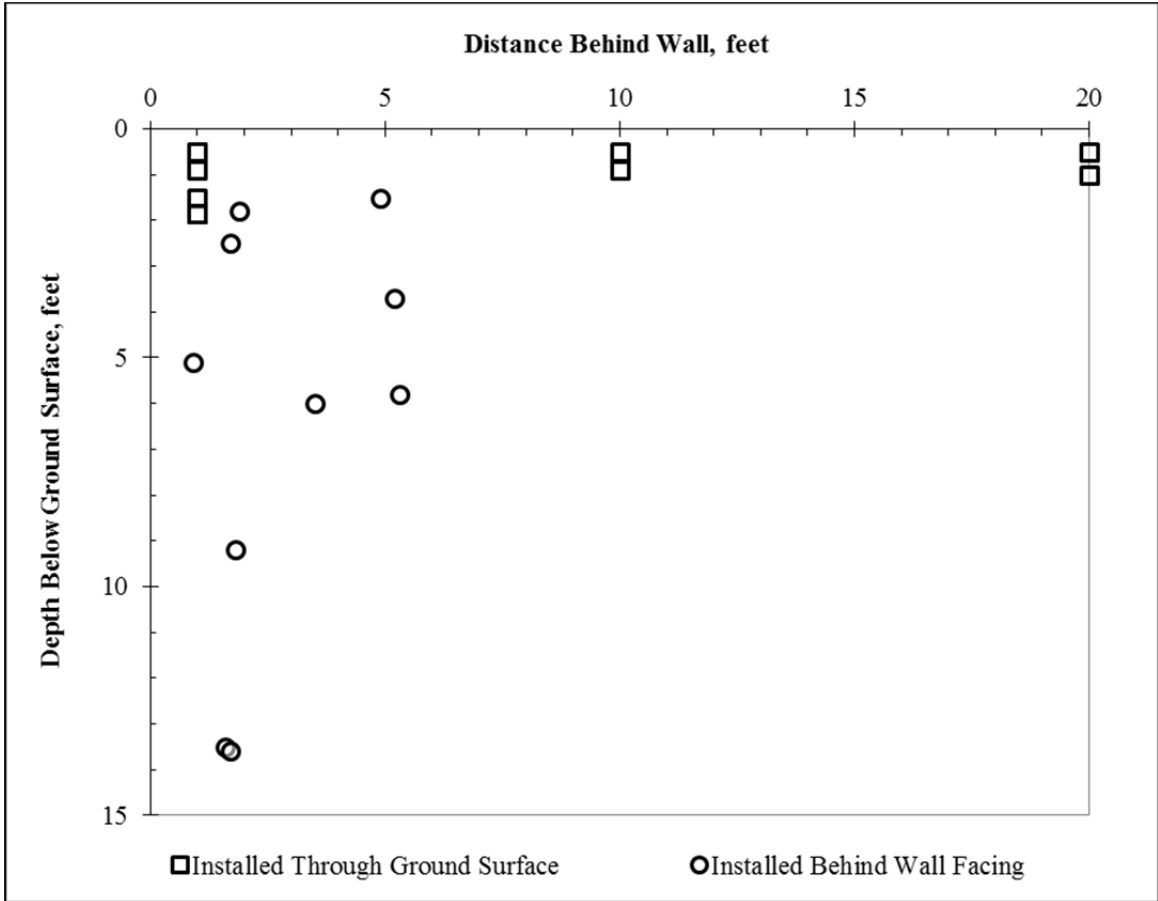
Figure 4.19: Approximate locations of TDR moisture probes.

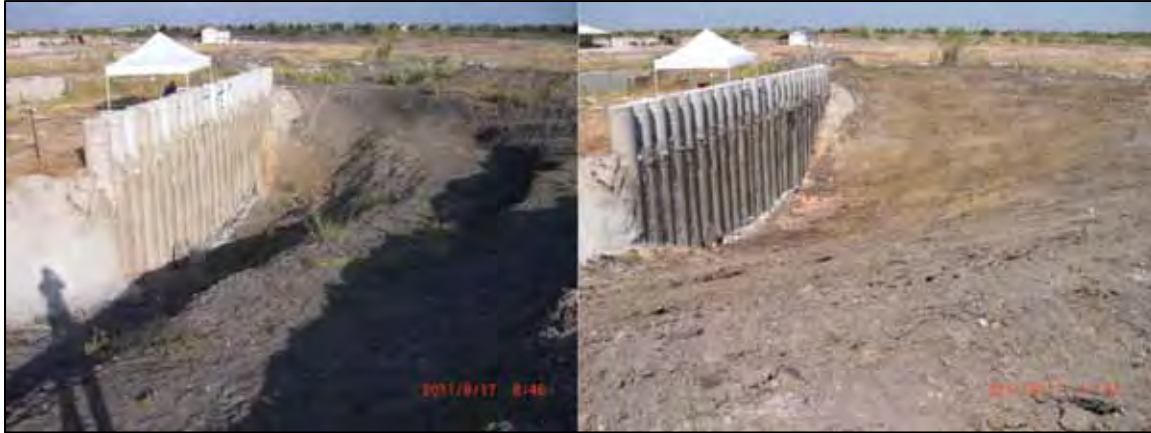
Figure 4.20: Excavation slopes are reshaped on August 17, 2011.

On August 17, 2011, the slopes were reshaped to reduce erosion and prevent surface water from draining into the excavation (Figure 4.20). On October 8, 2011, erosion control material was installed (Figure 4.21).

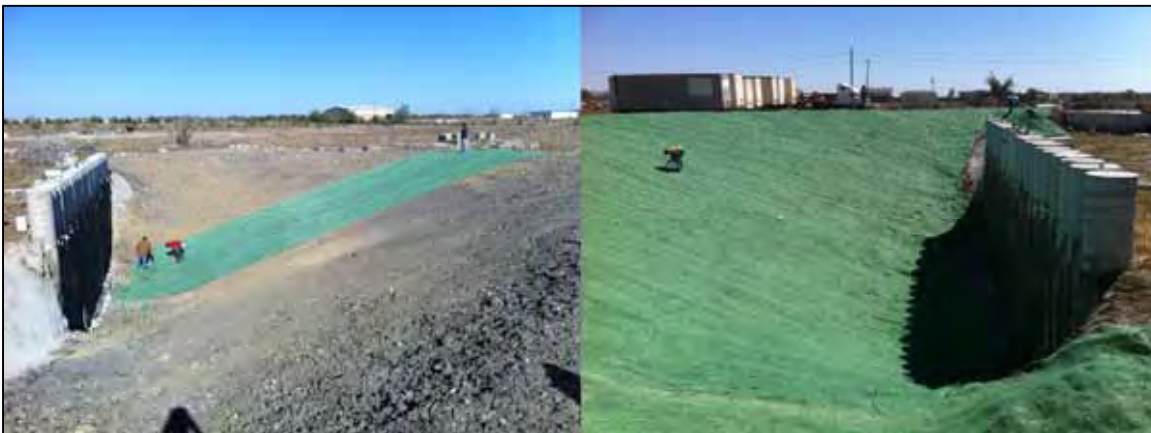
Figure 4.21: Erosion control material is installed on October 18, 2011.

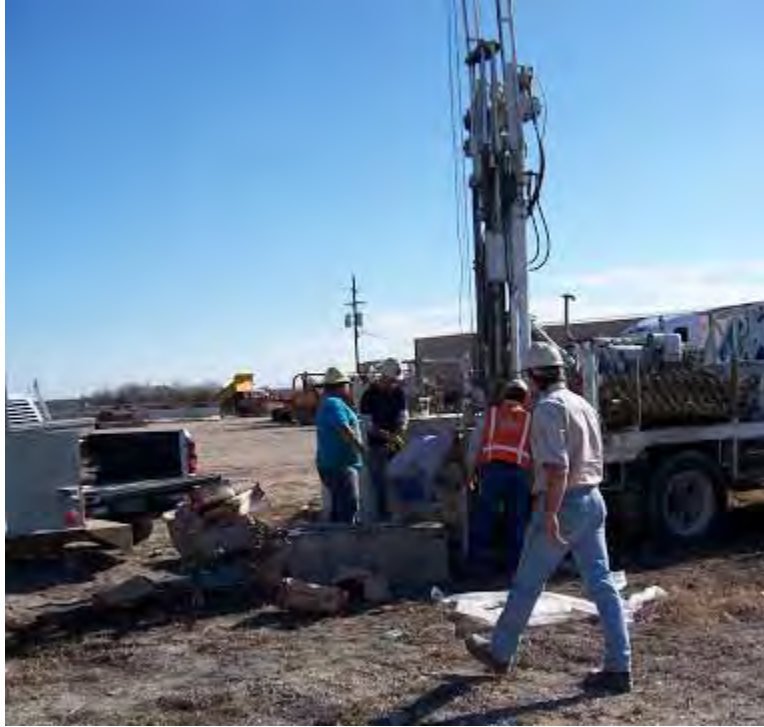
Figure 4.23: The piezometer installed in borehole B-3 being lowered into position.

Five piezometers were installed on site; Table 4.3 and Figure 4.22 provide the locations. On January 12, 2010, a piezometer screened 5 to 15 feet was installed in a boring from the site investigation by Fugro, Inc. (Figures 4.23–4.25). This piezometer was used to monitor the local water level conditions. On February 23, 2012, four more piezometers were installed in boring holes for a site investigation by Fugro, Inc. (Figure 4.26). These piezometers were used to monitor the water levels in the inundation test area. The piezometers were surrounded with a permeable sand and gravel interface between the piezometer and the walls of the borehole. Readings were taken using a buzzing water level indicator and a tape measure.

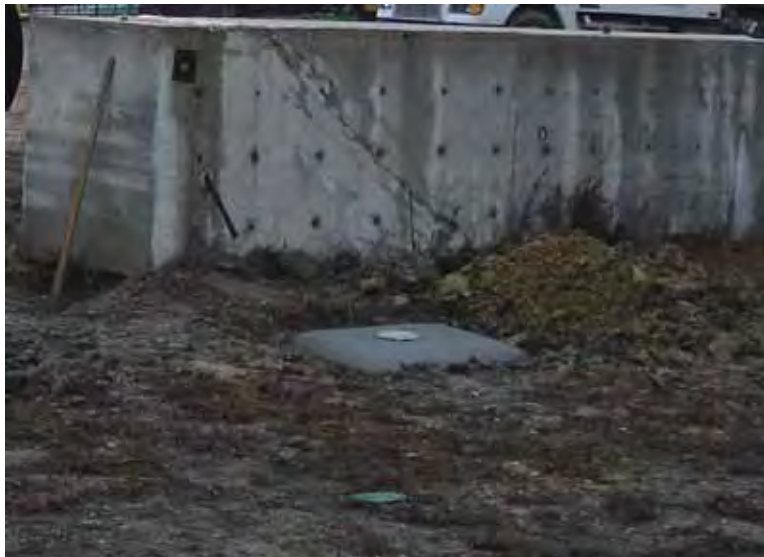
Figure 4.24: The piezometer installed and covered in borehole B-3.
