| 4. Title and Subtitle The Long-Term Performance of a Drilled Shaft Retaining Wall in an Expansive Clay | | | 5. Report Date October 2013 | | |

The Long-Term Performance of a Drilled Shaft Retaining Wall in an Expansive Clay

| CTR Technical Report: | 0-6603-2 |

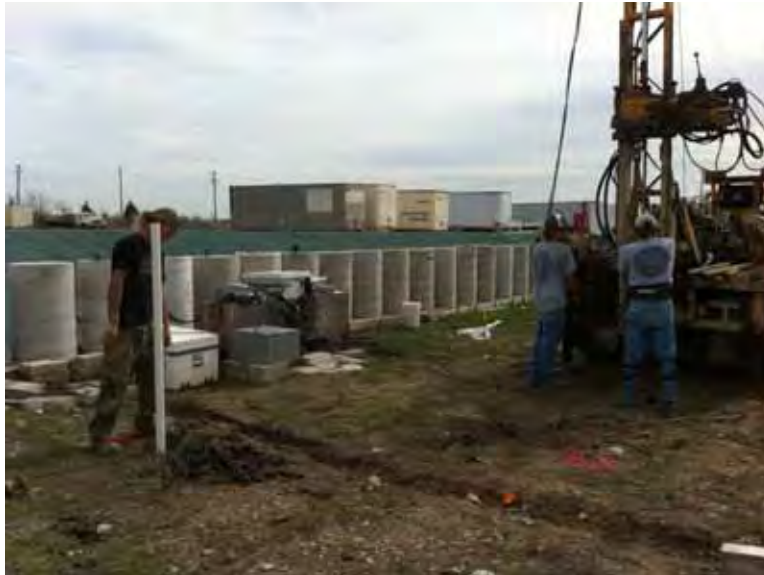
Figure 4.25: Piezometer being installed in borehole A.

Five piezometers were installed on site; Table 4.3 and Figure 4.22 provide the locations. On January 12, 2010, a piezometer screened 5 to 15 feet was installed in a boring from the site investigation by Fugro, Inc. (Figures 4.23–4.25). This piezometer was used to monitor the local water level conditions. On February 23, 2012, four more piezometers were installed in boring holes for a site investigation by Fugro, Inc. (Figure 4.26). These piezometers were used to monitor the water levels in the inundation test area. The piezometers were surrounded with a permeable sand and gravel interface between the piezometer and the walls of the borehole. Readings were taken using a buzzing water level indicator and a tape measure.

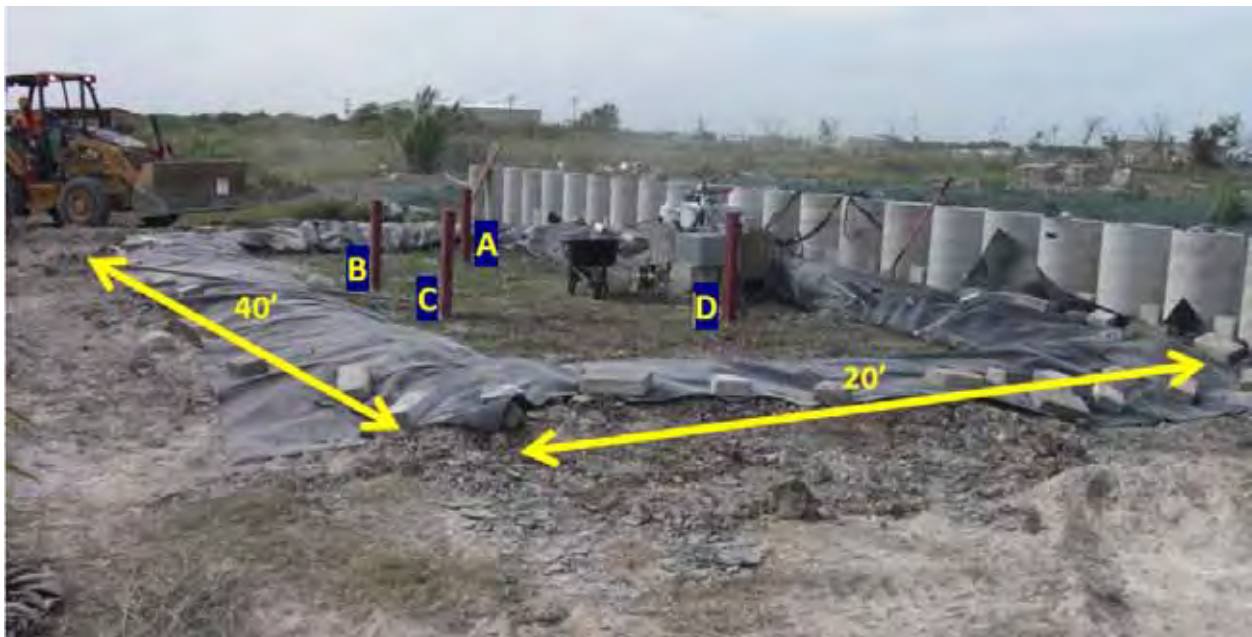
Figure 4.26: The four standpipe piezometers installed behind the wall in the inundation berm.

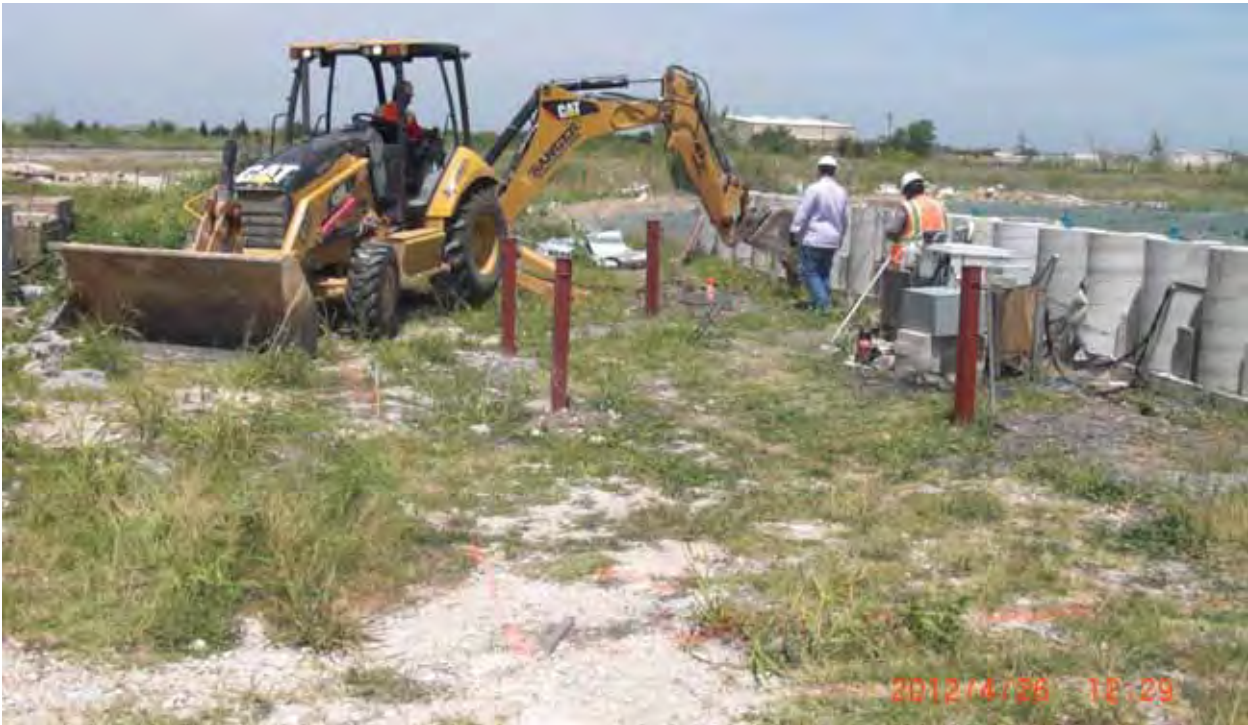
Figure 4.29: Excavation of trench for inundation berm.

The inundation berm encloses an area approximately 40 feet wide and 20 feet behind the test wall (Figure 4.27). A cross section of the berm design is shown in Figure 4.28. The berm is keyed into the native soil with a 2-foot deep trench and is lined with a geomembrane to minimize the lateral loss of water (Figure 4.29).

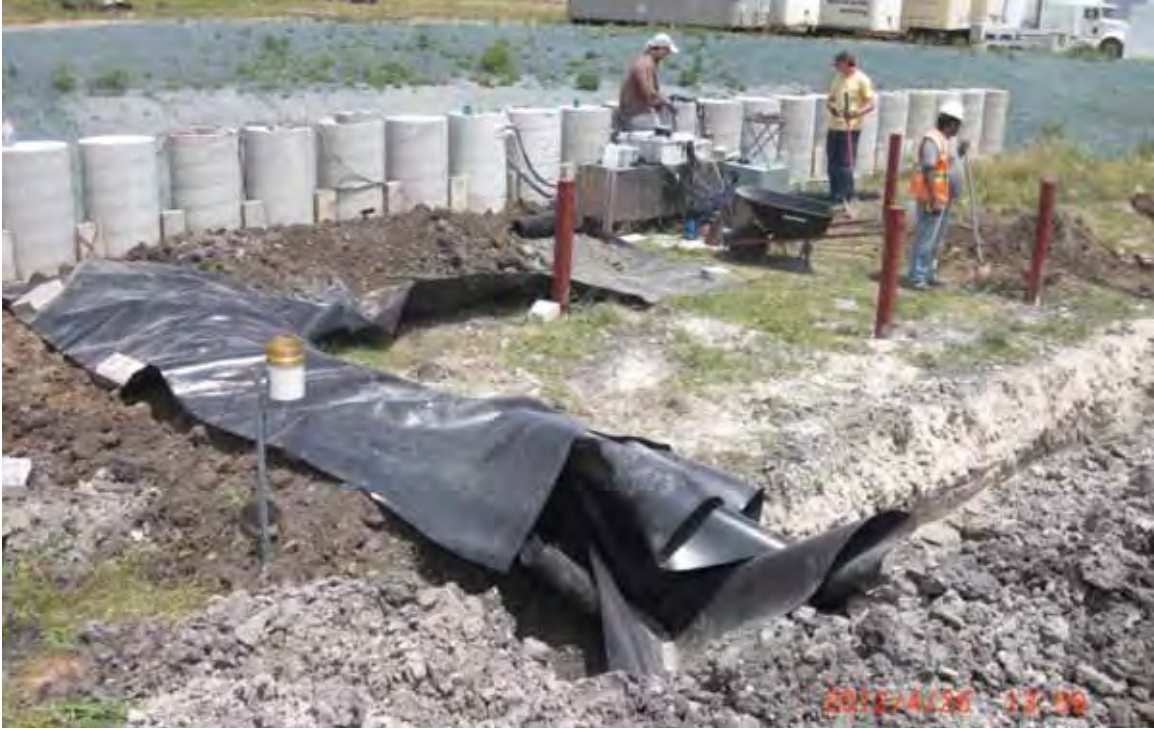
Figure 4.30: Installation of geomembrane in trench.

The inundation berm was constructed by Ranger Excavating on April 26, 2012. A backhoe was used to excavate the trench (Figure 4.30). After excavation of the trench, the geomembrane was installed (Figure 4.31). The soil was replaced and compacted, along with

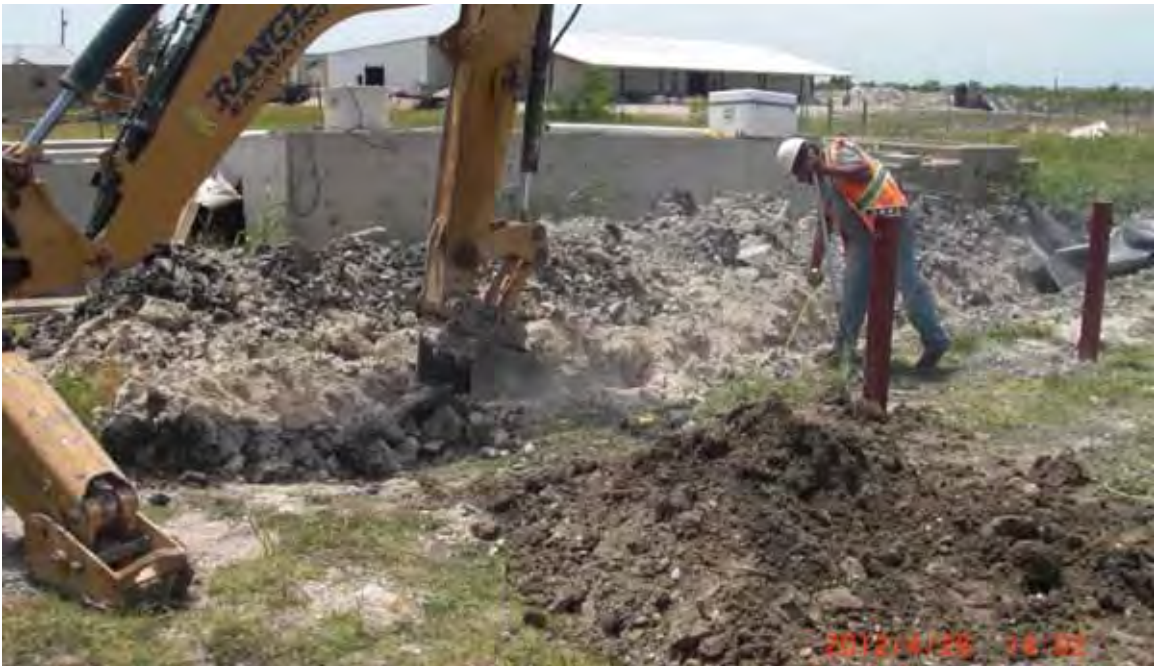
Figure 4.31: Compacting soil with backhoe bucket.

stockpiled soil from the project site, using the backhoe bucket (Figure 4.32). After the installation of the geomembrane and compacted soil (Figure 4.33), the seams were joined together with duct tape (Figure 4.33). The completed inundation berm is shown in Figure 4.34. Initial filling of the berm occurred on May 2, 2012 (Figure 4.35). While some leakage of the seams occurred, the leakage rate was slow enough that the water level could be maintained with water from the on-site supply (Figure 4.36–Figure 4.37).

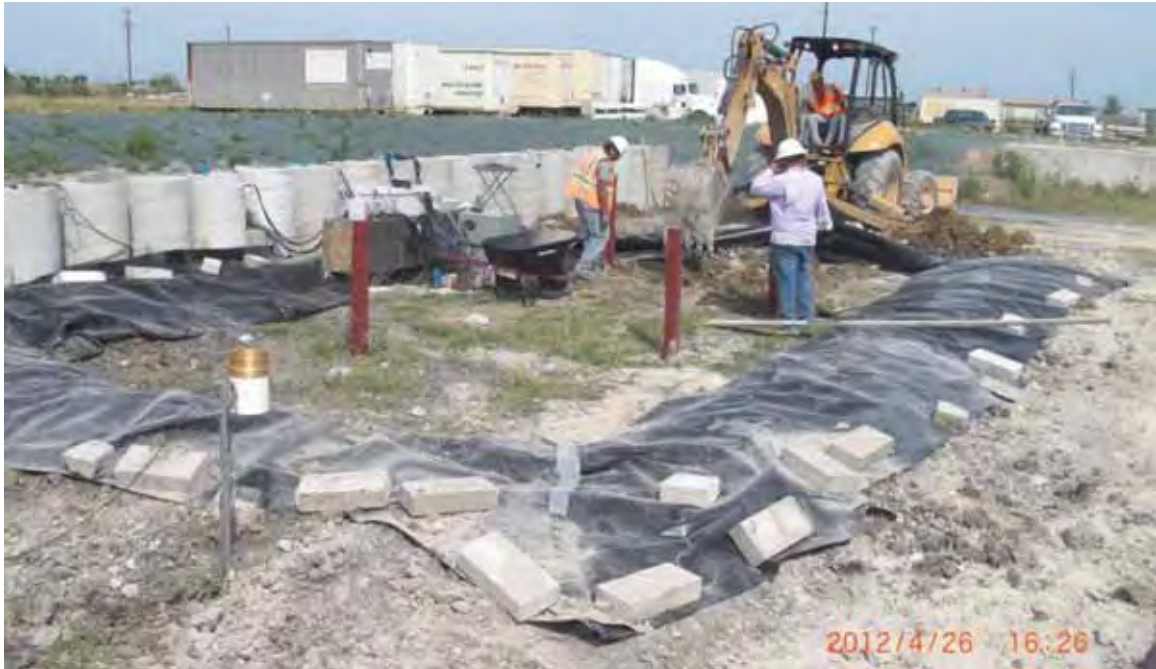
Figure 4.32: Compacting soil with backhoe bucket.

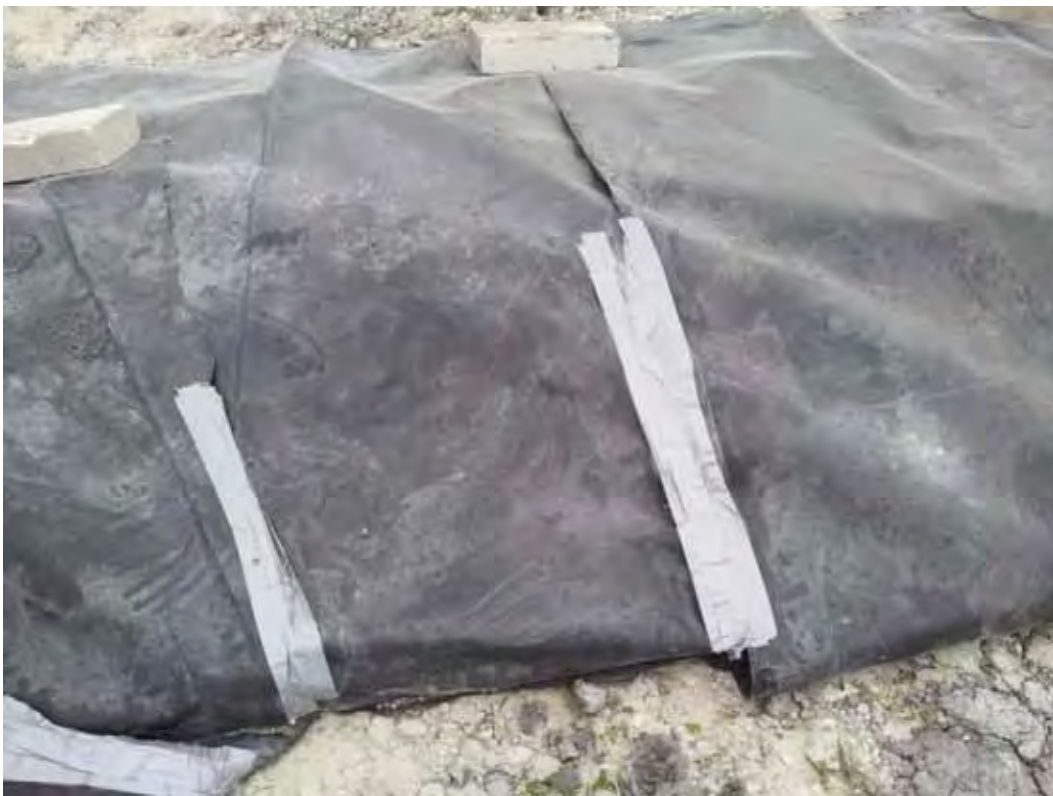
Figure 4.33: Detail of geomembrane seam.

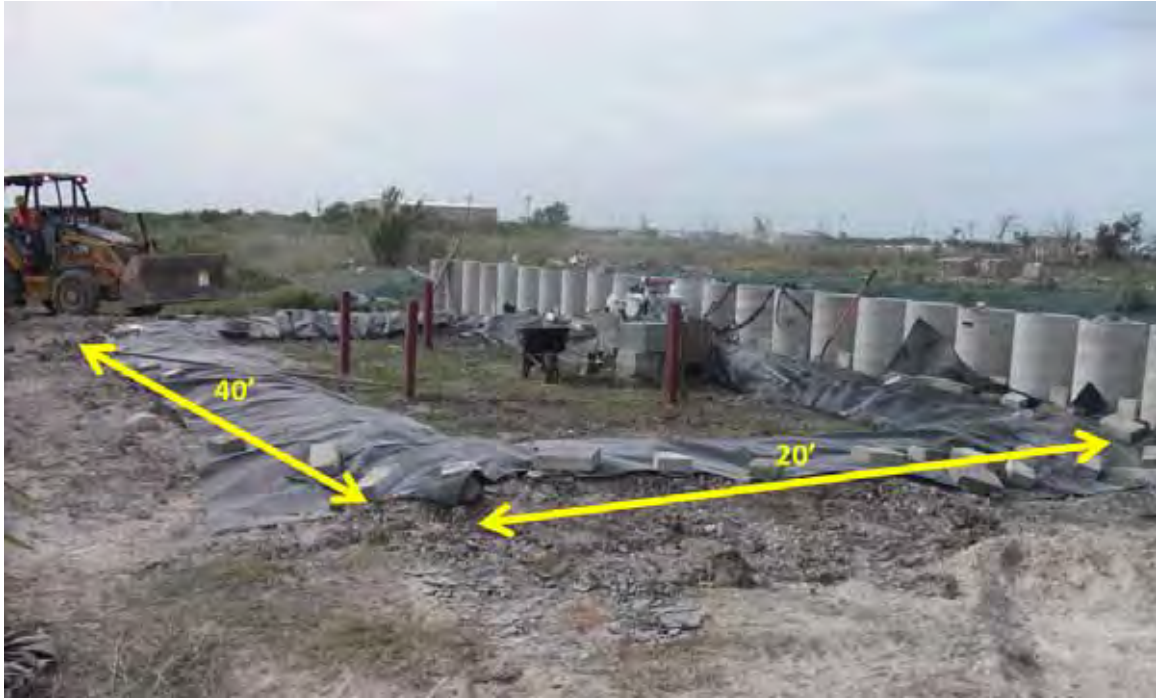
Figure 4.34: Completed inundation berm.

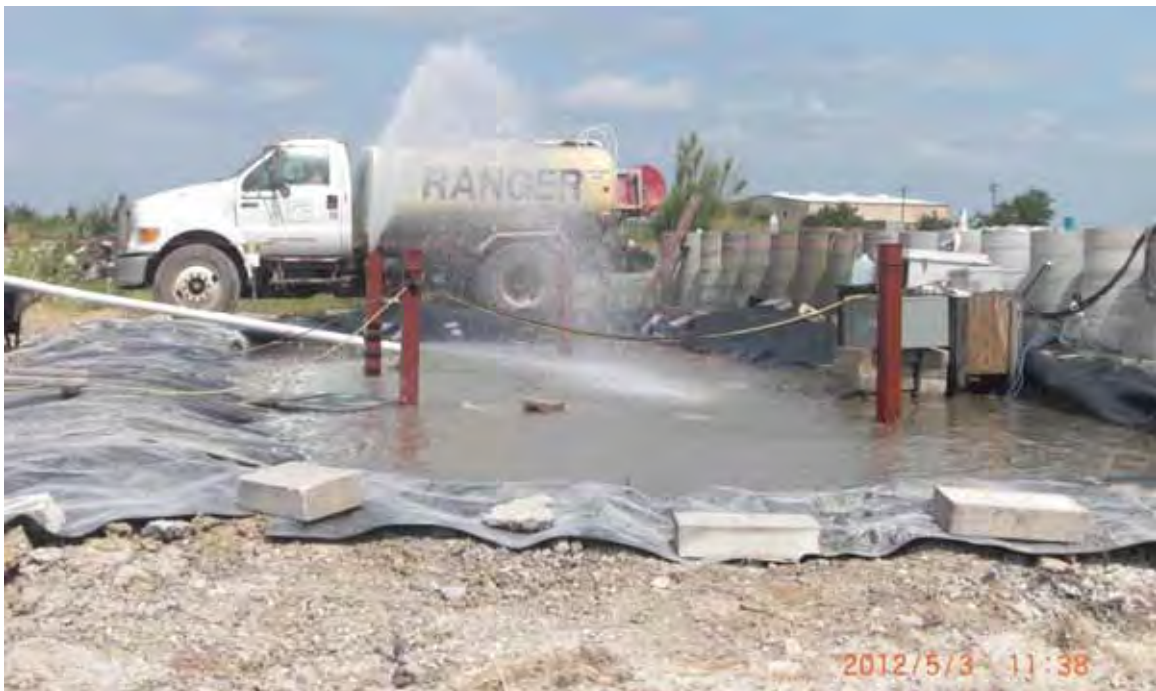
Figure 4.35: Filling the inundation zone.

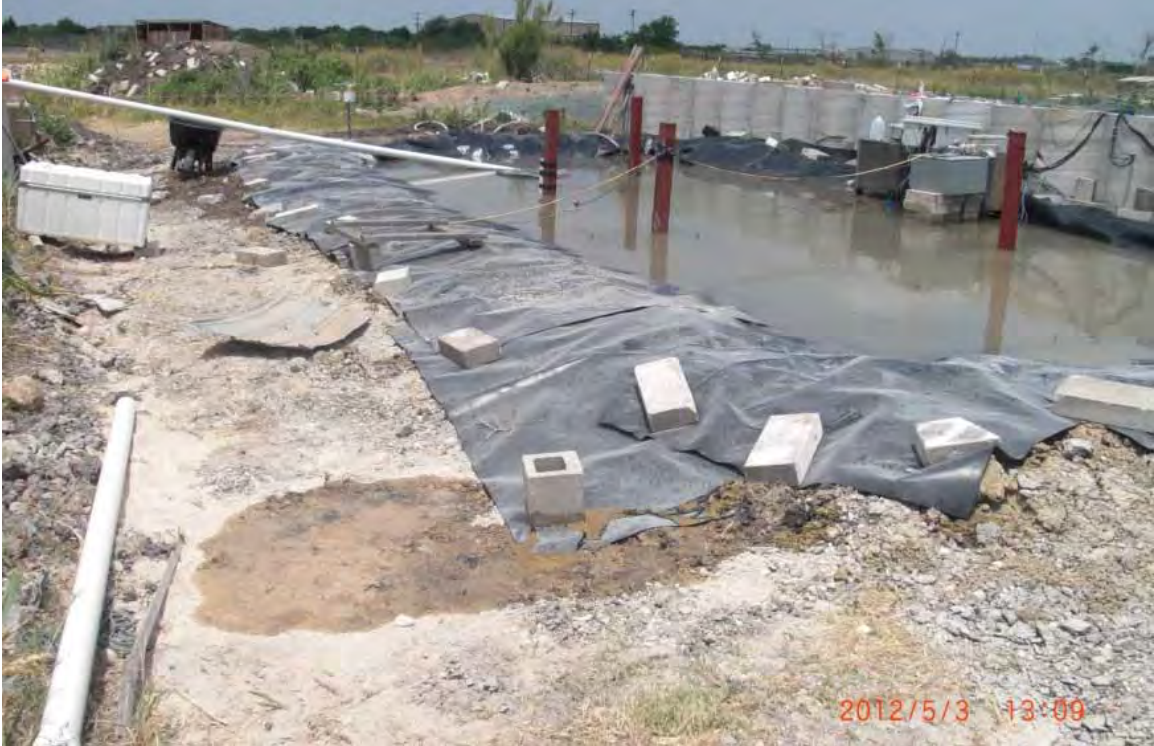
Figure 4.36: Leakage from southeast corner of inundation zone.

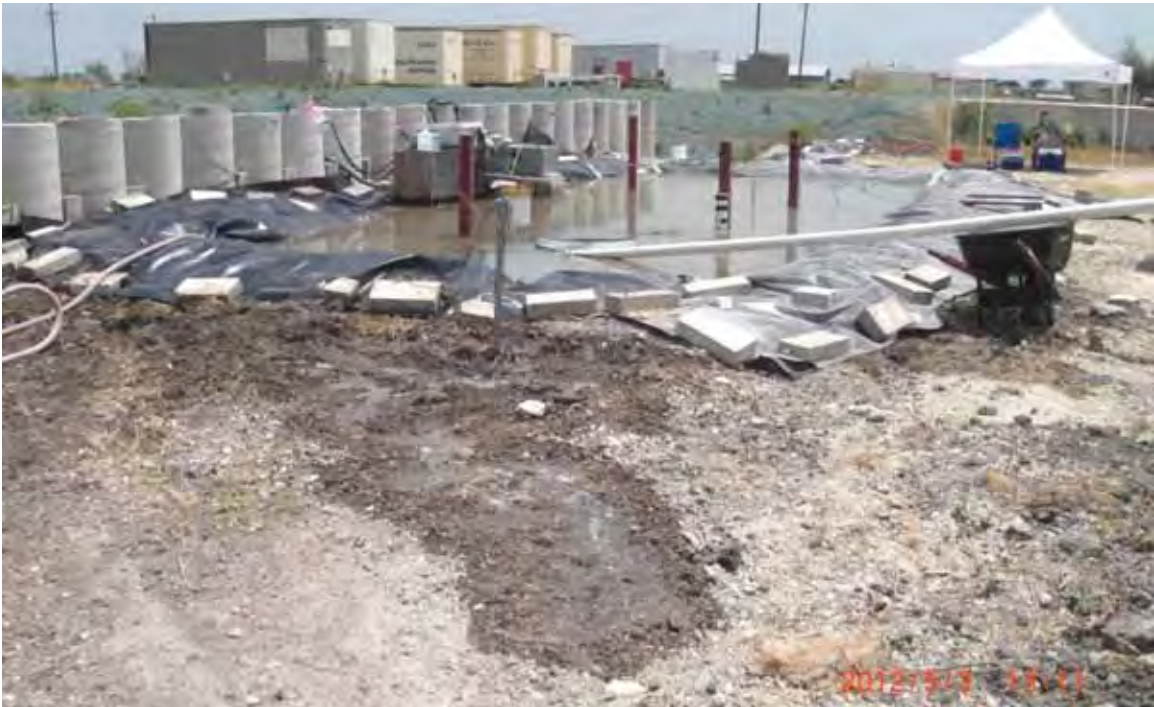
Figure 4.37: Leakage from west side of inundation zone.

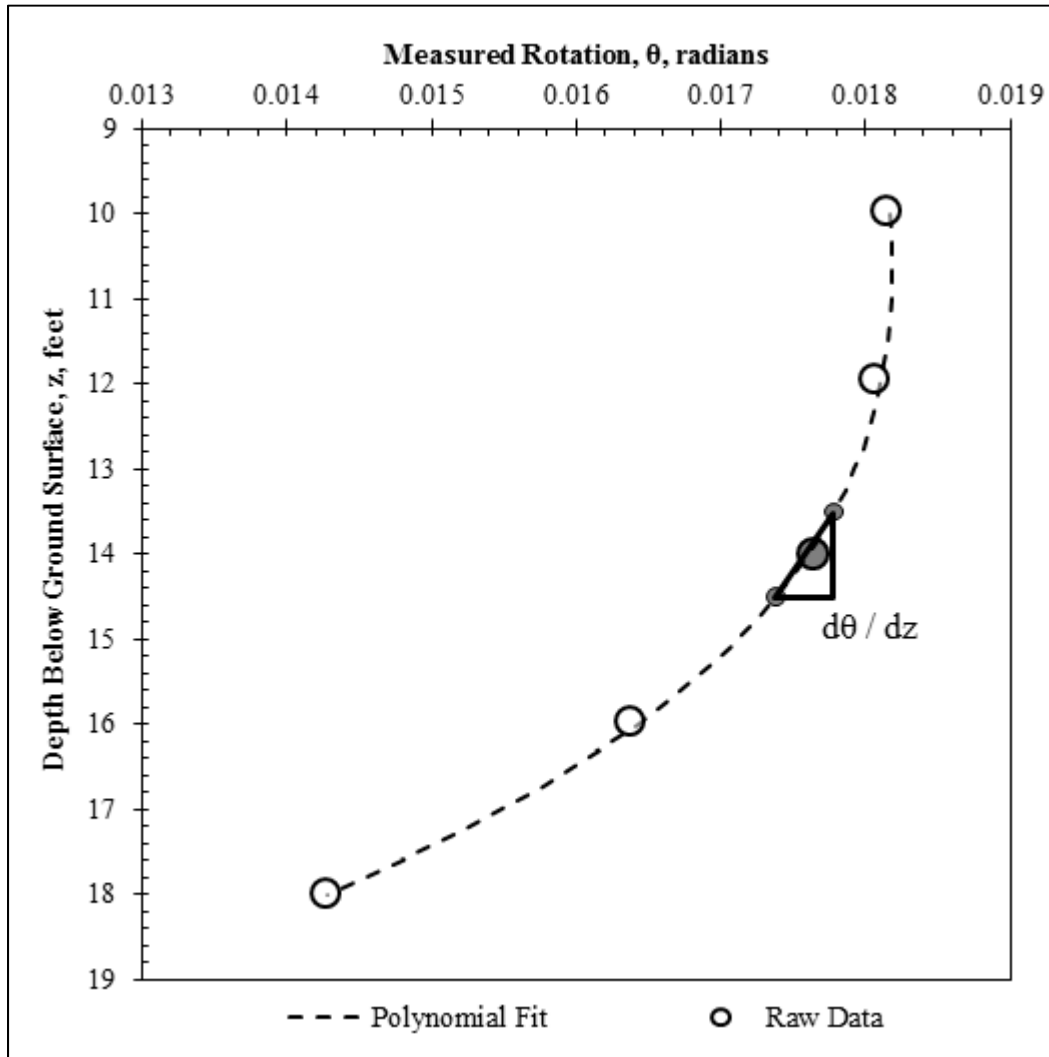
Figure 4.45: Illustration of piecewise third-order polynomial fitting to a moving window of five points at a depth of 14 feet.

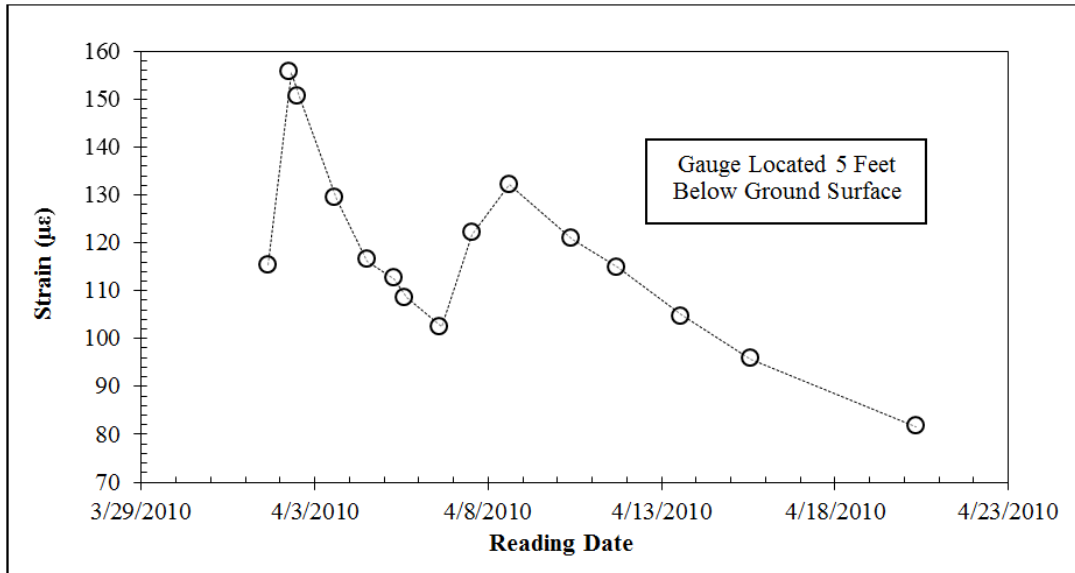
Figure 5.2: Three weeks of strain measurements during concrete curing. Concrete placed on April 1; concrete in adjacent shafts placed on April 6. Positive strain indicates tension.

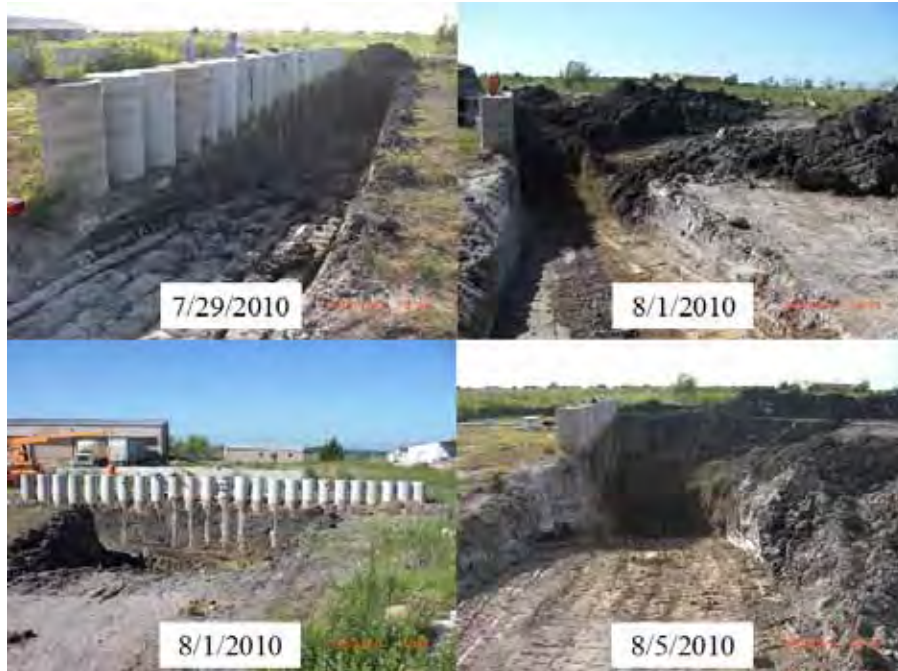
Figure 5.5: Photos of initial excavation progress (7/29/2010–8/5/2010).

Excavation of the test wall began on July 29, 2010, and took place over a period of approximately 4 weeks. The full cantilever height of 14 to 15 feet was reached on August 13, 2010, and the preliminary slopes were completed on August 19, 2010. The slopes were improved on September 30, 2010, and facing was installed on October 8, 2010. Photos of the excavation progress are provided in Figure 5.5–Figure 5.6.

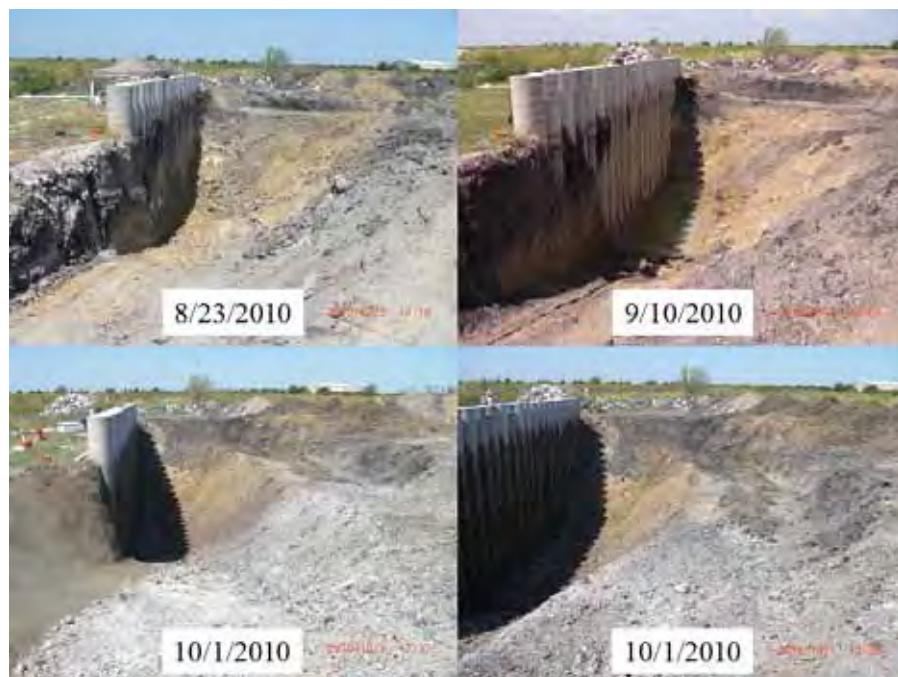
Figure 5.6: Photos of later excavation progress (8/23/2010 - 10/1/2010).

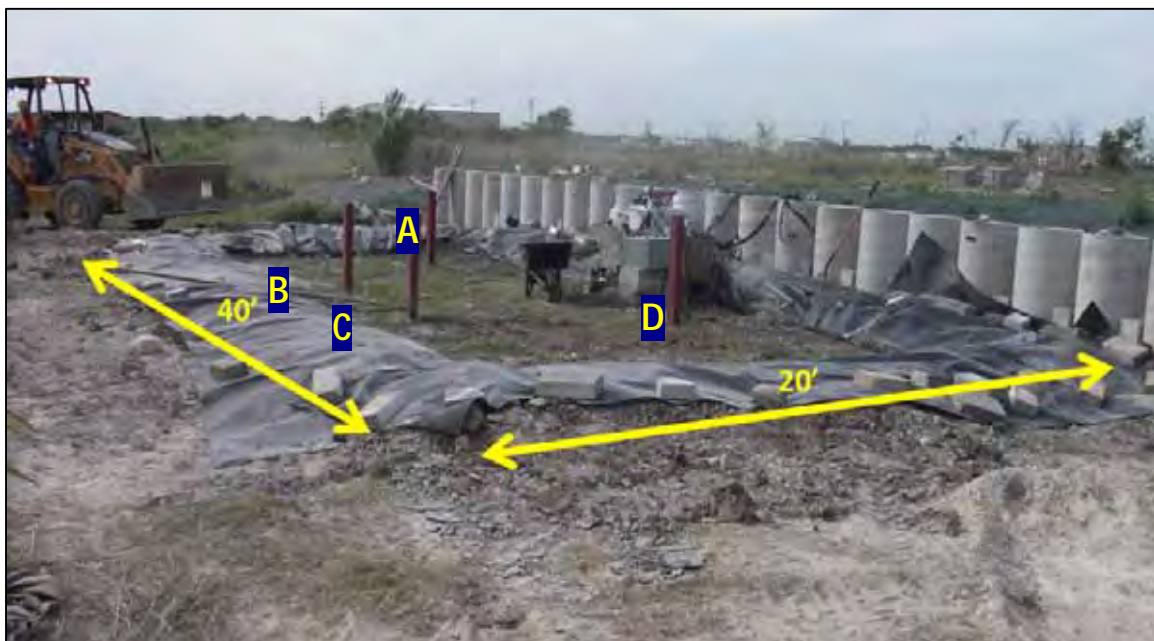
Figure 5.25: Inundation berm and stand pipe piezometers (April 26, 2012).

On February 23, 2012, a site investigation was conducted and four stand pipe piezometers were installed as shown in Figure 5.23. On April 26, 2012, the inundation berm was constructed as shown in Figure 5.24–Figure 5.25.

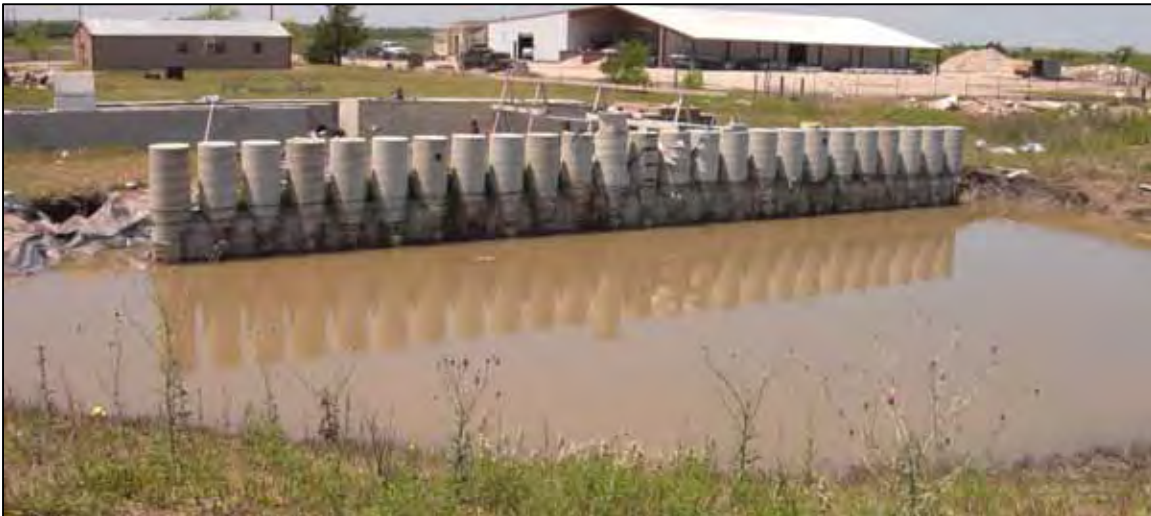
Figure 5.26: Flooding in response to a large storm before the May 6, 2013, data surveys. Water level in the excavation reached ground surface.

Beginning on February 5, 2013, the inundation zone was filled a second time. After approximately 4 months of inundation, the wall deflections and piezometer water levels stabilized. In response to a large storm event, a major flood occurred in which the water level in the excavation reached the ground surface prior to the inclinometer and strain gauge data surveys recorded on May 6, 2013 (Figure 5.26). During this flood event, significant erosion of the excavation slopes occurred; due to additional soil transported to the excavation base, the excavation depth had decreased to approximately 13.5 feet below ground surface.

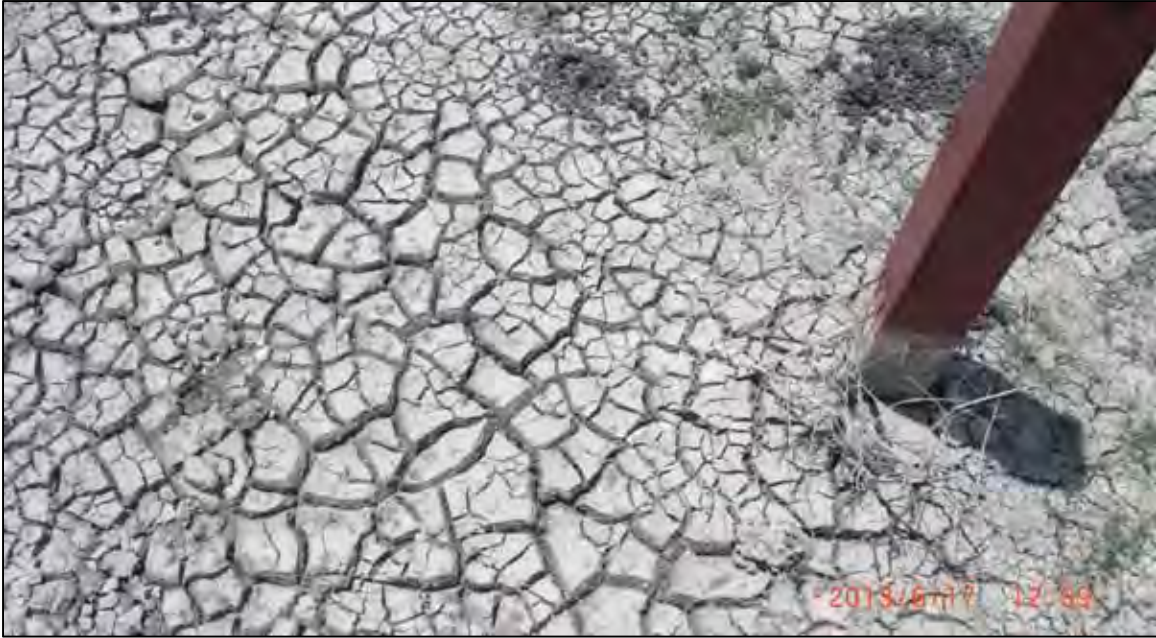
Figure 5.27: Inundation zone on June 17, 2013, 2 weeks into second drying cycle. Stand pipe piezometer casing is 4" across.

On June 3, 2013, a second drying cycle began. Water moved out of the soil quickly, and shrinkage cracks appeared in the surface soil (Figure 5.27). As water moved out of the soil, top-of-wall deflections began to decrease fairly quickly. At the time of this writing, the wall deflections had been monitored during drying for a period of approximately 2 months. At the conclusion of data recording in July 2013, top-of-wall deflections and stand pipe piezometer levels had nearly stabilized, but had not completely reached equilibrium. Based on previous observations, it is likely that when water levels return to their natural values of approximately 8 feet below ground surface, the top-of-wall deflections will stabilize.

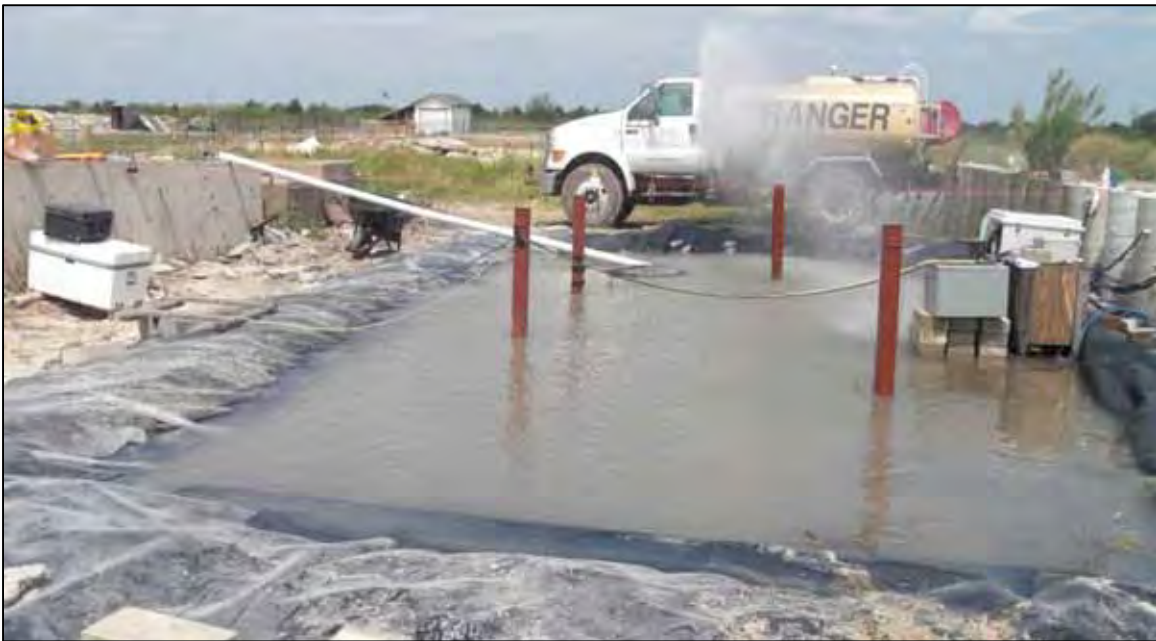
Figure 5.36: The inundation zone is filled on May 3, 2012.

The inundation test began on May 3, 2012, and the wall and soil responded nearly immediately to the presence of water (Figure 5.36). Within minutes, the TDR probes installed throughout the retained soil registered the presence of free water (Figure 5.37), and within hours, water had begun to infiltrate through the wall drainage system into the excavation (Figure 5.38). This immediate response is consistent with the response observed at the test wall during large rainfall events, and suggests that the fissures present in the expansive clay provide preferential pathways for moisture flow.

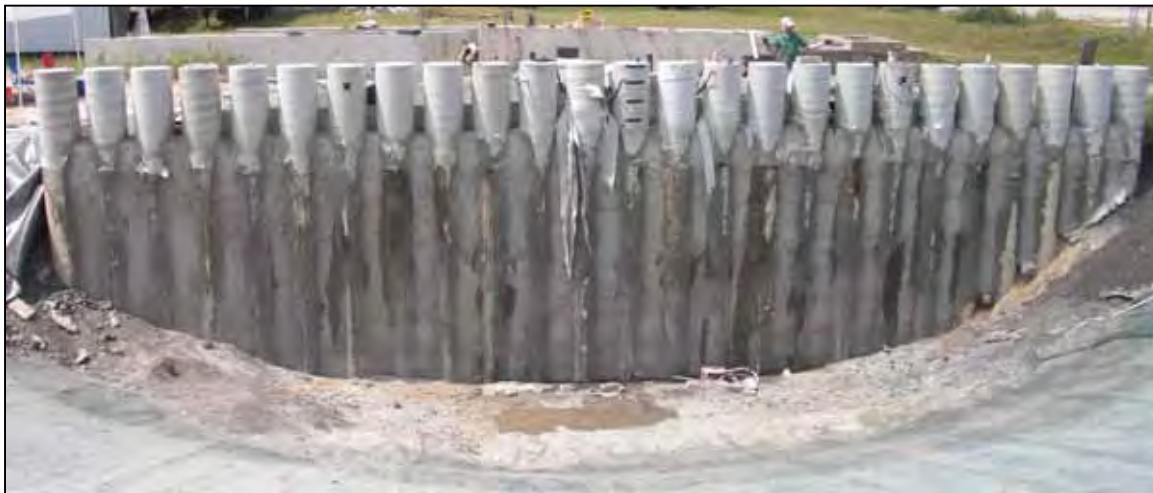
Figure 5.38: Water infiltration into the excavation was first observed 90 minutes from the start of inundation.

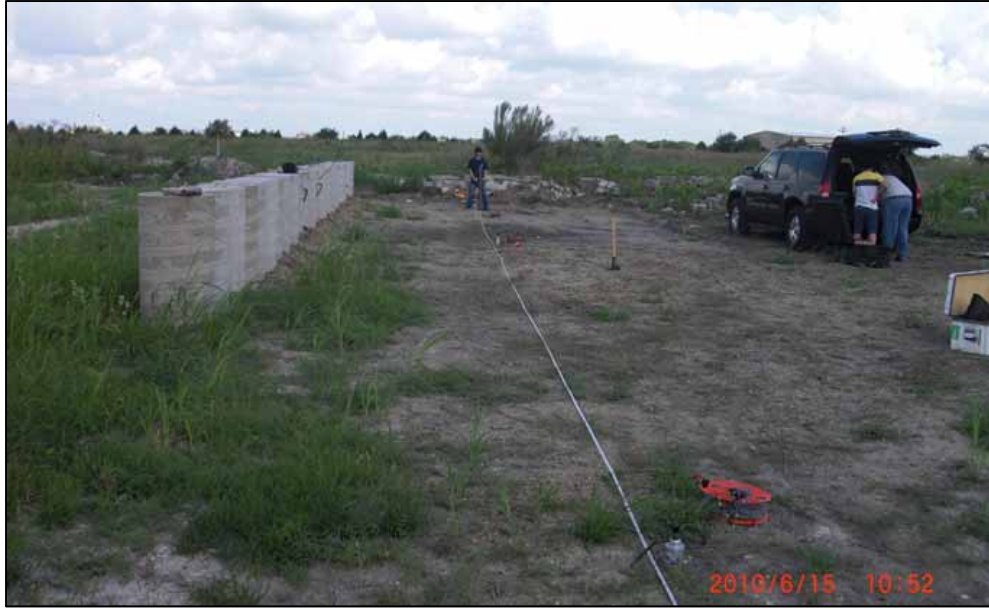
Figure 6.5: SASW testing at the test wall prior to excavation, June 2010.

The input for the modeling was based on available information from the preliminary site investigation. The soil unit weight was assumed to be 125 pcf. The Young's modulus values versus depth were estimated based on a design profile of undrained shear strength (s_u) versus depth (Figure 6.4) and a ratio of E/s_u . An E/s_u value of 1000 was first assumed based on laboratory UU triaxial tests and based on in situ Spectral Analysis of Surface Wave (SASW) testing conducted at the project site just prior to the excavation (Figure 6.5 and Figure 6.6).

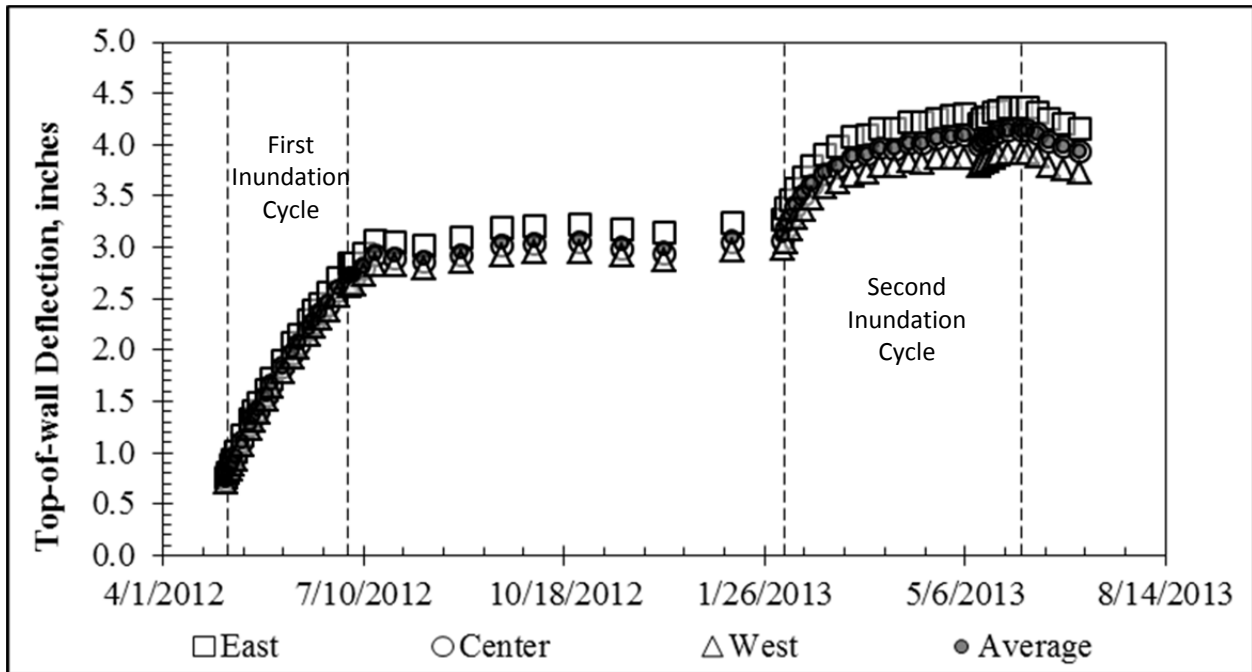
Figure 6.11: Lateral deflection at top of wall after first and second inundation cycles.

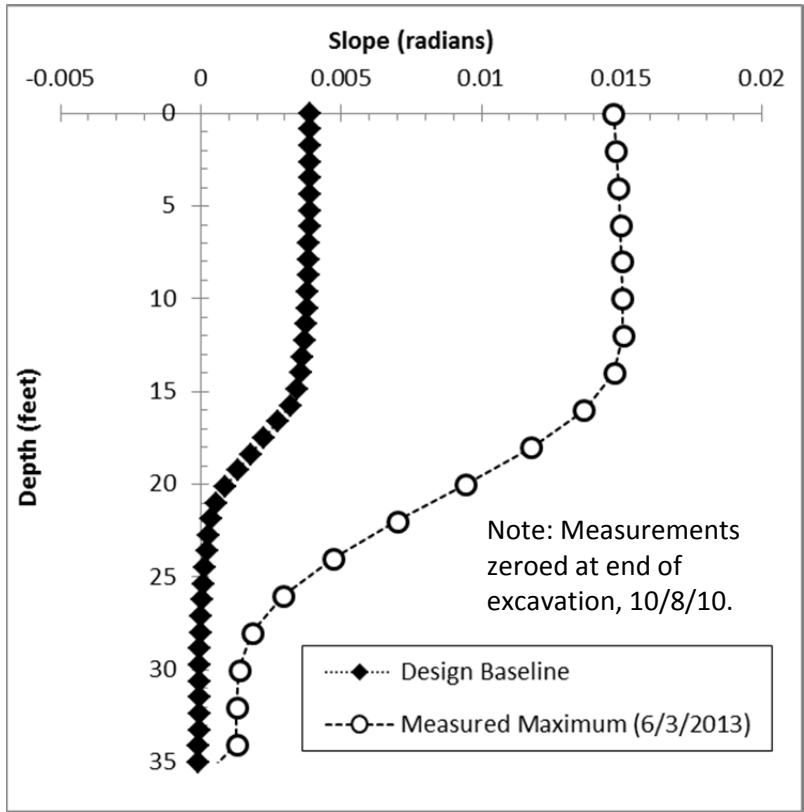
Figure 6.13: Comparison of shaft rotation profile predicted by standard design procedure with rotation profile measured at equilibrium condition under long-term loading with full inundation.

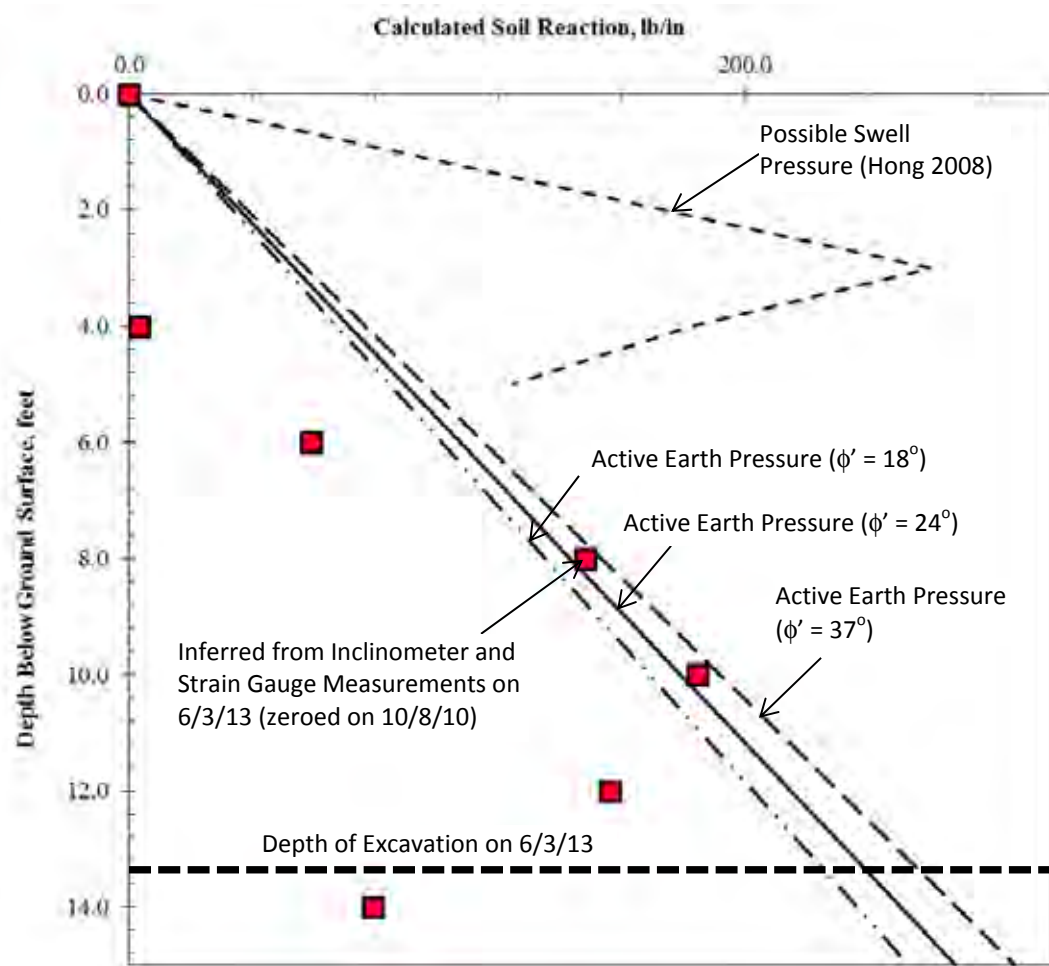
Figure 6.18: Comparison of calculated and measured active earth pressures on wall in retained soil.
