Reinforcement of pavements over expansive clay subgrades

J.G. Zornberg & R. Gupta

The University of Texas at Austin, USA

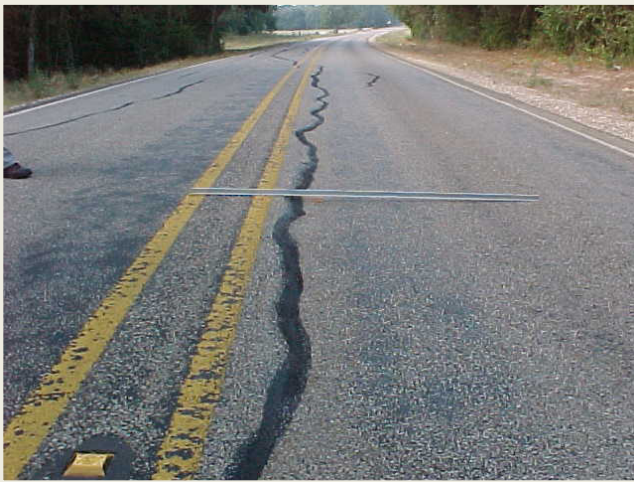
Figure 1. Typical longitudinal crack developed on pavements over expansive clays.

A new application of basal reinforcement of pavements has been used in Texas, USA, with the purpose of mitigating the development of longitudinal cracks in pavements constructed over expansive clays. Figure 1 shows the development of a longitudinal crack on a farm-to-market road (a low traffic volume road) in central Texas. The crack shown in the figure initiated below the pavement structure and has propagated to the surface. This pattern of cracking is typical of volumetric changes associated with expansive clays. Figure 2 shows the layout of a geogrid-reinforced pavement system as used by the Texas Department of Transportation (TxDOT) in the case of expansive clay subgrades. Geogrid-reinforcement has often been used in combination with lime or cement stabilization.

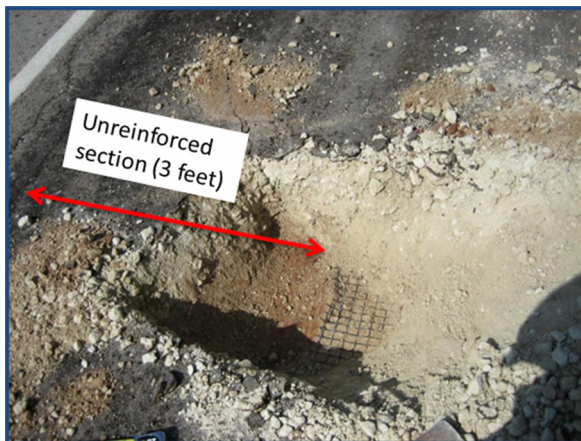
Figure 5. View of edge of geogrid reinforcement, directly underneath longitudinal crack.

During the summer of 2004, longitudinal cracks were observed to develop in the pavement sections reinforced with Geogrid B, while pavement sections reinforced with Geogrid A were observed to continue to perform adequately. Upon excavation for forensic evaluation of the early developed longitudinal cracks, it was evident that Geogrid B had failed at their junction (i.e. the bonded portion of the geogrid where the longitudinal and transverse ribs intersect), as shown in Figure 6. The material properties of the two geogrids used in this project are listed in Table 3, along with the recommended values defined by project specifications.

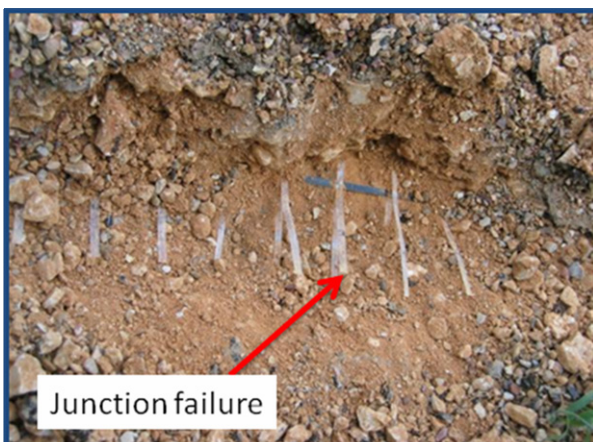
Figure 6. Separation of longitudinal and transverse ribs at junctions of Geogrid B at FM 1774

The geogrid B has lower junction efficiency than Geogrid A. The junction efficiency is defined as the ratio between the strength of the junction and the rib tensile strength. However, it should be noted that Geogrid B was considered to meet the specifications because the actual junction strength was comparatively high (the low junction efficiency was result of the fact that Geogrid B had a particularly high tensile strength).
