Case Histories on Geogrid Reinforced Pavements to Mitigate Problems Associated with Expansive Subgrade Soils

J.G. Zornberg, Department of Civil and Environmental Engineering, University of Texas, Austin, USA
R. Gupta, Department of Civil and Environmental Engineering, University of Texas, Austin, USA
J. Prozzi, Department of Civil and Environmental Engineering, University of Texas, Austin, USA
D. Goehl, Texas Department of Transportation, Texas, USA

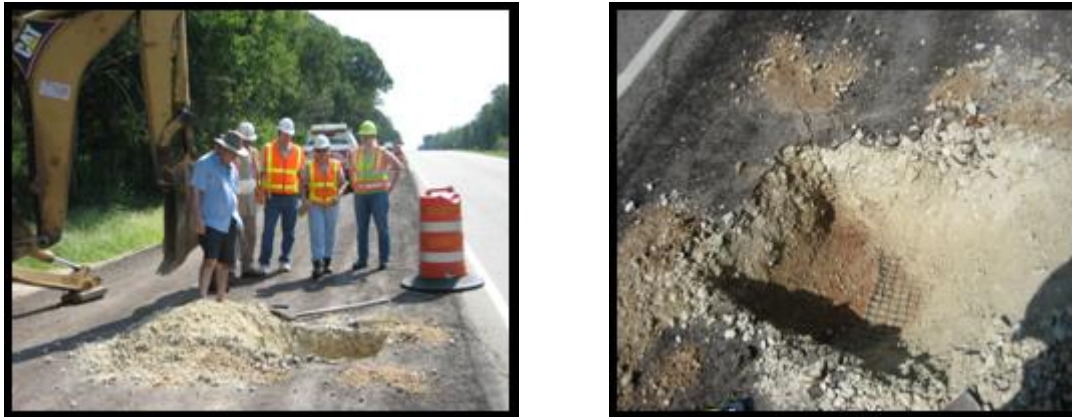
Longitudinal cracks were observed in the shoulder section of the pavement before it was opened to the traffic. Accordingly, a forensic investigation of the site was performed to establish the reasons for premature failure of the road. During visual inspection of the site, 50 mm-wide longitudinal cracks were observed close to the junction of the recently constructed shoulder and previous main road section. A backhoe was then used to excavate the asphalt and base course to expose a vertical section of the cracked portion of the pavement. The excavation indicated that there was no geogrid below the cracked portion of the pavement. Further, a borehole was made at this location with soil samples collected at 0.15 m intervals to a depth of 1 m. The top 0.5 m of soil was red colored sand underlain by light brown clay. The in-situ water content and plasticity index values at the time of excavation are summarized in Table 3. The subgrade is a clay of low plasticity. The water content of the soil compared to the plastic limit indicates that the soil is relatively dry, which may have been the cause of the observed cracking.

Figure 2 Longitudinal cracks in the unreinforced section of FM 542 pavement

The geogrid rolls supplied by the manufacturer were 3m wide, but the proposed lane was 4.2 m wide. The contractor had placed only one roll of the geogrid along the centerline of the road, leaving 1.2 m of unreinforced pavement near the edge of the road. While the section consisting of the geogrid was observed to still have good performance at the time of excavation, cracks were observed in the unreinforced section of the pavement. In fact, most of the cracks were observed at the junction of the unreinforced and reinforced section as shown in Figure 2 below. The shrinkage cracks were not observed to pass into the subgrade. This indicates the benefit of using geogrid-reinforced pavements instead of unreinforced pavements when constructing roads over expansive subgrade soils.

Forensic investigation conducted at a newly constructed FM 542 was reported. The longitudinal cracks were observed in the geogrid reinforced pavement before it was open to traffic. But when site was excavated near the cracks, no geogrid was found below the pavement section. Further investigation revealed that the contractor had laid 3 m roll of geogrid and the pavement being 4.2 m long, remaining 1.2 m section was unreinforced and thus cracked. This study showed that use of geogrid can prevent cracking in the pavements.

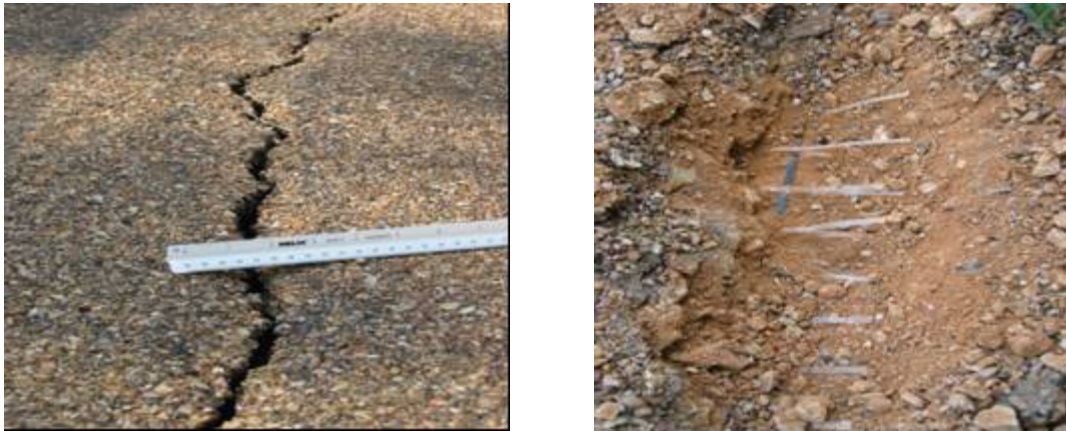
In summer 2004, longitudinal cracks were observed in a pavement section reinforced with geogrid type 2, while pavement section reinforced with geogrid type 1 was observed to still have satisfactory performance. Upon excavation of the cracked road section, it was observed that the geogrids had failed at their junction (the bond between the longitudinal and transverse elements of the geogrid). Longitudinal cracks and slippage at the junction of the geogrids in the pavement section reinforced with geogrid 2 are shown in Figures 4(a) and 4(b) respectively.

Figure 4.a) Longitudinal crack on the pavement reinforced with geogrid type 2 at FM 1774 (Bryan District) b) Slippage between longitudinal and transverse ribs at junction of geogrid type 2 at FM 1774 (Bryan District)

Although geogrid type 2 has higher tensile strength in both the machine and cross-machine directions than geogrid type 1, geogrid type 2 had lower junction strength. The TxDOT specification for the use of geogrids in this project only included both geogrid index properties (e.g., aperture size, % open area) and performance properties (e.g., tensile modulus, junction efficiency, ultimate strength in machine and cross-machine direction). A preliminary review of the test results for geogrid type 1 (performing satisfactorily) indicates that the geogrid had a junction efficiency, defined as the ratio between the strength of the junction and the rib tensile strength, of 94%. However, the test results for geogrid type 2 (poor performance) had a junction efficiency of only 35%. As specifications developed since the time of this project require 90% junction efficiency, the inadequate junction efficiency value could be inferred as being the potential cause for the difference in pavement performance.

However, closer inspection of the available test results indicated that the tensile modulus (at 2% strain) for geogrid type 2 in the poorly-performing section is approximately twice as high as that in the well-performing section. As the tensile modulus is a key property in the definition of the junction strength, this geogrid was unfairly penalized. This indicates the need for additional material characterization to provide insight into the actual causes of the differences in pavement performance. For example, the tensile modulus in the cross-machine direction is rarely specified, even though it is just as relevant as the tensile modulus in the machine direction. However, the tensile modulus in the machine direction is usually the only variable typically specified. Also, the time-dependent response of different polymers to sustained loading may lead to different strength values, especially if tensile tests are conducted at different strain rates. Accordingly there is need of having additional laboratory tests that will capture the geogrid mechanism and provide independent verification of the geogrid properties that can better predict its performance in the field. As per the current specification help to characterize the unconfined behavior of the geogrid, but no tests have been done to understand the behavior of geogrids when they are used

Field performance of two geogrid reinforced pavement consisting of subgrade having clay of high plasticity are reported. The pavement had two different types of geogrid. Both the geogrids meet the project specifications set by TxDOT. Whereas one section reinforced with geogrid type 1 (polypropylene) was found to be performing well, the other section reinforced with geogrid type 2 (polyester) showed longitudinal cracking. The review of the material properties leads to the preliminary conclusion that poor performance in the geogrid type 2 sections is due to inadequate junction efficiency but closer inspection indicated the higher tensile modulus of geogrid in this section. Since tensile modulus is an important property of geogrid, the need for better material characterization is stressed to predict the actual cause of difference in field performance.
