Use of geosynthetics to mitigate problems associated with expansive clay subgrades

J. G. Zornberg¹ and G. H. Roodi²

REFERENCE: Zornberg, J. G. and Roodi, G. H. (2021). Use of geosynthetics to mitigate problems associated with expansive clay subgrades. *Geosynthetics International*, 28, No. 3, 279–302. [<https://doi.org/10.1680/jgein.20.00043>]

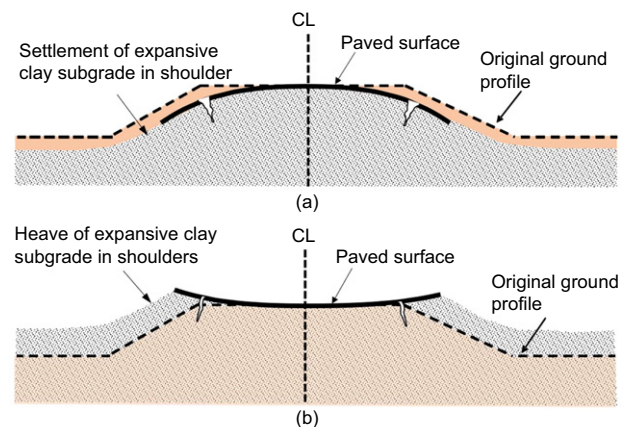
Figure 1. Schematic view of roadway profile on expansive clay subgrades, showing likely locations of environmental longitudinal cracks: (a) dry season; (b) wet season

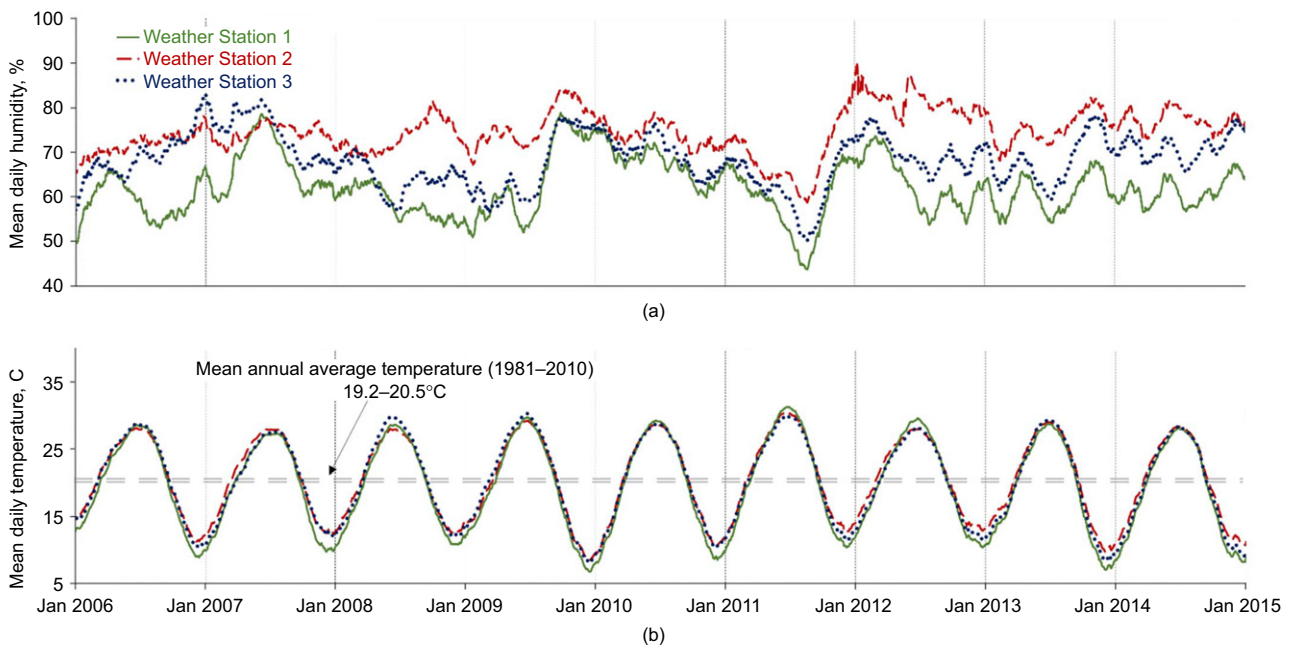
Figure 4. Mean daily climatic data at three weather stations (2006 to 2015): (a) humidity; (b) temperature

The mean daily temperature and relative humidity values gathered from the three weather stations over a 9-year period (from 2006 to 2015) are presented in Figure 4. This figure also shows the mean annual average temperature from the NOAA’s 1981–2010 Climate Normals. The three weather stations recorded consistent cyclic temperature variations ranging from low mean daily temperatures of 7 to 10°C in December and January to high mean daily temperatures of 27 to 32°C in mid-summer. However, the low temperatures recorded at Weather Station 2 were slightly higher than those in Weather Stations 1 and 3.

The changes in mean daily humidity, presented in Figure 4, also show similar trends among the three weather stations. High-humidity periods lasting over several months have been intermittently followed by few, comparatively low-humidity months. Overall, Weather Station 2 recorded comparatively higher humidity values than Weather Stations 1 and 3. The highest humidity values in Weather Station 2 ranged from 85 to 90% while the lowest humidity value from this weather station was recorded in 2011 and corresponds to approximately 60%. On the other hand, the lowest humidity recorded in 2011

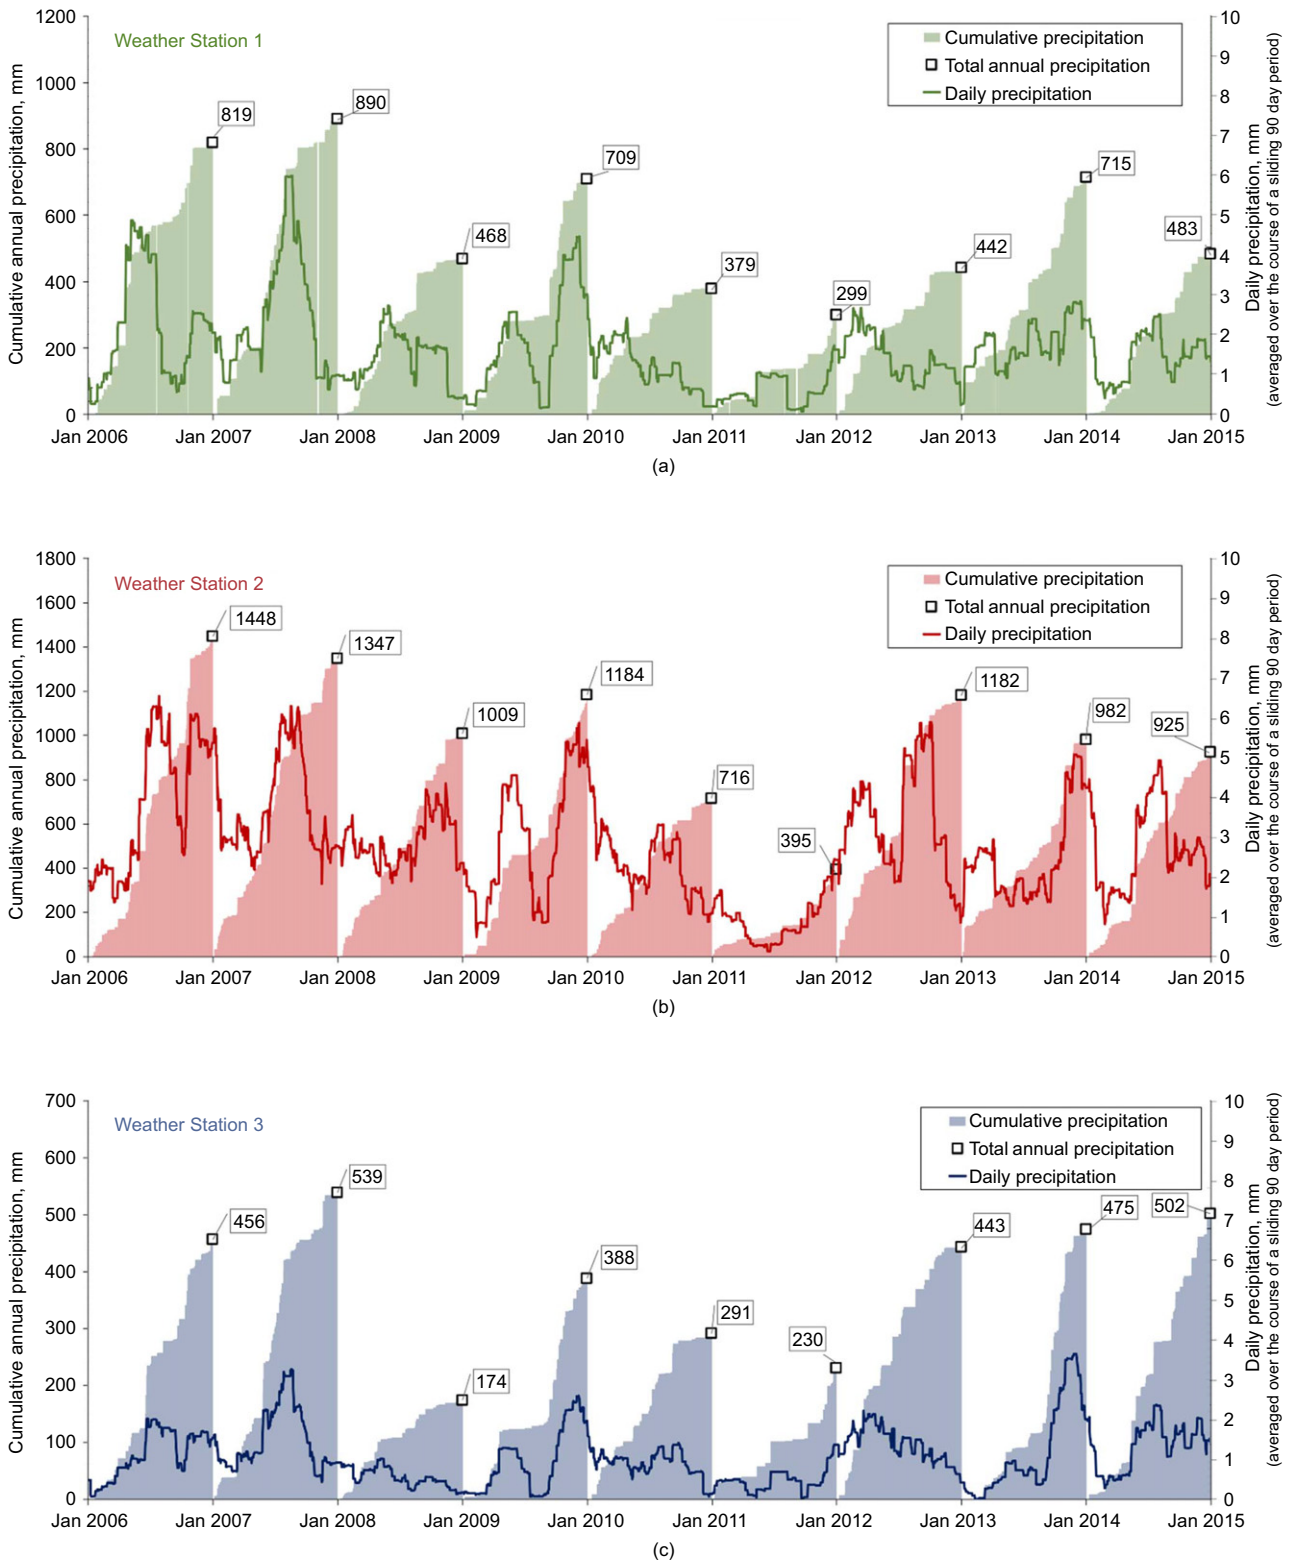
Figure 5. Cumulative annual and daily precipitation (2006–2015): (a) Weather Station 1; (b) Weather Station 2; (c) Weather Station 3

with gradual increase in the high temperature value (and decrease in the low temperature value) toward the West. Precipitation data at the three weather stations presented in Figure 5 is consistent with the humidity trends. This figure shows cumulative annual precipitation at the three weather stations for the same 9-year period evaluated for temperature and humidity. Overall, Weather Stations 1 and 3 (Figures 5a and 5c) recorded a lower rainfall than

Weather Station 2 (Figure 5b). However, several cycles of wet and dry years can be identified in all three weather station data sets. Specifically, the years 2010 and 2011 have been among the driest years for all three weather stations and the years 2006, 2007, and 2013 have been among the wettest years for all three weather stations. Figure 5 also shows the daily rainfall averaged over the course of a sliding 90-day period centered on each day.

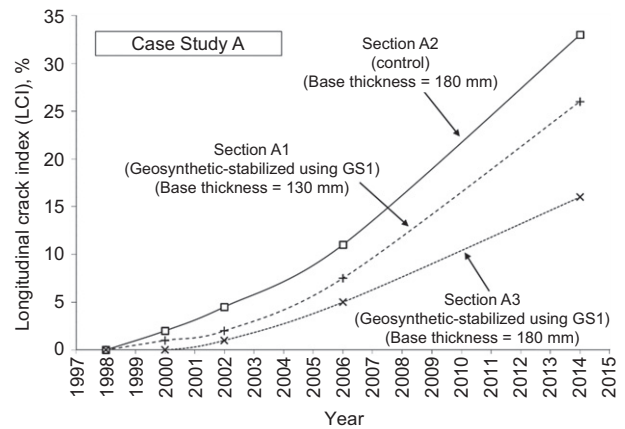
Figure 7. Longitudinal crack index (LCI) from 1998 to 2014 at the FM1915 test sections (Case Study A)

The performance of FM1915 was also evaluated using performance data collected using TxDOT's Pavement Management Information System (PMIS) database. Specifically, changes in LCI were evaluated for each test section from 1998 to 2014. As summarized in Figure 7, LCI results indicate that the two geosynthetic-stabilized sections (A3 and A1) performed significantly better than the control section (A2). The average LCI obtained in 2014 for Section A3 (geosynthetic-stabilized section with base thickness equal to that of the control section) was found to be particularly small (approximately 16%). Instead, the average LCI in Section A1 (geosynthetic-stabilized section with reduced base thickness) was approximately 26%, while the average LCI in Section A2 (control section) was approximately 33%. These results indicate that use of the geosynthetic adopted in this project for base stabilization resulted in a performance equivalent to using a thickness of at least 50 mm additional base course (i.e. it was equivalent to a reduction of approximately 28% of the original 180 mm-thick base layer). The corresponding CMR values for Sections A1 and A3 are 2.1 and 1.3,

Performance data obtained for Case Study A showed the benefits of geosynthetic stabilization even in a test section constructed with reduced base thickness (Table 5, Lesson 5). Accordingly, and consistent with design strategies for a geosynthetic-stabilized base in roadways under traffic loads, the design of a geosynthetic-stabilized base under environmental loads can consider the benefit of an increased roadway service life (for a given base course thickness) or of a reduced base course thickness (for a given service life). For the conditions corresponding to Case Study A, the use of geosynthetic was found to be equivalent to reducing the base course thickness by 28% (see Figure 7).

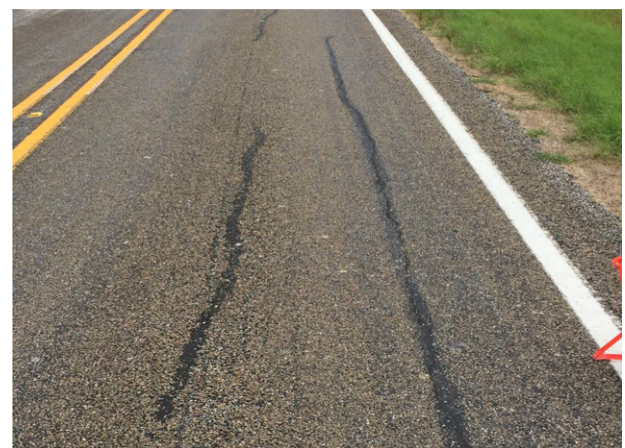
Figure 8. Roadway conditions at the FM1915 (Case Study A) test sections in 2017: (a) Section A1 (geosynthetic-stabilized section); (b) Section A2 (control section)

respectively, further underscoring the reduction in longitudinal cracking when adopting a geosynthetic-stabilized base. Figure 8 shows the FM1915 road conditions from a 2017 condition survey, illustrating that clearly more significant longitudinal cracks have developed in the control than in the geosynthetic-stabilized sections.

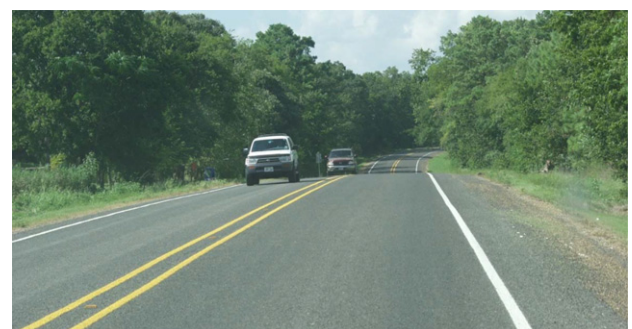
Figure 10. View of road conditions in 2004 at the FM1774 test section stabilized using GS1 in Case Study B

Results from condition surveys conducted in the summer of 2004 indicated clear differences between the performances of Sections B1 and B2. While Section B1, stabilized with GS1, had a relatively small number of longitudinal cracks (Figure 10), a significant number of longitudinal cracks was observed in Section B2, stabilized with GS2. One of the longitudinal cracks that developed in Section B2 is presented in Figure 11, which shows the road conditions before and after a forensic excavation. It was determined that the junctions of geogrid GS2 had often failed. The junction breakage led to slippage of the transverse geogrid members at this location (Figure 11b).

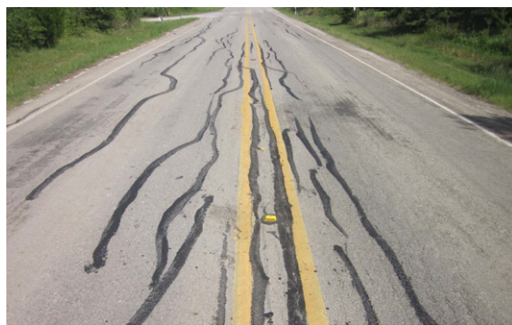
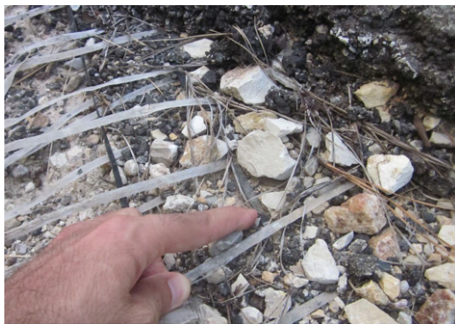
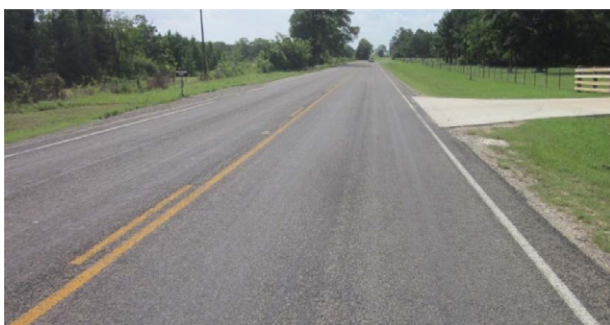
Figure 13. Images collected during 2017 condition survey at FM1774 (Case Study B): (a) extensive cracks observed in Section B2; (b) view of junction failure in GS2 used in Section B2; (c) view of comparatively good condition (no cracks) in Section B1

the average LCI in Section B1 was below 10%, it reached almost 60% in Section B2. Results from a subsequent condition survey, conducted at FM1774 in 2017, also highlighted important differences between the extent of longitudinal cracks in Sections B1 and B2. Severe cracking at the edge and in the paved area of Section B2 could be observed during the 2017 condition survey (Figure 13a). Breaks in laser-bonded junctions between GS2 longitudinal and transverse ribs were identified in areas where geosynthetics were exposed (Figure 13b). On the other hand, Section B1 showed a very good overall condition (Figure 13c).

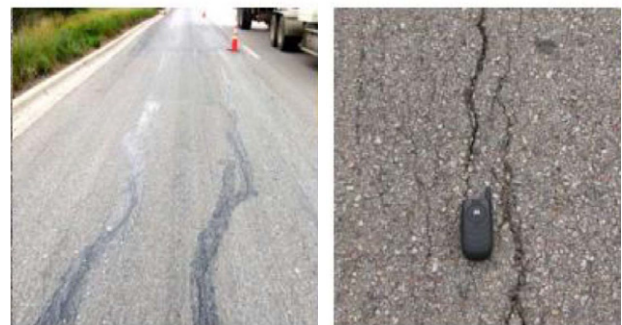
Figure 14. Conditions at FM734 (Case Study C) before rehabilitation (photo courtesy of TxDOT): (a) longitudinal cracks on the road; (b) close-up view of longitudinal cracks

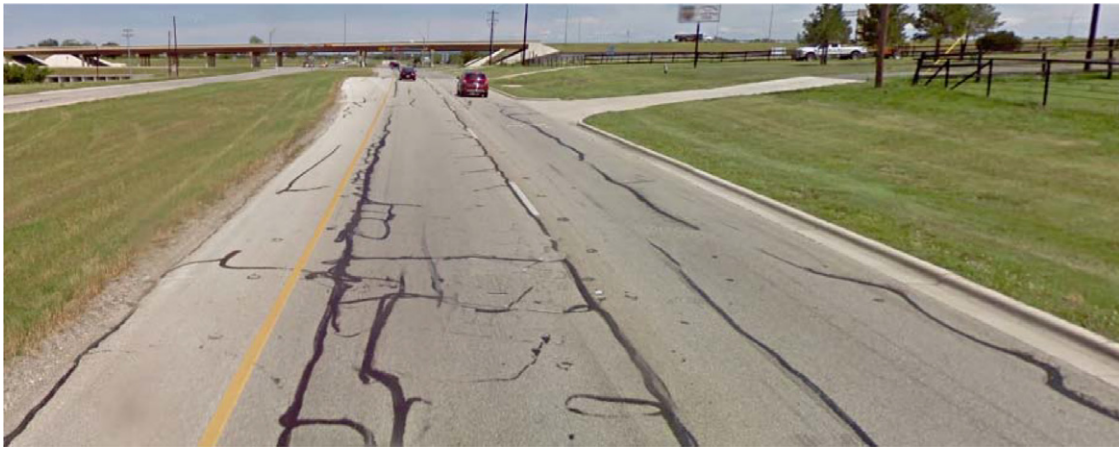
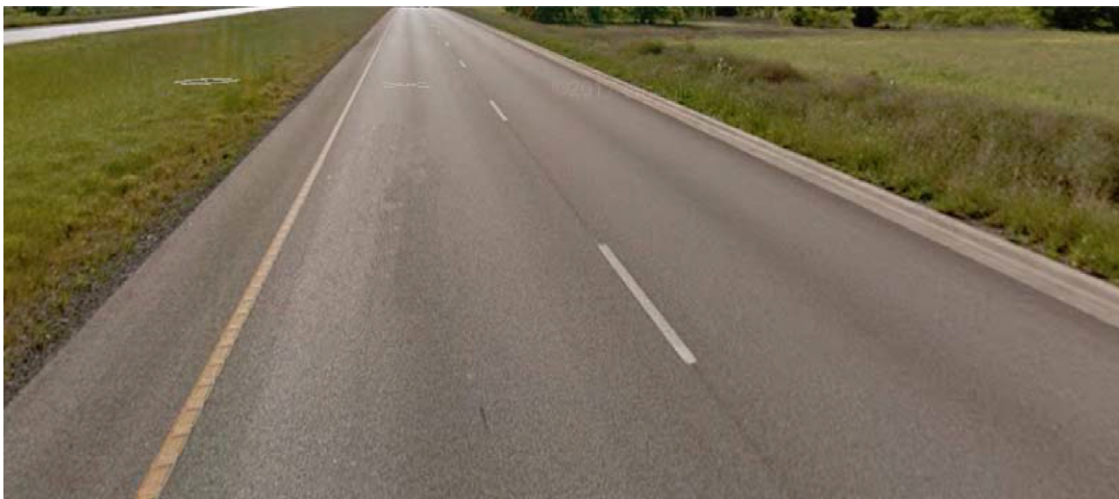
Figure 18. Road surface conditions at FM734 test sections (Case Study C) over nine years after their constructions: (a) Section C1 (control) in 2009; (b) Section C2 in 2011; (c) Section C3 in 2016

Sections C2 and C3 presented only minor surface cracking. FWD and DCP tests were also conducted on Sections C1 and C2 to characterize the pavement layer moduli. Table 4 summarizes the pavement layer moduli, as obtained from back calculations of FWD data and from correlations with DCP test data. Evaluation of the data presented in this table indicates that the moduli obtained through FWD and DCP were reasonably similar for the subgrade layer, but somewhat different for the base course layer. However, inspection of both data sets shows that both subgrade and base course layer moduli were higher in the geosynthetic-stabilized section (Section C2) than in the control section (Section C1). Surface condition of the test sections was also evaluated using historical images. Figure 18 shows the road conditions after nine years of construction for both sections. While Section C1 showed a significantly large number of longitudinal cracks (Figure 18a), Section C2 only showed comparatively less cracking (Figure 18b) and Section C3 was found to show good conditions (Figure 18c).

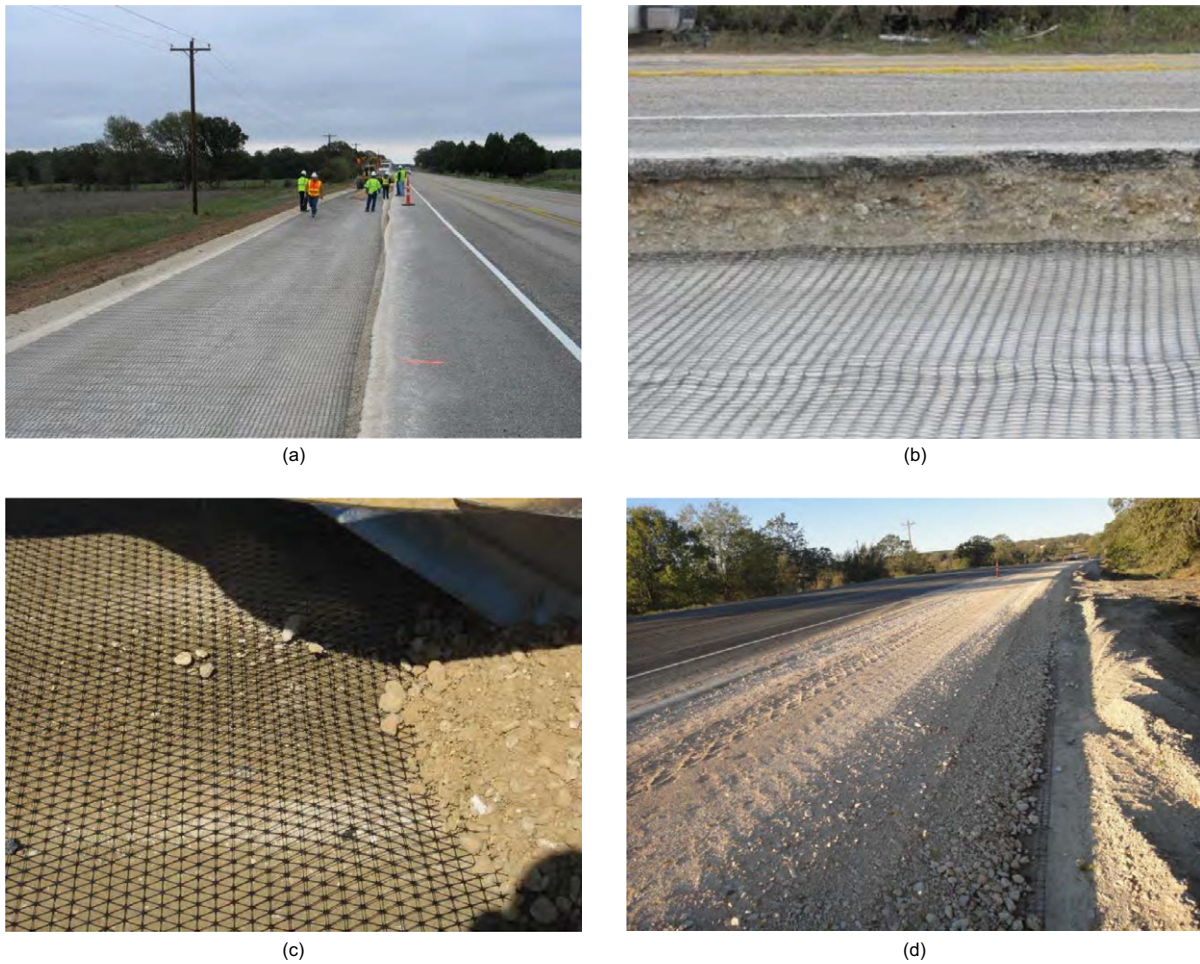
Figure 20. View of geosynthetic deployment during 2011 reconstruction of SH21 (Case Study D) (photos courtesy of TxDOT): (a) installation of biaxial geogrids; (b) view of old pavement layers; (c) installation of multiaxial geogrids; (d) widening of shoulders and construction of new base course

The test sections involved extension of the shoulders and stabilization of the base layer in the outer lanes using five different geosynthetic products (three multiaxial and two biaxial geogrids). Figure 19 shows the extent and cross-section details of the different SH21 test sections. The original 300 mm-thick base layer in the outer lanes was excavated and replaced with a 150 mm-thick cement-treated subbase layer overlain by a new 150 mm-thick base layer. A geogrid was installed at the subbase-base interface in each test section and the shoulders were reshaped and widened by 1.5 m to provide additional lateral support to the pavement layers. Figure 20 illustrates different stages during the SH21 reconstruction.

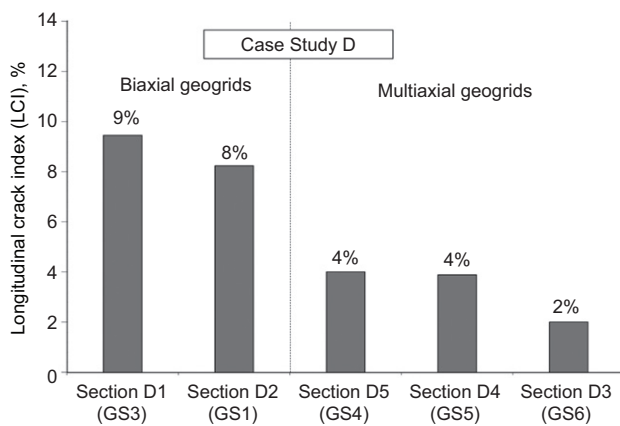
Figure 21. Comparative performance of test sections in Case Study D based on 2017 LCI in the various test sections

section. Results obtained from the 2014 condition survey indicated only minor distresses in all test sections. However, the condition survey conducted in 2017 revealed significant differences among the performances of the different test sections, particularly between those constructed using biaxial and multiaxial geogrids. LCI values obtained in the 2017 condition survey are shown in Figure 21. The test sections stabilized using multiaxial geogrids (i.e. Sections D3, D4 and D5) were found to perform better than those stabilized using biaxial geogrids (i.e. Sections D1 and D2). Specifically, while LCI was under 4% in Sections D3, D4 and D5, it exceeded 8% in Sections D1 and D2.

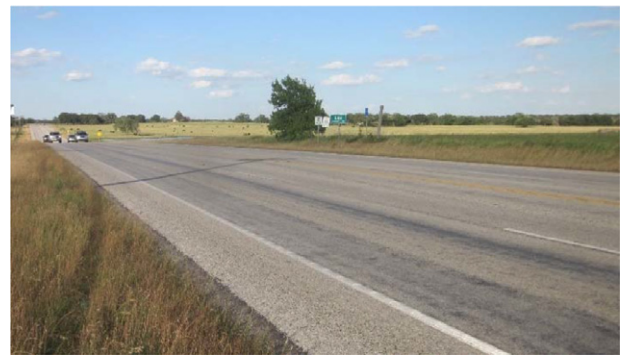
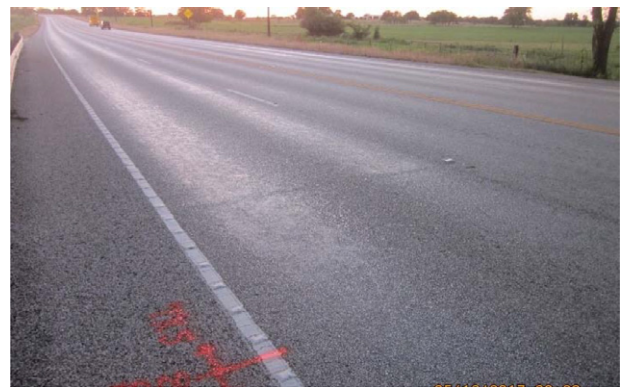
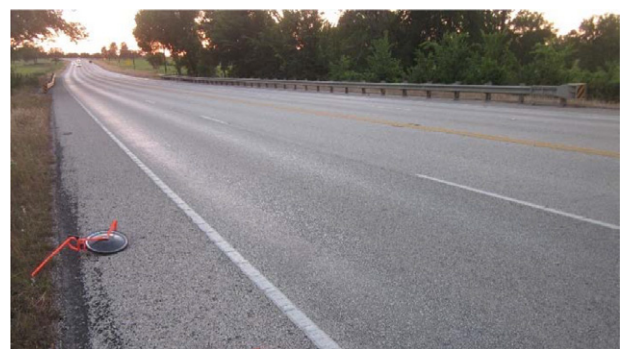
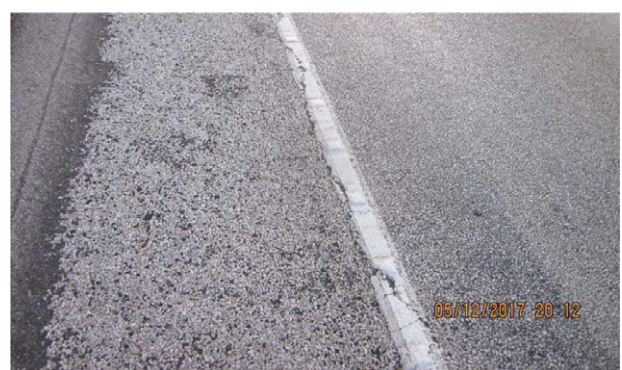
Figure 22. Road conditions during 2017 survey in SH21 test sections (Case Study D): (a) Section D5; (b) Section D4; (c) Section D3; (d) Section D2

Among the sections stabilized using a multiaxial geogrid, Section D3, which involved the geogrid with the highest rib thickness, was found to perform comparatively better than Sections D4 and D5. Images of the roadway conditions collected in 2017 at the SH21 test sections are shown in Figure 22. Sections D5, D4 and D3, stabilized with multiaxial geogrids, are shown in Figures 22a–22c, respectively. Figure 22d shows longitudinal cracks observed in Section D2, which was stabilized using a biaxial geogrid.

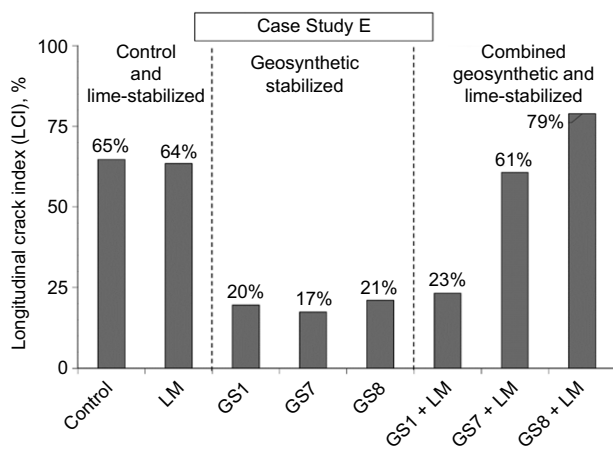
Figure 25. Comparative performance of FM2 test sections (Case Study E) based on 2011 LCI after a severe drought

Performance evaluation of the FM2 test sections included field assessments conducted before and after reconstruction (Roodi 2016). As part of this program, condition surveys of road surface distresses were conducted, with particular focus on quantifying the extent and severity of longitudinal cracks. The average LCI for each test section, as obtained after a severe drought that occurred 6 years after reconstruction, is presented in Figure 25. As shown in the figure, performance evaluation of the test sections indicated that the geosynthetic-stabilized sections performed considerably better than non-stabilized sections. In particular, the extent of environmental longitudinal cracks was found to be significantly lower in geosynthetic-stabilized sections than in control sections. On average, the test sections stabilized using the three geosynthetic types were found to exhibit approximately the same level of performance. In fact, while the average LCI in control sections was 65%, the average LCI in geosynthetic-stabilized sections was below 21%. These

values for LCI result in a crack mitigation ratio (CMR) exceeding 3.0. Specifically, the CMR values obtained for sections stabilized using GS1, GS7, and GS8 were 3.3, 3.8 and 3.1, respectively.

Comparison of the LCIs in control sections versus those in the lime-stabilized sections, presented also in Figure 25, indicates that lime stabilization of the subbase was not necessarily helpful in mitigating the development of longitudinal cracks. Indeed, field data presented in this figure indicates that combination of lime treatment of subbase and geosynthetic stabilization of base was less effective than using only geosynthetics. These results are consistent with experiences within the TxDOT Austin District, which have shown that for roadways founded on expansive clay subgrades, treatments incorporating a rigid yet brittle layer (e.g. lime-stabilized layers) would not tolerate soil differential settlements, resulting in longitudinal cracks often more severe than cases where lime stabilization was not adopted (Sebesta and Scullion 2014). Therefore, mitigation techniques for roads founded over expansive clays should avoid approaches that lead to stiff, brittle performance (e.g. lime stabilization of subbase layers) and focus instead on approaches leading to comparatively ductile

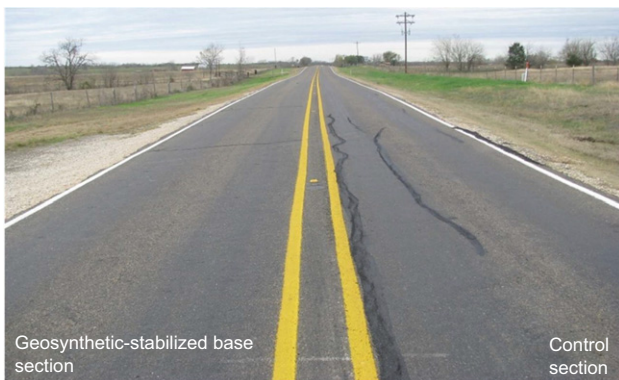
Figure 26. View of road conditions of a control section (right) and a geosynthetic-stabilized base section (left) from 2011 condition survey conducted in FM2 test sections (Case Study E)

responses (e.g. geosynthetic-stabilized base courses). Figure 26 shows FM2 road conditions in 2011, illustrating a clear contrast between the good performance of the geosynthetic-stabilized section compared to the companion control section.
