Moving Down
**the Road of
Progress**

**Geosynthetics Subdue
Failures on Expansive Clays
and Frost-susceptible Soils**

By Jorge Zornberg, PhD, PE, F.ASCE,
and Xiong Zhang, PhD, PE, M.ASCE

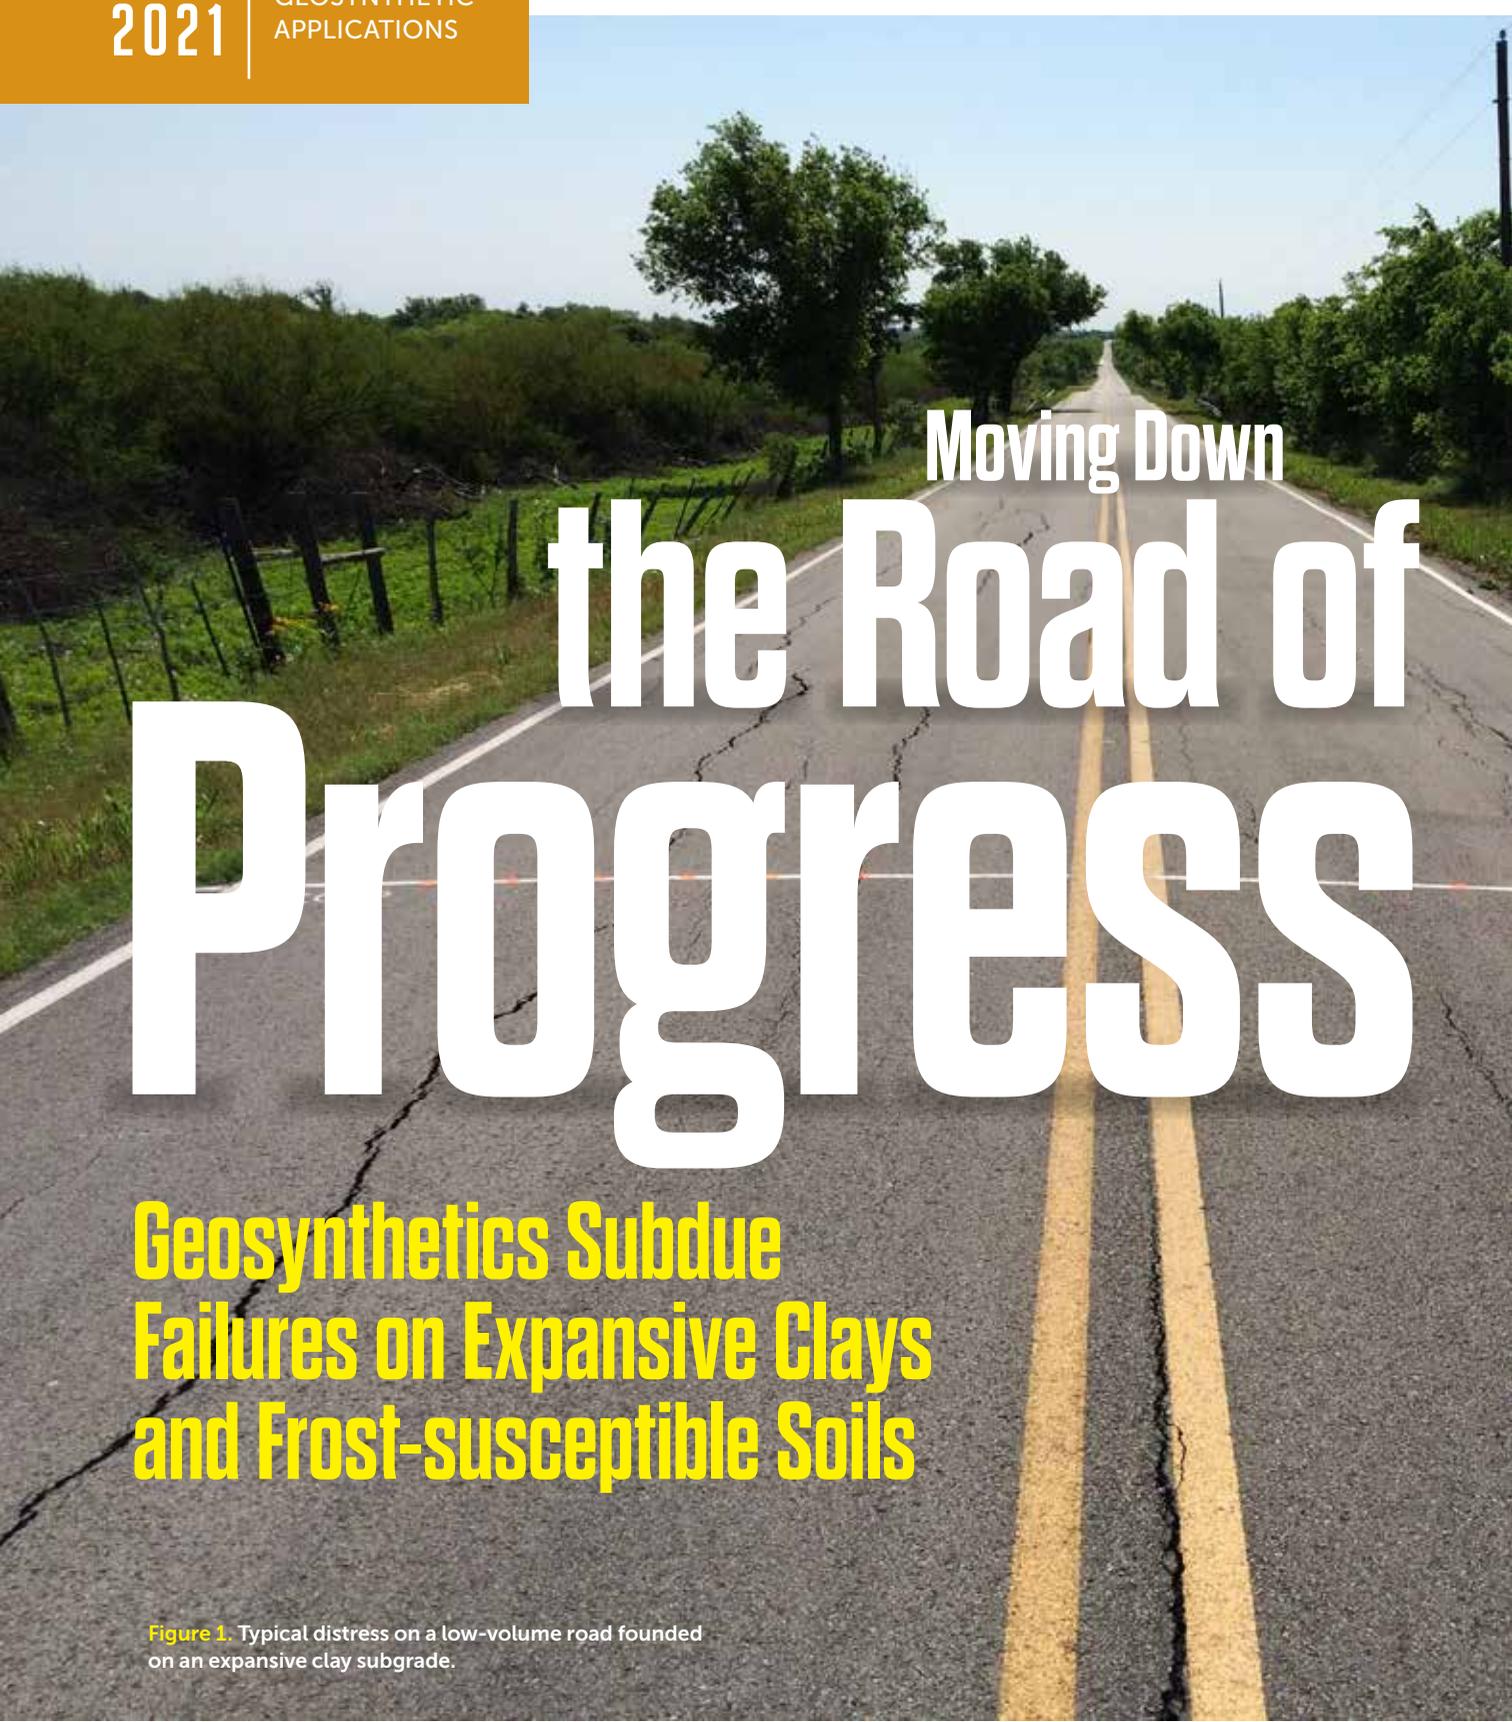
Figure 1. Typical distress on a low-volume road founded on an expansive clay subgrade.

In the U.S. alone, \$15 billion in annual total reported damages can be attributed to expansive soils. While not life-threatening compared to natural disasters, expansive soils constitute a natural hazard with an average annual cost exceeding that caused by floods, hurricanes, earthquakes, and tornadoes combined. Common across much of the central and southern U.S. and many other regions worldwide, expansive clays may trigger large volumetric changes that result in ground heave during wet seasons and settlements during dry seasons. Figure 1 depicts a common type of distress often referred to as “environmental longitudinal cracking.” This one was observed on a low-volume road founded on an expansive clay subgrade in Texas, after

being subjected to cyclic differential movements caused by varying moisture conditions.

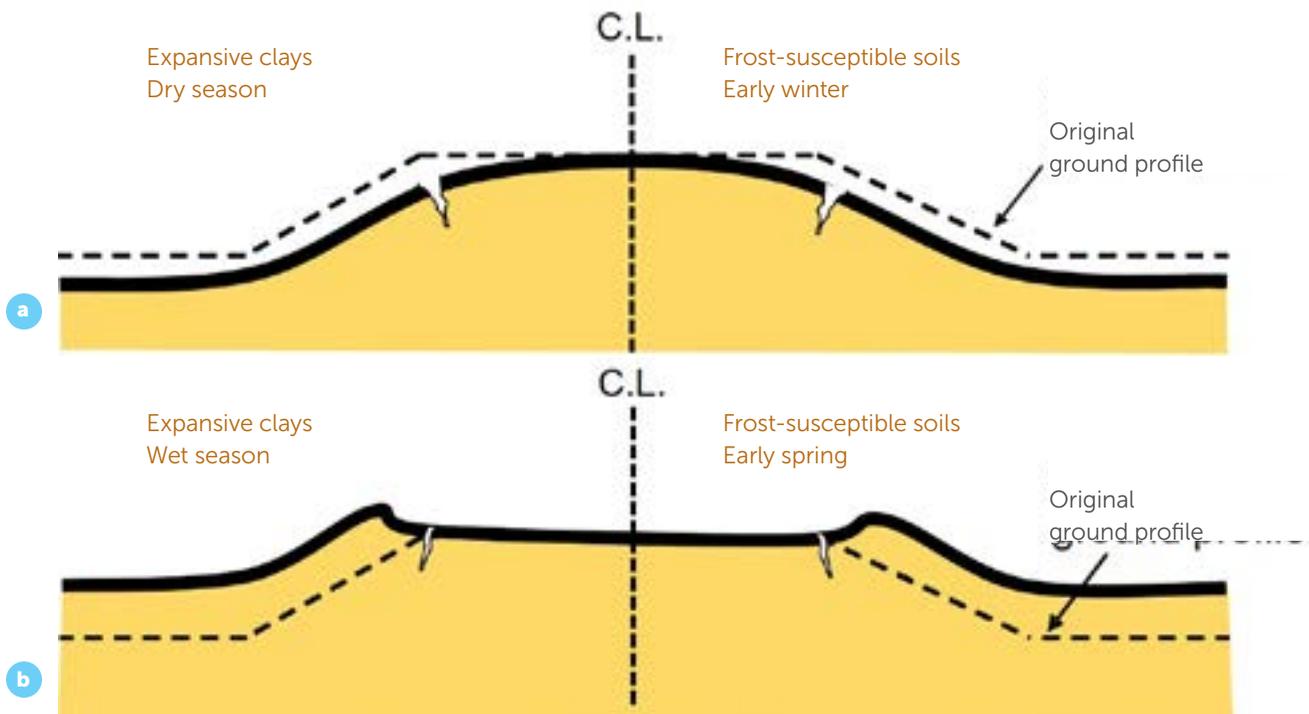
Figure 2. Schematic roadway profiles.

Cycles of wet and dry seasons may lead to significant changes in the moisture content of surficial subgrade soils (Figure 2). However, such changes are comparatively more significant near the pavement shoulders. Instead, moisture fluctuations in subgrade soils beneath the paved roadway centerline are markedly less affected by precipitation events, leading to a nonuniform distribution of moisture along the roadway cross-section. If the subgrade involves expansive clays, such nonuniform moisture changes result in nonuniform volumetric changes over the roadway cross-section.

seasons. Pavement shoulders will then settle in relation to the roadway centerline during dry seasons (Figure 2a) and show a relative heave during wet seasons (Figure 2b). Such differential movements induce flexure and, consequently, tensile stresses and associated distress in the roadway surface layer.

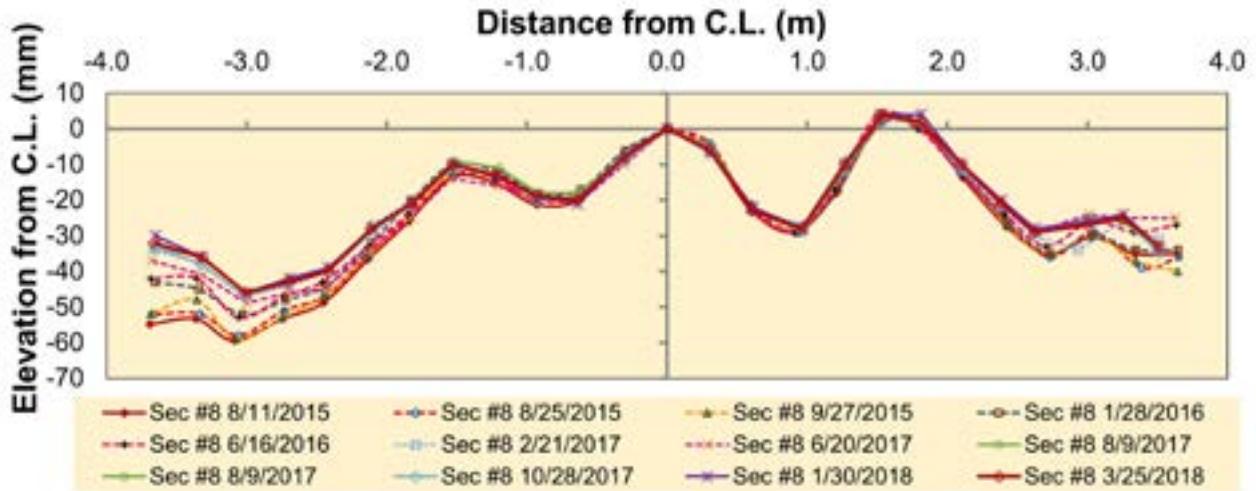
Figure 3. Differential vertical movements between the edge and centerline at a low-volume road founded on expansive clay subgrade shown in Figure 1.

For example, the magnitude of differential vertical movements between the edge and centerline of the road (Figure 3) exceeded 1.2 in. over a three-year monitoring of vertical movements. Consistent with this mechanism, significant longitudinal cracks will often develop, particularly after sustained dry seasons (i.e., when tensile strains are the greatest). Longitudinal cracks may even partially close during wet seasons, although water will continue to infiltrate the damaged pavement surface. These longitudinal cracks are due to “environmental” loads rather than the “traffic” loads for which roadways are conventionally designed.

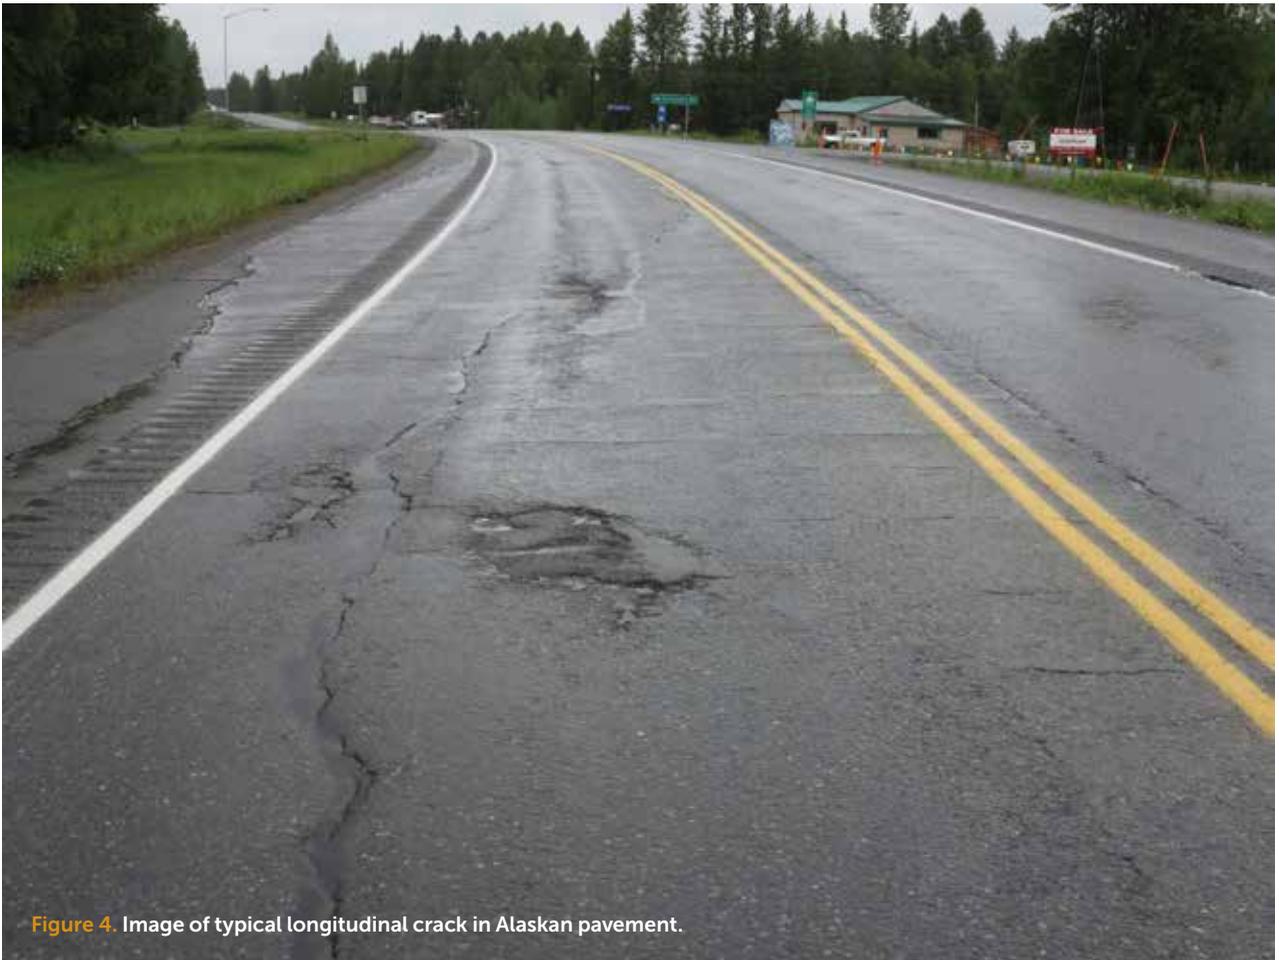
Figure 4. Image of typical longitudinal crack in Alaskan pavement.

A pattern of shoulder differential vertical movements in relation to the road centerline, similar to that present in expansive clays, is also observed in cold regions. Figure 4 shows typical distress of a road in Alaska caused by nonuniform frost actions and, consequently, uneven

vertical movements. The road surface in a pavement structure has distinctly different thermal characteristics in terms of heat absorption and release than the road shoulders, which may trigger differential frost heaving across the road section under cycles of warm-cold seasons. Common winter maintenance operations, such as removing the insulating snow from the roadway and depositing it on the road shoulders, further aggravate the situation by promoting freezing under the roadway and retarding it under the shoulders. For example, the reported annual average surface temperatures on Alaskan roads is approximately 32°F, while the average surface temperature on the road shoulders ranged from 35°F to 40°F. Accordingly, such differences in temperature changes lead in turn to nonuniform frost action and differential movements over the road cross-section. Longitudinal cracking at the center of the pavement often initiates due to transverse differential heaving when the induced tensile stresses in the pavement structure exceed the tensile strength. That is, the volume changes in frost-susceptible soils of cold Alaska show a similar pattern to the expansive soils in hot Texas! This makes frost heave another clear example of

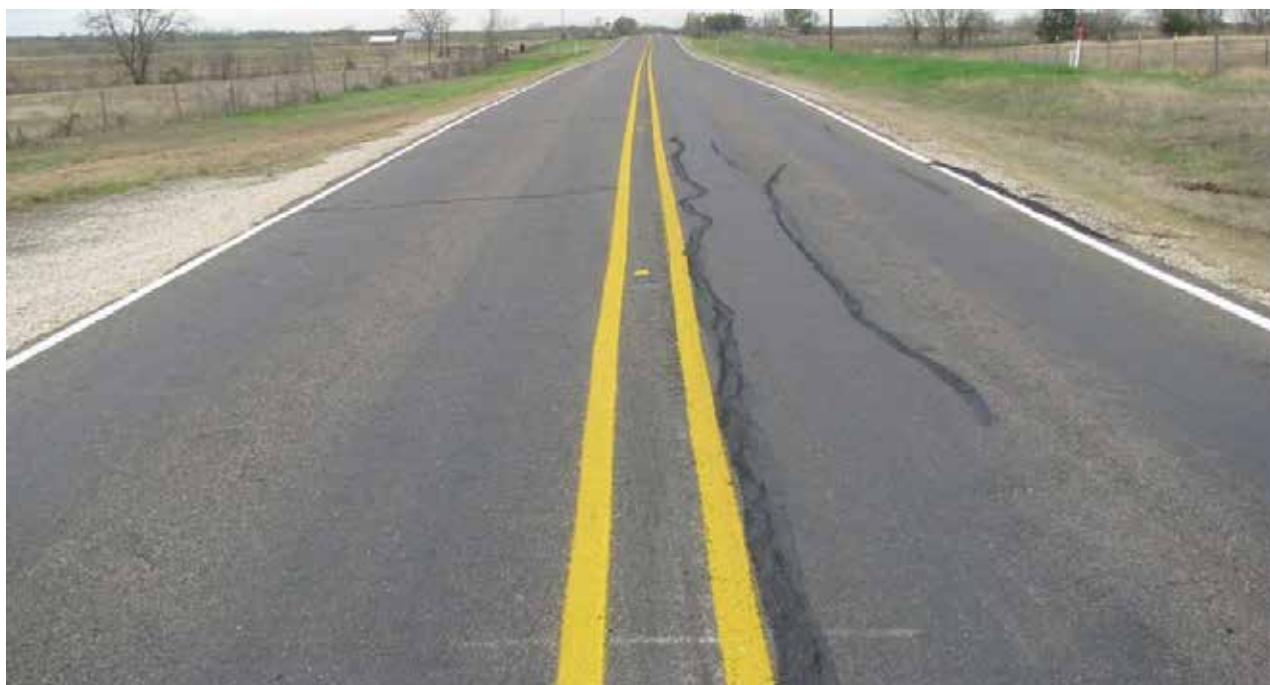
Figure 5. Road conditions showing control section (right) and geosynthetic-stabilized base section (left).

of longitudinal cracking. Quantifying the longitudinal cracking proved particularly revealing after a severe drought that occurred six years following reconstruction. Performance evaluations of the test sections showed that the geosynthetic-stabilized sections performed considerably better than the nonstabilized sections. On average, the test sections stabilized using the three geosynthetic types were found to exhibit approximately the same level of performance. In fact, the average length of environmental longitudinal cracks in the control sections was 65 percent of the section length compared to 21 percent in geosynthetic-stabilized sections. Figure 5 shows a section of FM2, following a 2011 drought, that includes a geosynthetic-stabilized section (left

lane) and a nonstabilized (control) section (right lane). The difference in longitudinal crack development is definitive, as the sections (intentionally constructed along the same roadway stretch) have identical soil, weather, and traffic conditions.

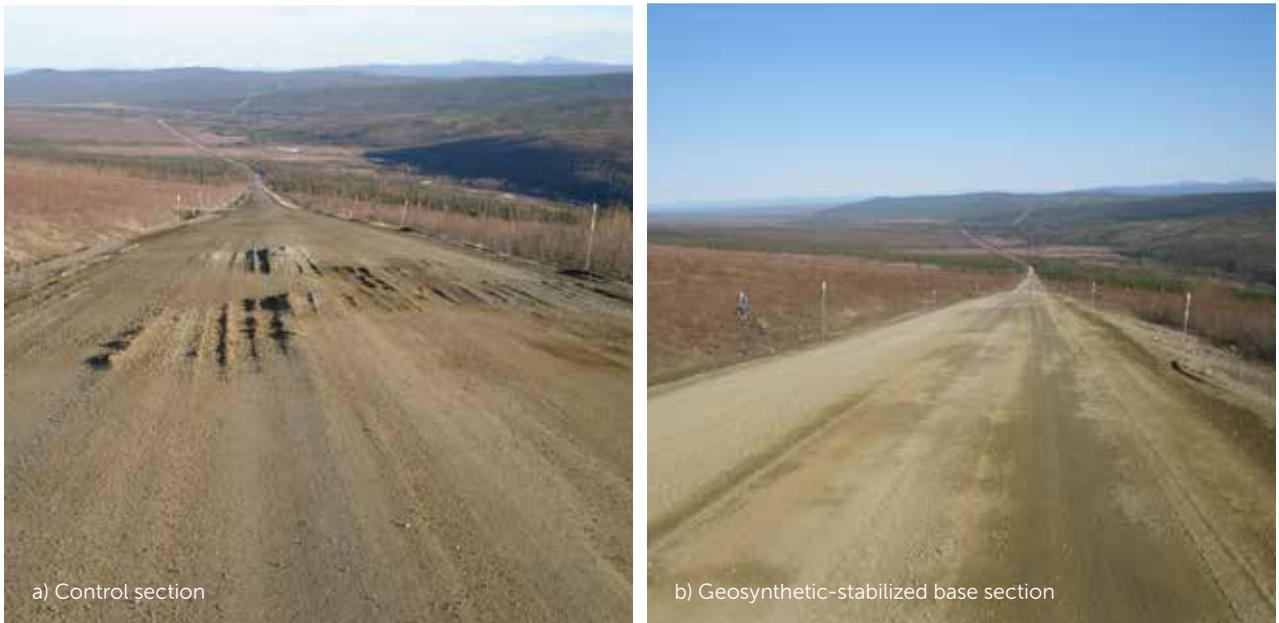
Figure 6. Performance of wicking fabric at Beaver Slide test section on Dalton Highway: a) Before treatment (May 2010), and b) After treatment (May 2011).

side hill embankment (3 ft on the west side and 9 ft on the east side). Each year, “frost boils” that usually appear in late April and remain throughout the summer (Figure 6a), have created extremely unsafe driving conditions and contributed to more frequent accidents. Conventional repairs, such as installation of French drains at a skew, had not worked adequately. The alternative option of replacing the road section with more adequate material only temporarily resolved local frost boils and moved the problem down slope.

Figure 6b shows the roadway’s condition one year after treatment. As the figures show, the soil above the wicking geotextile remained unsaturated during the 2011 thawing period. Visual evidence and monitoring data have showed very good performance of the test section over the past 10 years. Neither soft spots nor frost boils developed in the test section treated with wicking geotextiles, while soft spots or frost boils were observed just beyond the upper and lower ends of the test section. Monitoring results

have also revealed that water was flowing along the direction of the wicking geotextile to the shoulder of the pavement. The wicking geotextile has successfully eliminated frost heave and thaw weakening in the upper 3.5 ft. below the second layer of wicking fabric. The observed volumetric moisture contents indicate that the soils in the test section did not reach saturation. When the water supply from the underlying soils was cut off by the wicking geotextile, frost action was eliminated.
