## Mitigation of Cracks in Flexible Pavements with Expansive Subgrade Using Geosynthetics: A Case Study in Austin, Texas

Geosynthetics have been effective in minimizing the detrimental effects of expansive soil subgrades on the performance of flexible pavements. This study presents a case history on the use of geosynthetic reinforcement to minimize cracks in a flexible pavement with an expansive soil subgrade in an urban roadway in Austin, Texas. The crack mitigation techniques included use of a fiberglass geogrid reinforcement at the interface of pre-existing asphalt layer and the overlay. Specifically, the geogrid was placed directly over the severely cracked surface, after cleaning dirt, dust and other deleterious material, and a trackless tack was then applied prior to the installation of the asphalt overlay. The test sections with and without geogrid reinforcement was monitored for over a period of 8 years and it was observed that the longitudinal edge cracks reappeared along the unreinforced section. While, the geosynthetic reinforced sections did not show any signs of crack development during the monitoring period. Overall, the field monitoring program demonstrated that the

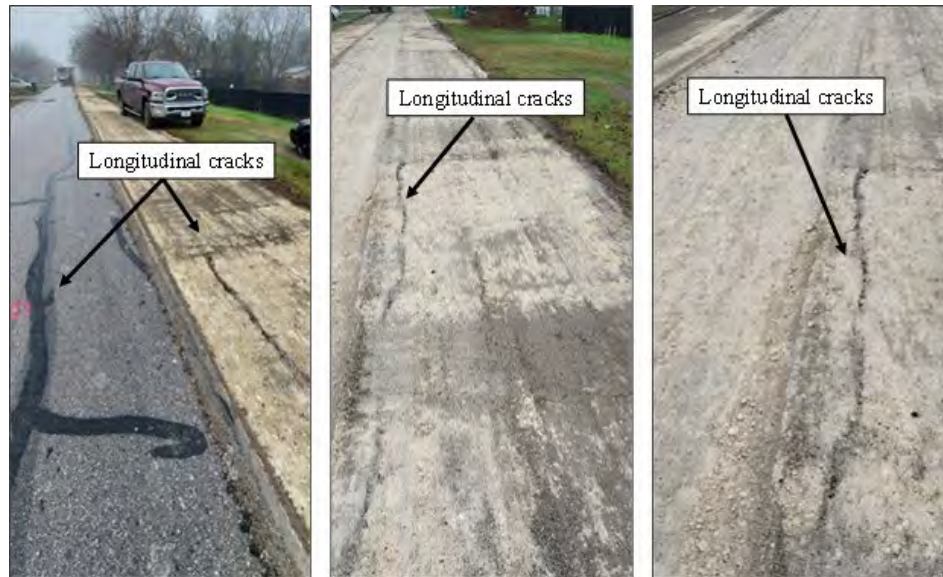
**Figure 1. Examples of longitudinal cracks from expansive subgrades, in Taylor, Texas.**

Several techniques that mitigate the cracking in flexible pavements have been evaluated. Traditionally, the problems associated with flexible pavements built over expansive soil subgrades have been addressed by completely replacing these soils or by stabilization techniques (Zornberg, 2010). Among them, excavation and replacement, pre-watering, chemical or mechanical modification using lime or cement stabilization and moisture barriers are the most common and economic alternatives. The construction of flexible pavements over expansive subgrades treated with lime has been the most common alternative in regions such as central Texas. However, situations of compromised performance due to the appearance of longitudinal cracks over lime-treated subgrades are also common. Figure 1 presents an example of a typical scenario of longitudinal cracks in flexible pavement with lime-treated expansive soil subgrades in Taylor, Texas. As shown in the figure, the longitudinal cracks initiated from expansive subgrades, subsequently propagated into the asphalt surface through the 10% lime-treated base layer.

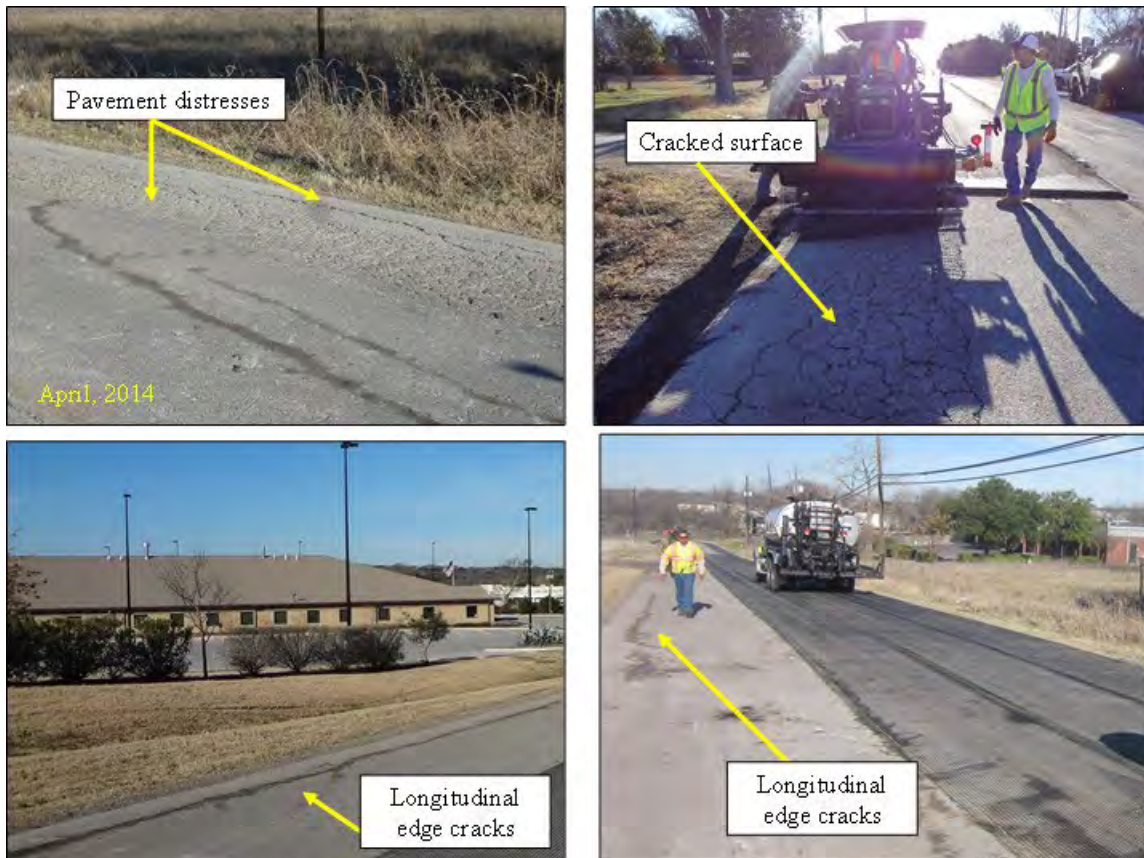
**Figure 3. Distresses in the Pre-existing Roadway: April 2014.**

The asphalt surface along the Ferguson Lane had developed distresses in the form of longitudinal cracks, alligator cracks and undulations/rut along the wheel paths as shown in Fig. 3. The Austin city transport authority proposed to rehabilitate the roadway to restore the serviceability to road users and the rehabilitation process is discussed in the following section.

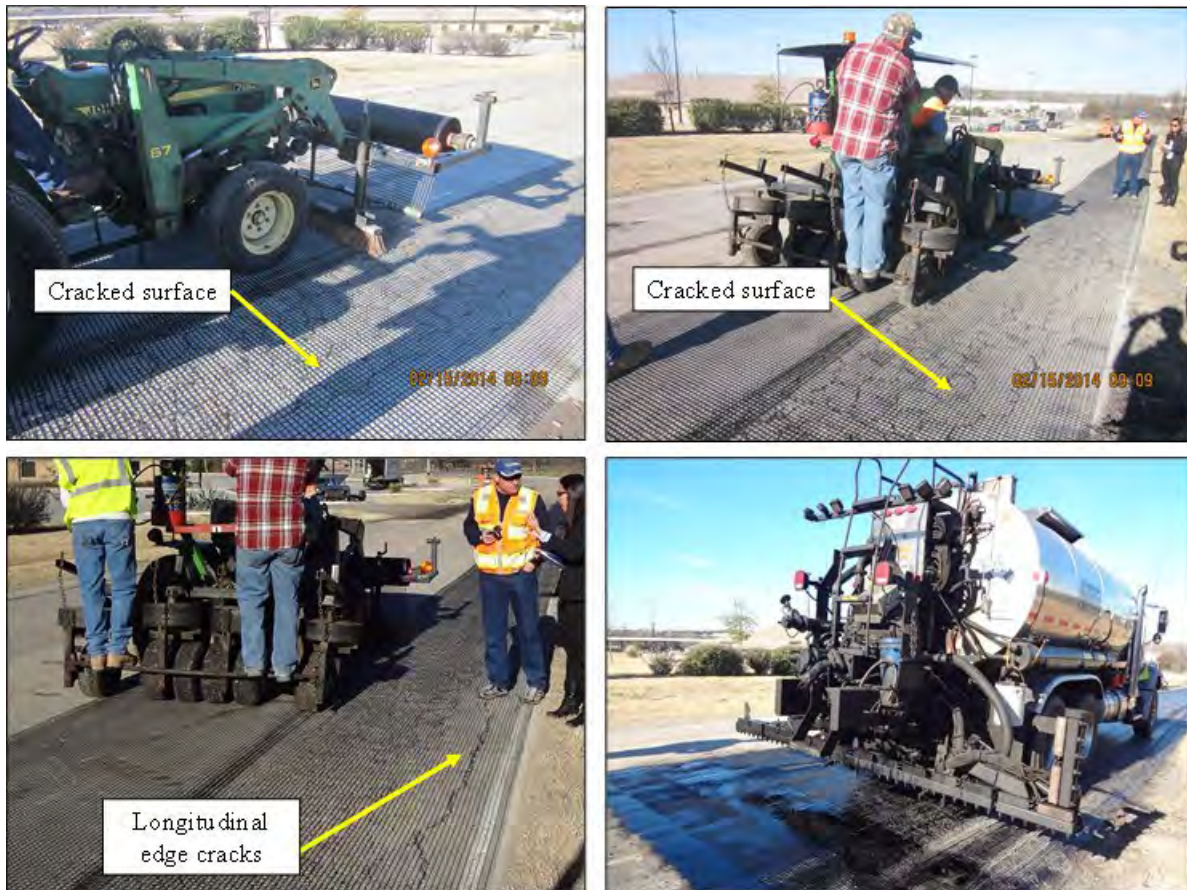
**Figure 4. Installation of geogrid reinforcement at Ferguson Lane in April 2014.**

The geosynthetic reinforcement adopted in the study was a biaxial geogrid made up of fiberglass strands that were coated with an elastomeric polymer and had a pressure sensitive adhesive backing to enhance their bonding with adjacent asphalt layers. The biaxial geogrid had an ultimate tensile strength of 100 kN/m at a strain of 3%, per ASTM D6637. The geogrid was placed directly on the pre-existing asphalt surface after removing dirt, dust, and other deleterious material. It is important to note that the pre-existing asphalt was not repaired i.e., neither milled nor levelled or any tack applied prior to the installation of geogrid. Figure 4 presents the treatment comprising the use of a geogrid reinforcement directly over alligator cracks and longitudinal edge cracks that were not treated. A polymer modified emulsion was then applied as a tack coat at a rate of 0.15 gal/yd<sup>2</sup> on the geosynthetic reinforcement.

This trackless tack emulsion is applied hot and would cool down in less than 20 seconds, helping the truck pass over the geogrid without damaging the geosynthetic installation.

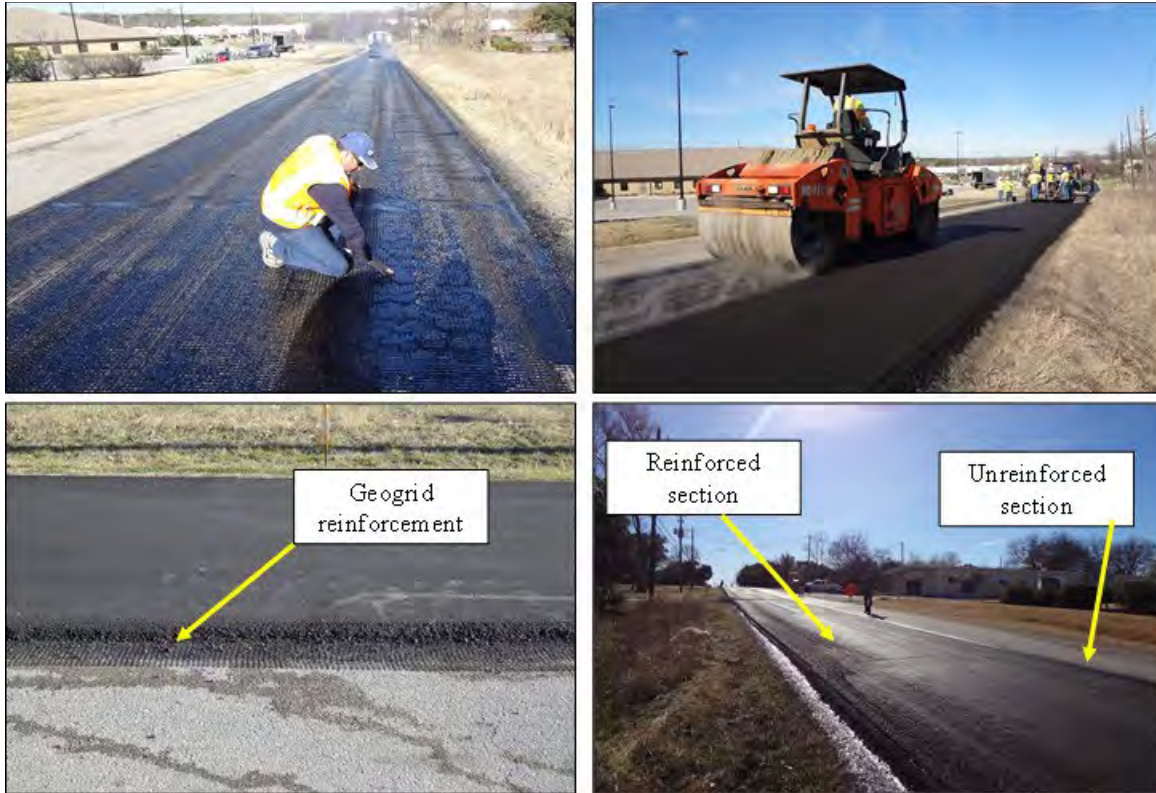
**Figure 5. Final paving work at the geosynthetic-reinforced section.**

Subsequently, a 75 mm-thick dense graded asphalt (TY-C) was placed at a temperature of 122 °C and compacted. As the trackless tack emulsion is heat-activated, it allows a better bonding between interlayers when hot asphalt is placed over it. Figure 5 presents the cooled tack coat and the compaction and final overview of the geosynthetic-reinforced asphalt overlay section.

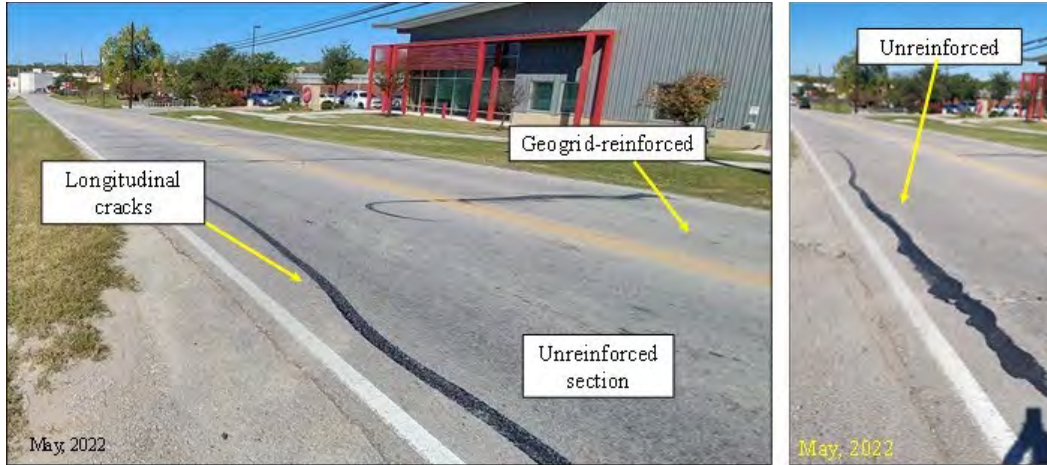
**Figure 6. Road conditions during 2022 survey.**

The experimental sections were evaluated in May 2022, after about 8 years of rehabilitation, to investigate the condition of unreinforced and geosynthetic-reinforced sections. The evaluation of experimental sections included visual examinations to identify the possible locations and types of distresses in both, unreinforced and geosynthetic-reinforced sections. Figure 6 shows the pavement surface conditions of the experimental sections during the visual examination survey conducted in 2022. As shown in the figure, the visual evaluation revealed that the longitudinal cracks reflected onto the asphalt overlays in the unreinforced section, while the geosynthetic reinforcements were effective in minimizing the reflection of such cracks from the pre-existing roadway. As shown in the figure, specifically, the longitudinal cracks existed on the pavement edges before pavement rehabilitation reflected in the unreinforced section. On the other hand, longitudinal edge cracks in the reinforced section did not reflect to the new surface suggesting that the geosynthetic reinforcement minimized the reflective cracks and any fresh longitudinal cracks from the expansive subgrade. This observation is particularly similar to the findings from Zornberg and Roodi (2021), in which environmental longitudinal cracks were found to be significantly lower in geosynthetic-stabilized sections than in control sections.

In addition, Figure 6 also revealed that some transverse cracks, roughly perpendicular to the centerline of the pavement, were observed in the unreinforced and geosynthetic-reinforced sections. However, it is important to note that these cracks are maybe caused due to the thermal expansion and contraction of the asphalt layer as a result of temperature variations. On the other hand, geosynthetic reinforcements were effective in resisting the reflection of severe alligator cracks for a duration of 8 years. Figure 7 shows a closer view of the edge cracks and the deteriorated surface condition in the unreinforced section, while the surface condition of geosynthetic-reinforced section looks much better in comparison.
