Installation of geosynthetic interlayers during overlay construction: Case study of Texas State Highway 21

V. Vinay Kumar^{a,*}, Gholam H. Roodi^b, S. Subramanian^{a,c}, Jorge G. Zornberg^a

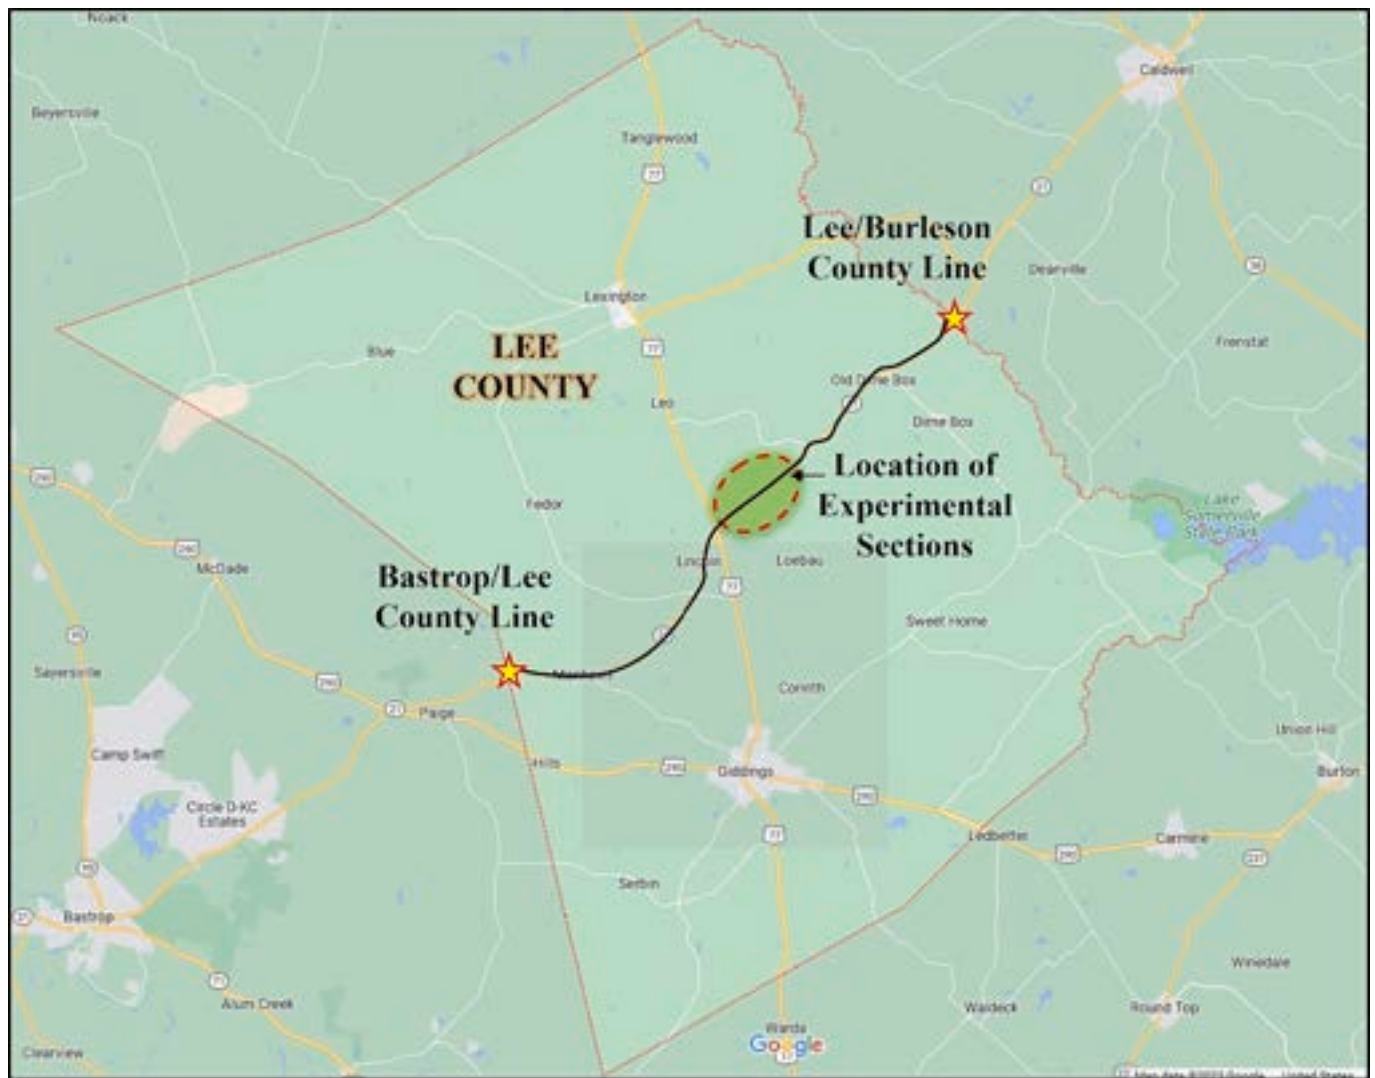
Fig. 2. Overall extents of SH21 rehabilitation project.

Fig. 2 shows the overall extent of the 33-km-long SH21 rehabilitation project within Lee County and the location of the experimental test sections. As the figure indicates, the experimental test sections were located to the east of the intersection of United States Highway (US) 77 and SH21. As part of the UT Austin-TxDOT research study, 32 experimental test sections (each approximately 70-m-long) involving different types of geosynthetic reinforcements (about 1.34 km in total length) were constructed. The roadway within the rehabilitation project limits consisted of four undivided lanes, each of which had a width of 3.35 m, and a paved shoulder with a width ranging from 0.6 m to 1.2 m. A schematic layout of the experimental test sections including sensor-instrumented and non-instrumented sections is presented in Fig. 3. Specifically, seven sections (six geosynthetic-reinforced and one unreinforced) of the eastbound outside lane (between STA 398 + 00 and STA 413 + 75) were instrumented with various sensors including moisture sensors in the subgrade; geophones in the subbase, base and pre-existing asphalt layers; asphalt strain gauges in the pre-existing asphalt layer; and thermocouples in the pre-existing asphalt and overlay. Additional moisture sensors were installed in the subgrade soil across all four lanes of the unreinforced section between STA 404 + 75 and STA 407 + 00. Experimental test sections that did not include any sensors are referred

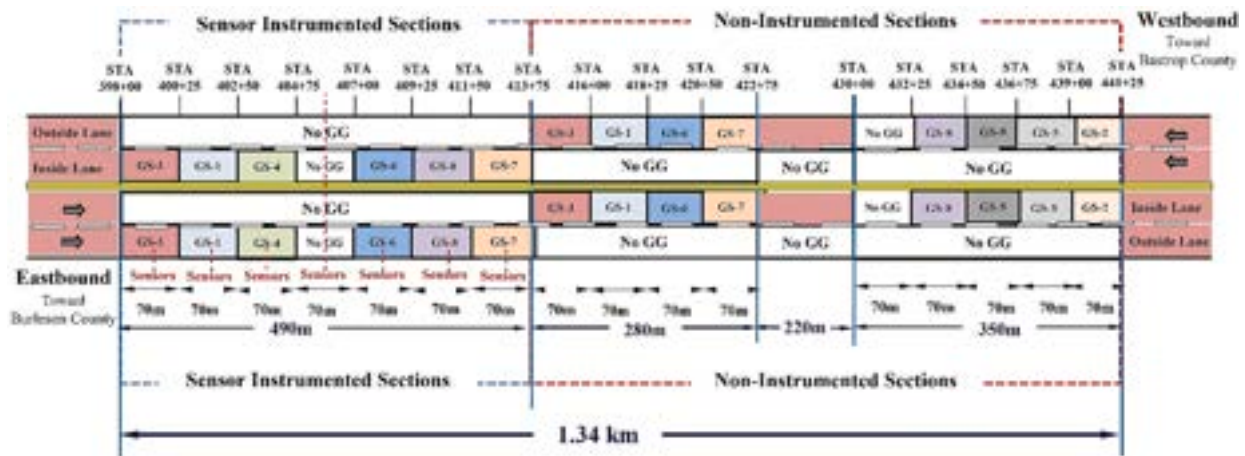
Fig. 3. Schematic layout of SH21 experimental test sections.

to as non-instrumented sections (see Fig. 3). The test section layout was designed so that the influence of traffic and temperature loadings on both inside and outside lanes could be considered. Consequently, the sensor-instrumented sections had geosynthetic interlayers on the westbound inside lane and eastbound outside lane, while the non-instrumented sections had geosynthetic interlayers on the westbound outside lane and eastbound inside lane (see Fig. 3). Furthermore, each geosynthetic-reinforced section had a companion unreinforced section to facilitate comparison of their responses under varying traffic and temperature conditions.

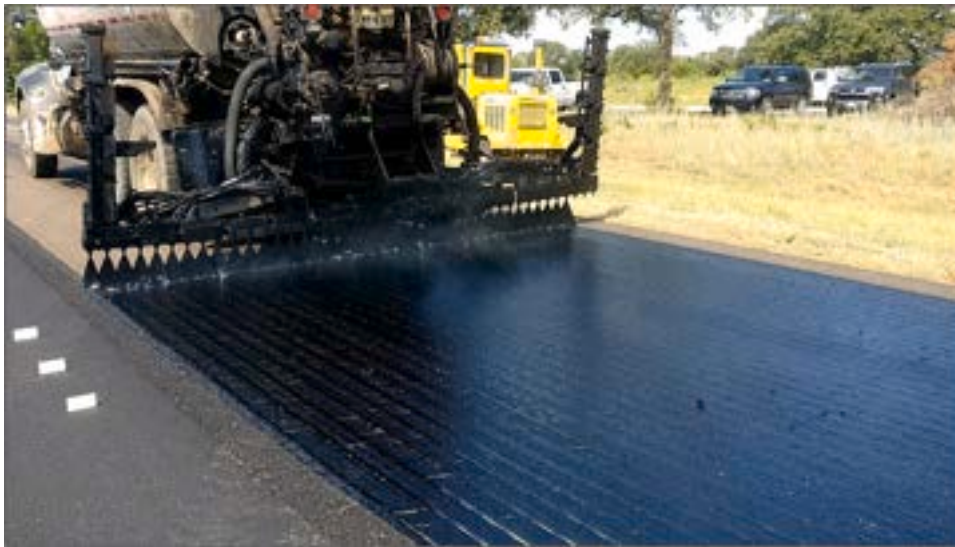
Fig. 8. Polymer asphalt cement (AC-15P) tack application in experimental test section.

Two different types of tack coat were used during the overlay construction. The first type, AC-15P, was applied as a tack coat on the 20-mm-thick level-up asphalt course that was placed after the pre-existing asphalt layer was repaired and prior to the installation of geosynthetic interlayers. A second type, CSS-1H, was applied as a tack coat at a rate of 0.27 l/m² on the 20-mm-thick level-up asphalt course in the unreinforced experimental section as well as over the 50-mm-thick TY-D layer prior to construction of the 25-mm-thick TOM layer in unreinforced and geosynthetic-reinforced sections.

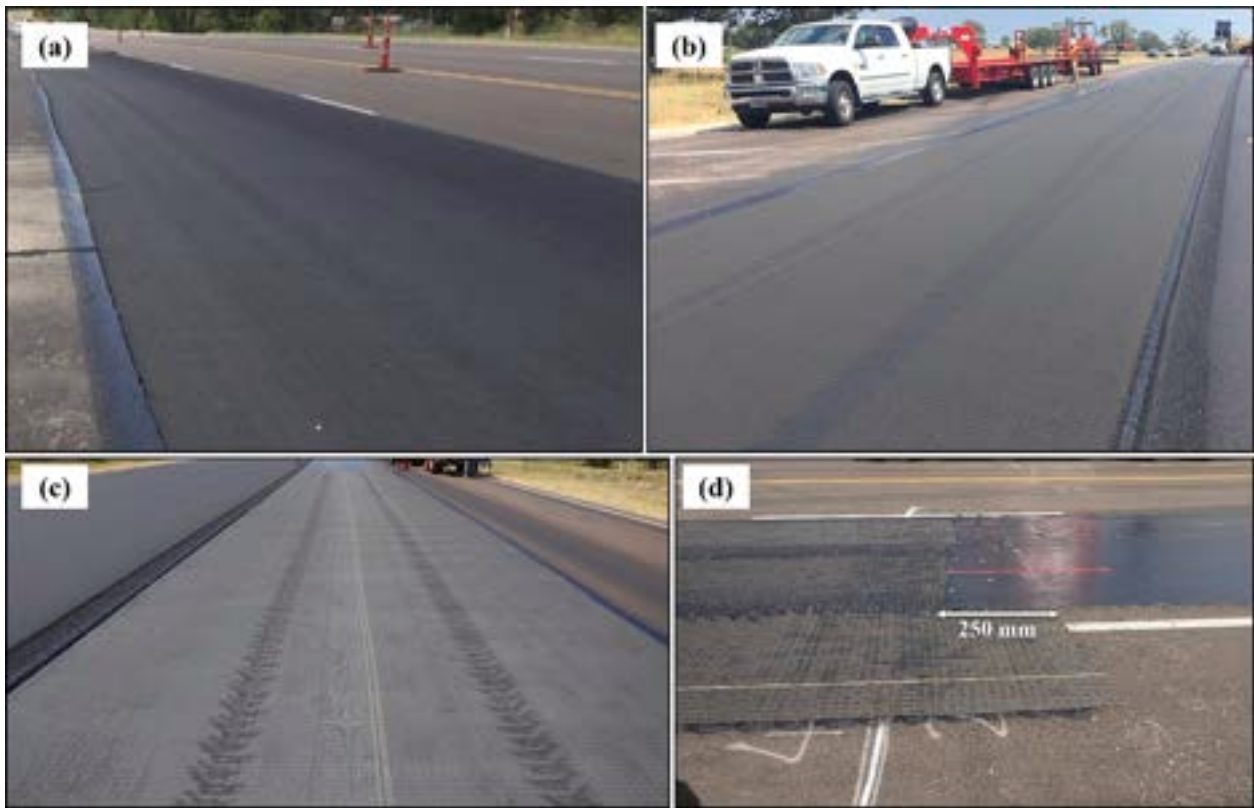
Fig. 10. Photos showing proficient geosynthetic installation in experimental test sections: (a) GS-1; (b) GS-2; (c) GS-3; and (d) overlap between geosynthetics GS-6 and GS-8 in longitudinal direction.

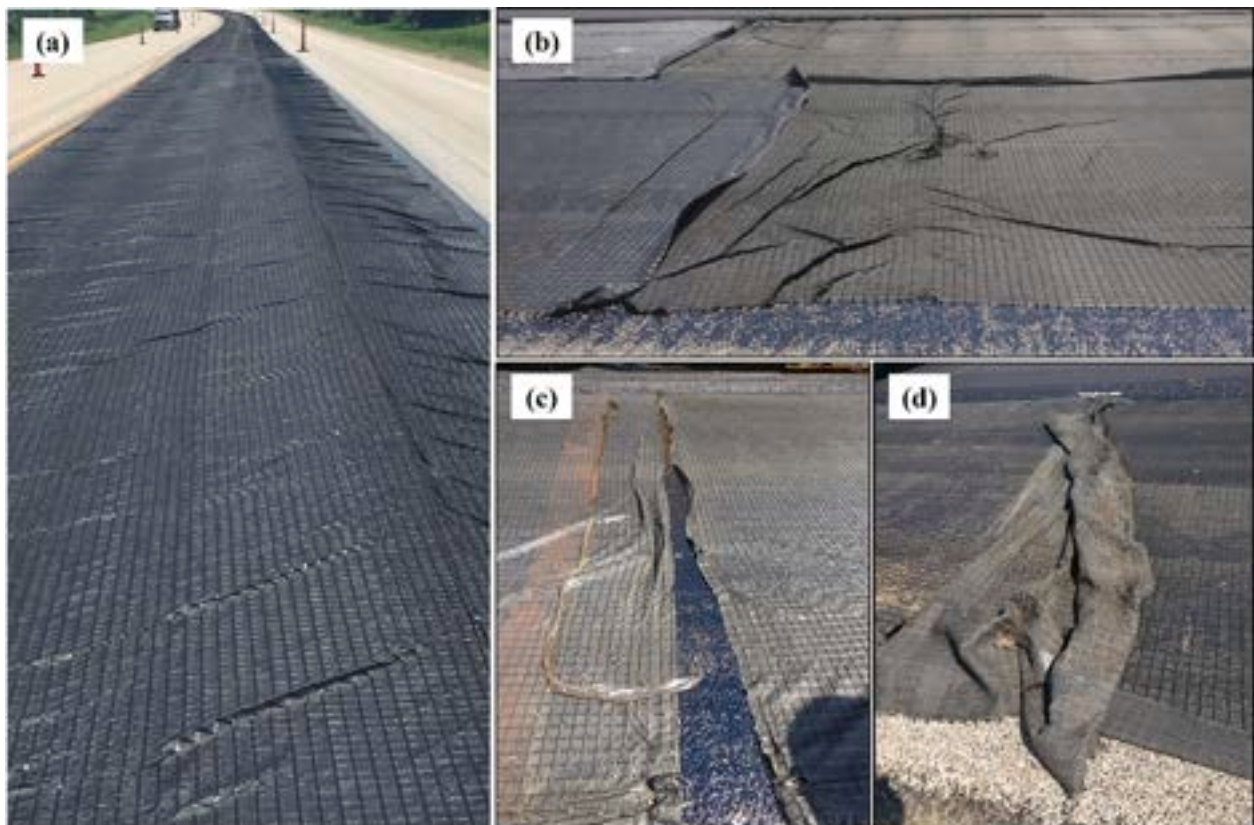
Fig. 11. Photos showing poor geosynthetic installation: (a) numerous wrinkles along roadway; (b) inadequate geosynthetic overlap in longitudinal and transverse directions; (c) no geosynthetic overlap in longitudinal direction; and (d) excess geosynthetic overlap in longitudinal direction.

geosynthetic installation at a number of locations beyond the experimental test sections but within the 33-km-long rehabilitation project. Fig. 11a and 11b shows multiple wrinkles exceeding 25 mm along the roadway and inadequate geosynthetic overlap in the longitudinal and transverse directions, respectively. Fig. 11c and 11d show no geosynthetic overlap and excess geosynthetic at the overlap in the longitudinal direction, respectively. Figs. 10 and 11 also reveal that the geosynthetic interlayers (specifically the composite products) were installed with the grid side facing down (i.e., geotextile facing up). When installed with the geotextile side facing up, construction traffic can avoid direct contact with the tack coat and geogrid. This light-weight geotextile is melted by the overlaying hot mix layer to facilitate interlock and bonding between the interlayer and asphalt as well as bonding between the asphalt layers (e.g., GS-1, GS-4, GS-5, GS-6). Overall, the geosynthetic installation procedures adopted in the experimental sections were proficient compared to the rest of the project. It is recommended to adopt an efficient geosynthetic installation technique to achieve the objectives expected from the geosynthetic interlayer installed during the asphalt construction.

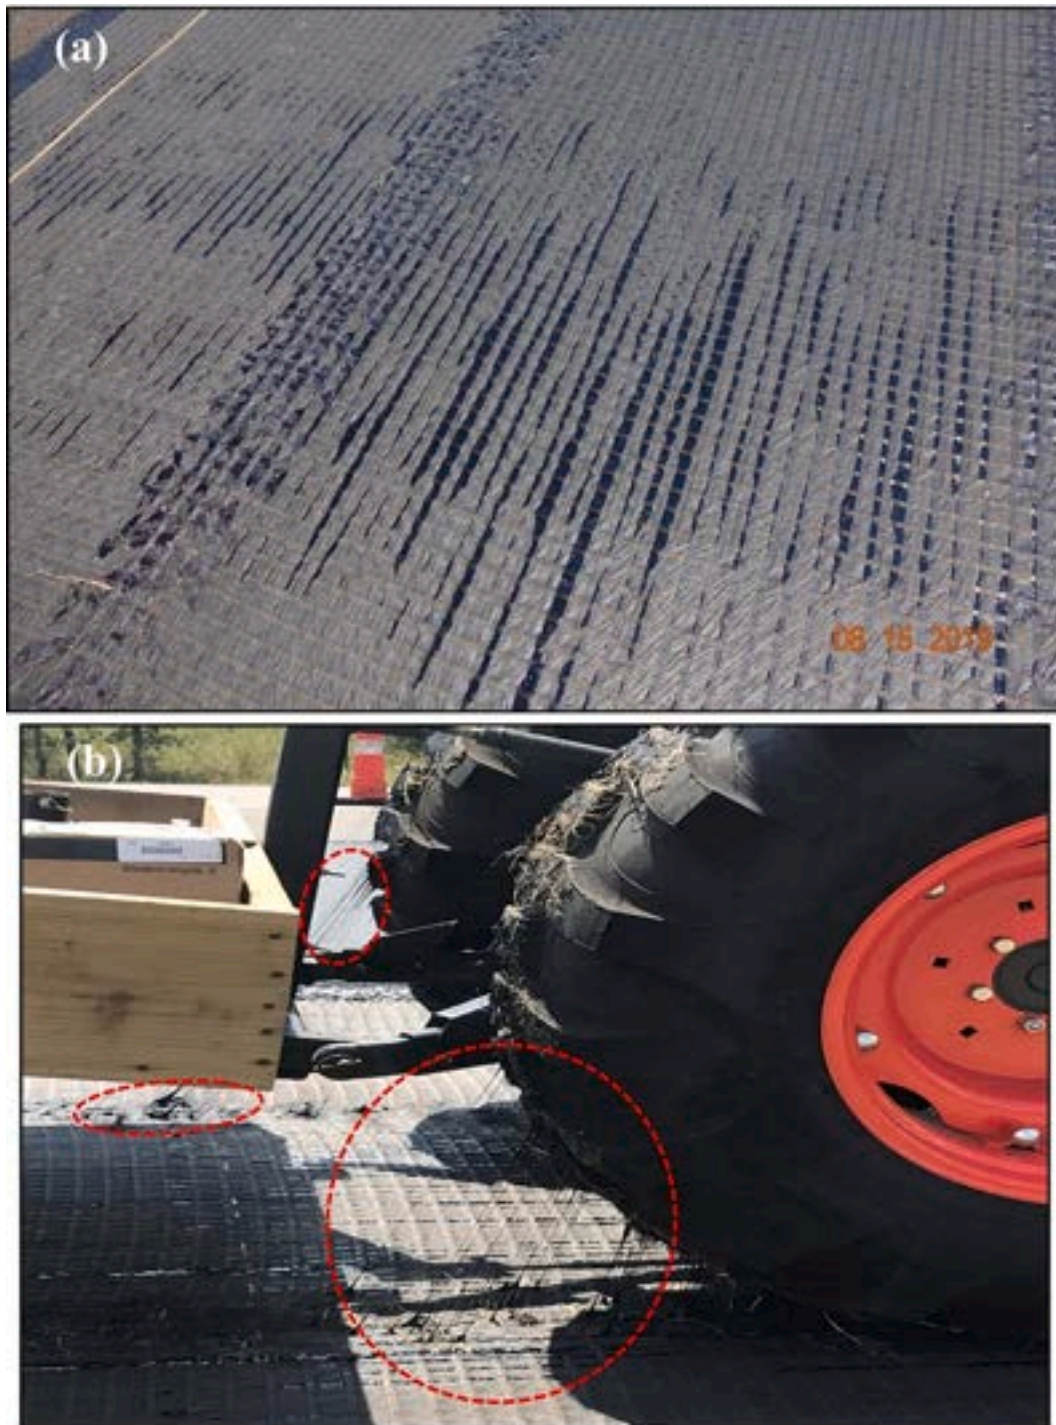
Fig. 12. Influence of temperature on tack coat and geosynthetics: (a) blistering of geotextile backing; and (b) tracking of geosynthetic installation tractor wheels.

greatly influence the bonding characteristics between the tack coat and geosynthetic interlayers. Typically, the tack application rates for geosynthetic-reinforced overlays are recommended based on the asphalt retention capacity of the geosynthetic interlayer, condition of the pre-existing asphalt surface (e.g., old and oxidized layer or a relatively new level-up layer or milled surface), temperature of the pre-existing asphalt surface (e.g., hot or cold) and type of tack coat adopted (e.g., asphalt binder or asphalt emulsion, slow-, medium- or rapid-setting). Accordingly, the manufacturer-suggested tack application rates were adopted in the non-instrumented experimental test sections prior to geosynthetic installation (see Table 5). However, the nonwoven geotextile backing of some of the geosynthetic interlayers (e.g., GS-1, GS-4, GS-5, GS-6) blistered shortly after installation due to high temperature of the pre-existing asphalt surface, as exhibited in Fig. 12a. Additionally, such high pre-existing asphalt surface temperatures increased the tack coat temperature and decreased its viscosity, causing the tack coat to bleed through to the geosynthetic surface via the blistered geotextile backing. This blistered geotextile backing exposed the tack coat to the surface (bleeding) through the reinforcement apertures, resulting in tracking of the geosynthetic installation tractor wheels shown in Fig. 12b.

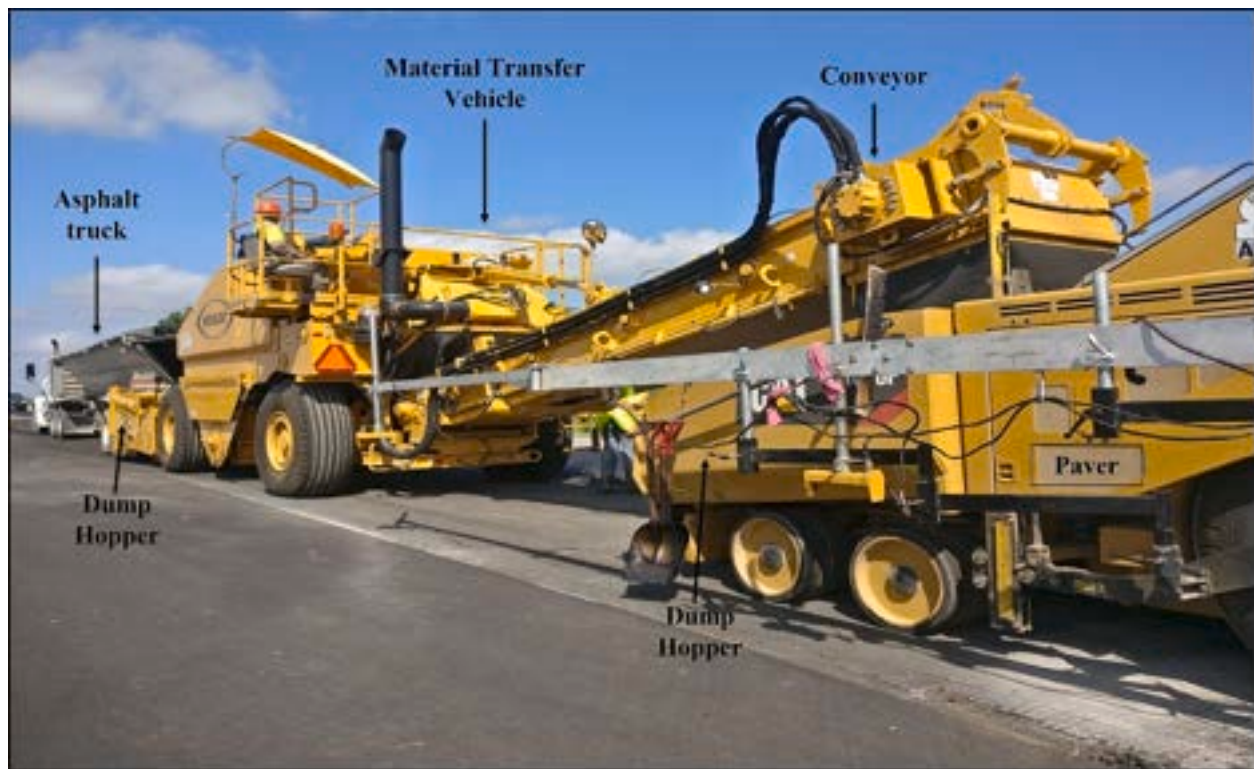
Fig. 14. Asphalt overlay construction equipment used in SH21 rehabilitation project.

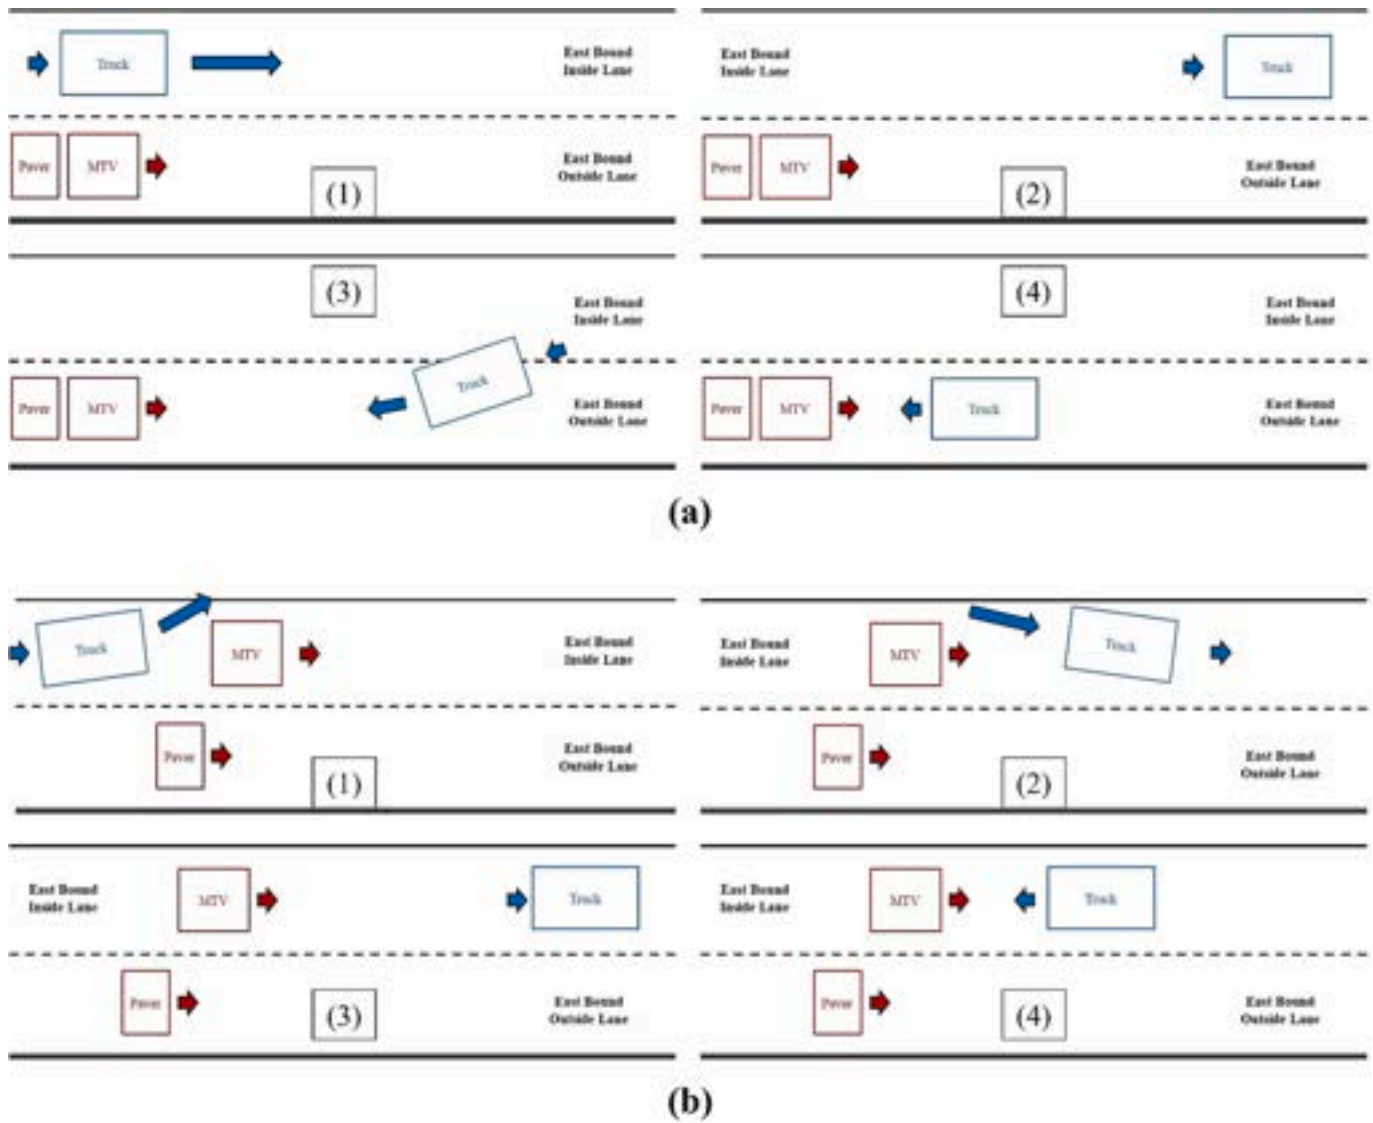
Fig. 15. Schematic of asphalt feeding sequence to Material Transport Vehicle (MTV) and paver in SH21 rehabilitation project: a) typical arrangement initially used in non-instrumented sections; and b) revised arrangement adopted to minimize damage to geosynthetic.

asphalt truck approached the MTV and paver from the adjacent lane (i.e., eastbound inside lane), passed them and finally backed up to the MTV to feed the asphalt. The asphalt truck, MTV and paver assembly moved on top of the geosynthetic interlayer during the paving of a few non-instrumented test sections. However, that resulted in complications (see next Section) and as a measure, the overlay construction process was revised during the paving of the rest of non-instrumented and sensor-instrumented test sections. The complications and the technical reasons behind the adoption of a revised overlay construction process is detailed next.

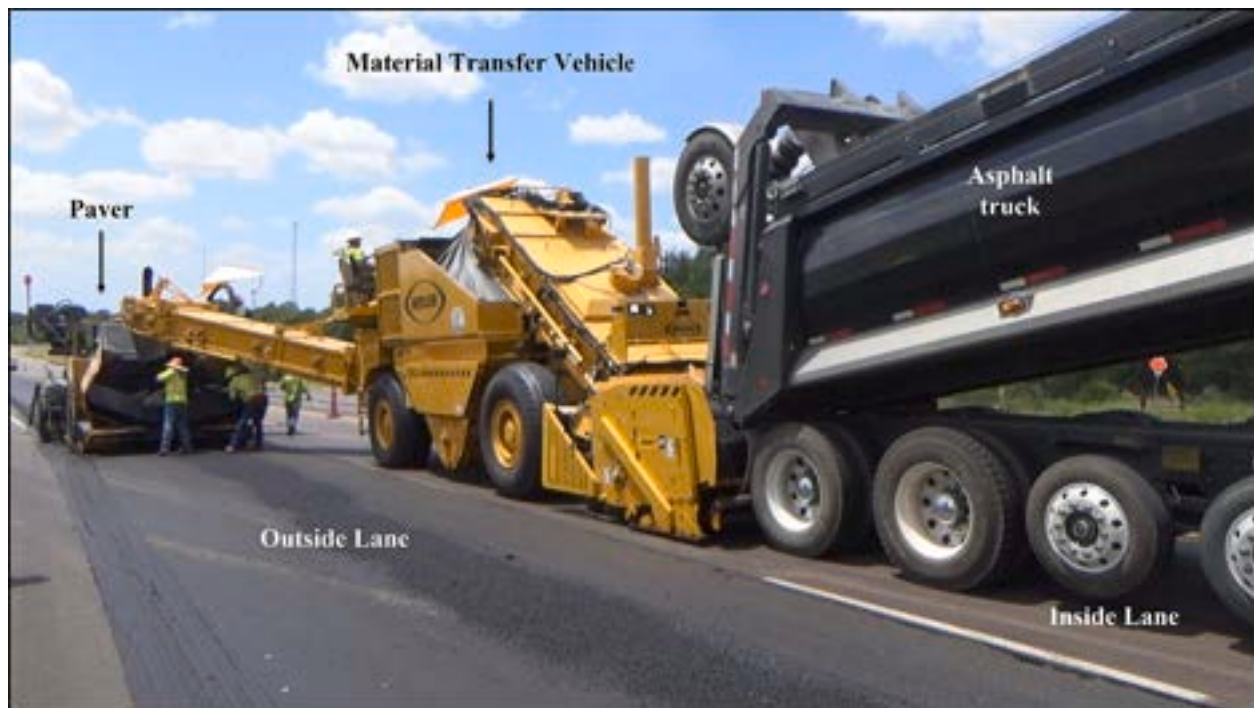
Fig. 17. Revised overlay construction process.

To overcome this critical construction issue, the overlay construction process was revised by moving the MTV and asphalt trucks to the adjacent lane while feeding asphalt to the paver. The revised arrangement of construction vehicles, presented in Fig. 17, restricted the movement of construction equipment on top of the geosynthetic interlayer to the paver only, thereby minimizing damage to the geosynthetic caused previously by the movement of MTV and asphalt trucks on the installed interlayer surface. The sketches provided in Fig. 15b demonstrate the revised asphalt overlay construction sequence. However, revising the construction process as previously described may not necessarily be possible (or prove very challenging) in projects with single-lane construction closures. Therefore, adopting an appropriate tack coat type and application rate are crucial to minimize such damages

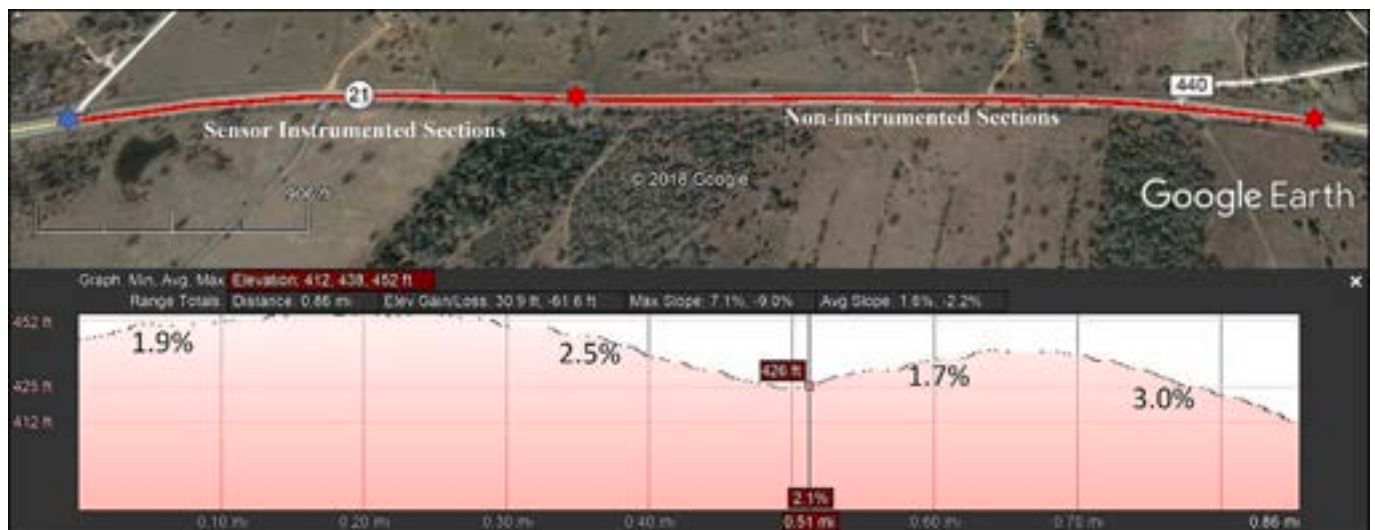
Fig. 18. Longitudinal profile of experimental test sections.

On the other hand, construction vehicles need an increased acceleration when paving along an upslope road (e.g., in a summit curve). Fig. 18 shows the longitudinal profile of the experimental test sections, including both sensor- and non-instrumented sections, which consist of both summit and valley curves with several up- and down-slopes. Specifically, the sensor-instrumented sections between STA 398 + 00 and STA 407 + 00 have an upward slope with a gradient of 1.9% followed by

a downward slope with a gradient of 2.5% that continues through the end of the sensor-instrumented sections and four of the non-instrumented sections (i.e., until STA 422 + 75). The remaining non-instrumented test sections, starting at STA 422 + 75 and ending at STA 430 + 00, have an upward slope with a gradient of 1.7% followed by a downward slope with a gradient of 3% until the end of the non-instrumented test sections (i.e., STA 441 + 25). This profile resulted in an upward roadway slope of 3% during construction of the non-instrumented test sections in the westbound lanes that required an increased acceleration of construction vehicles.

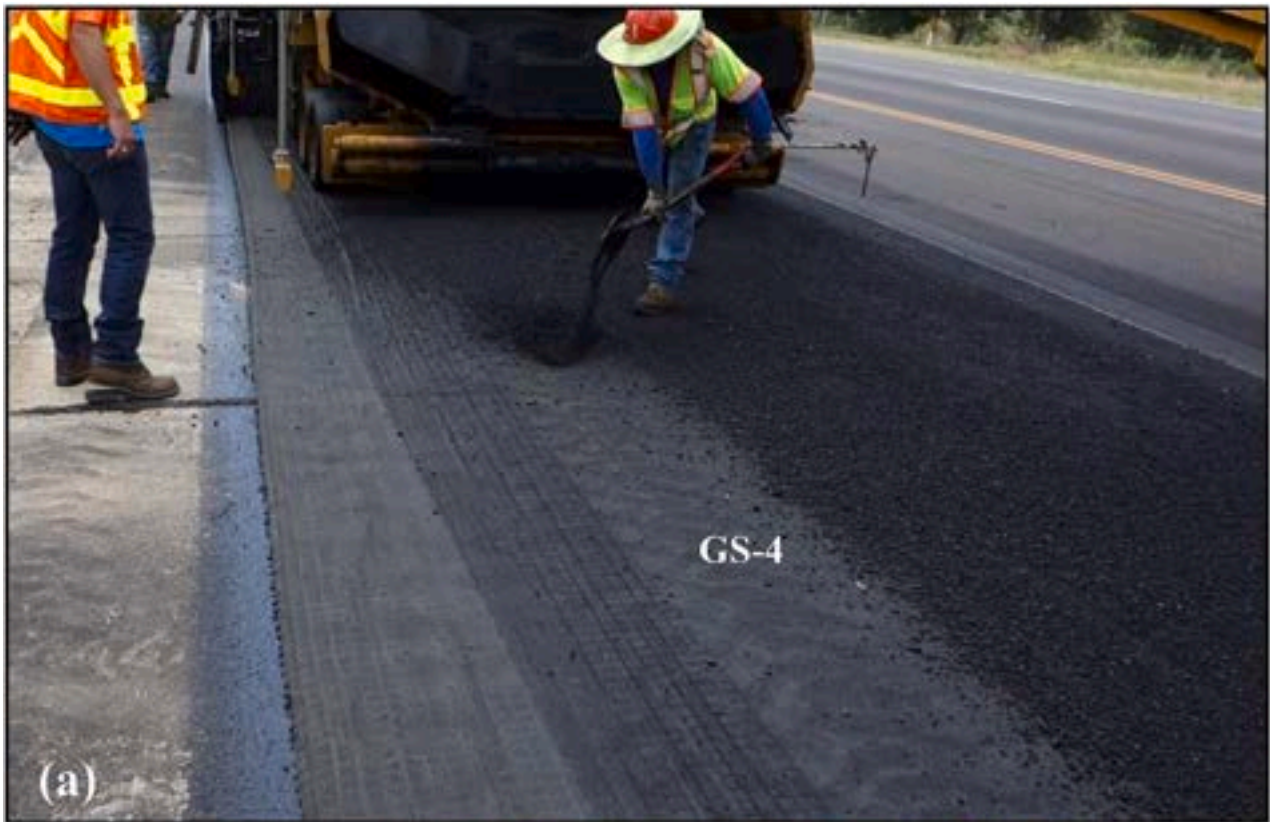
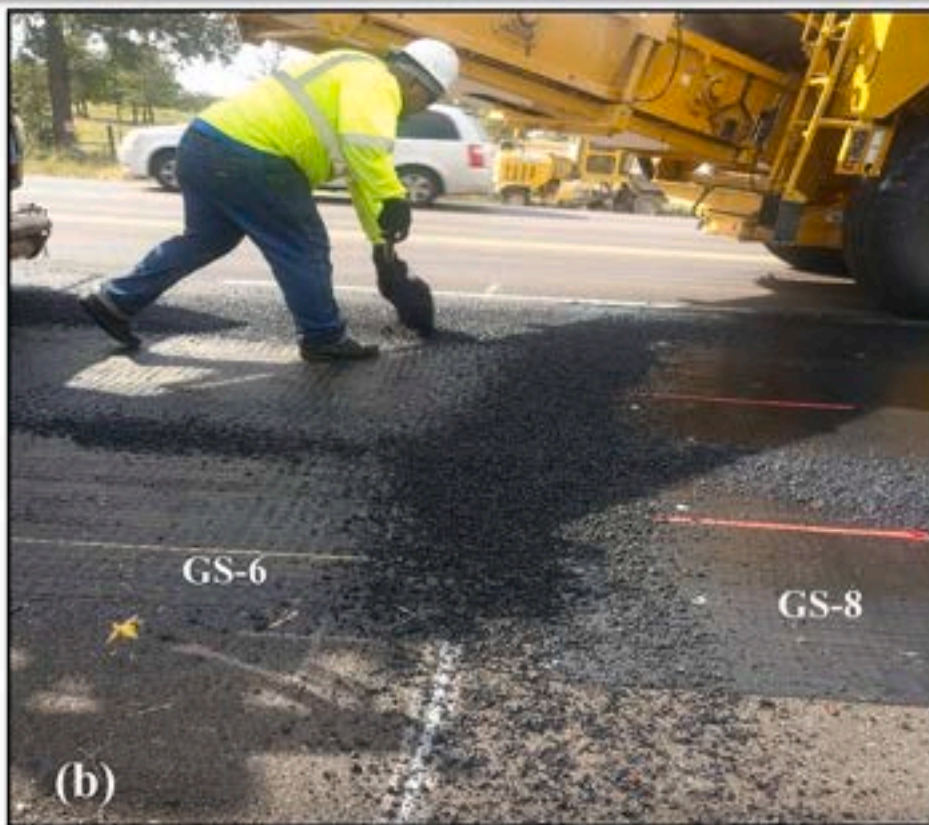
Fig. 20. Asphalt sanding: (a) uphill paver wheel path; and (b) geosynthetic overlap.

- Asphalt sanding technique adopted herein to overcome the effects of grade and paver on geosynthetic interlayers, was found to be particularly effective in restoring the friction between the paver and surface, and enhanced the efficiency of overlay construction without damaging the geosynthetic reinforcement. This corrective measure can be adopted in future geosynthetic-reinforced overlay construction operations.
